Fire Equipment Foot Valve Study Investigating Leakage Potential for Aquatic Invasive Species (AIS) Transfer

Summary

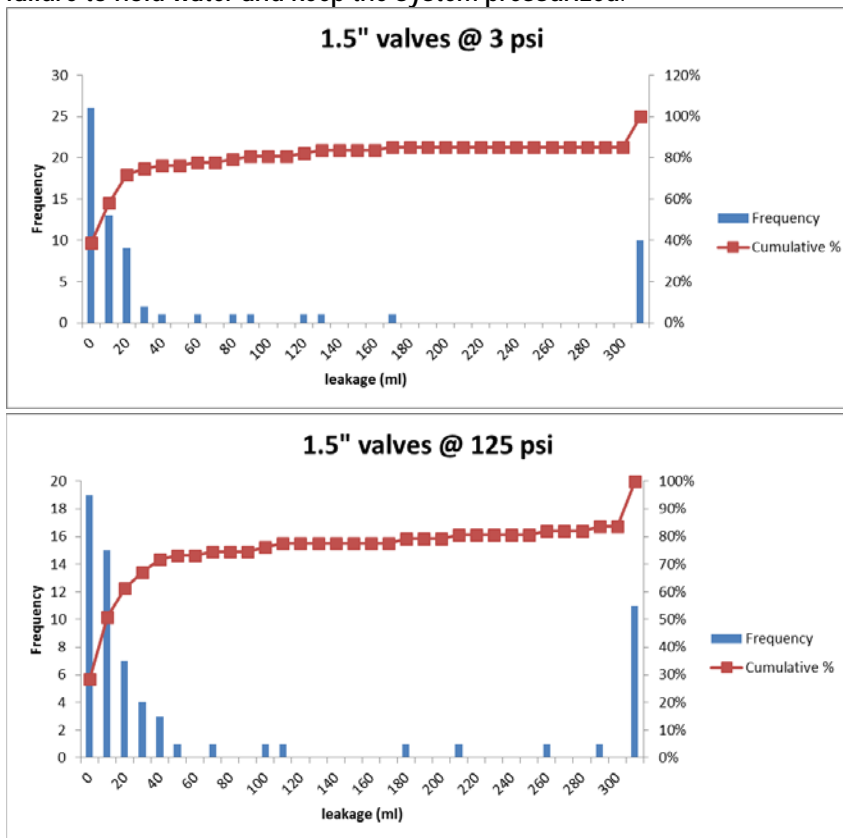
Fig 1. Frequency of 1.5" foot valves leakage (ml). Leakage values >1000 ml were considered complete failure to hold water and keep the system pressurized.

Between 60% and 70% of the 1.5” foot valves we tested leaked, and ~10% failed completely under pressure. Tables 1 and 2 and Fig 1 summarize leakage at 3psi and 125 psi for 3 minutes.

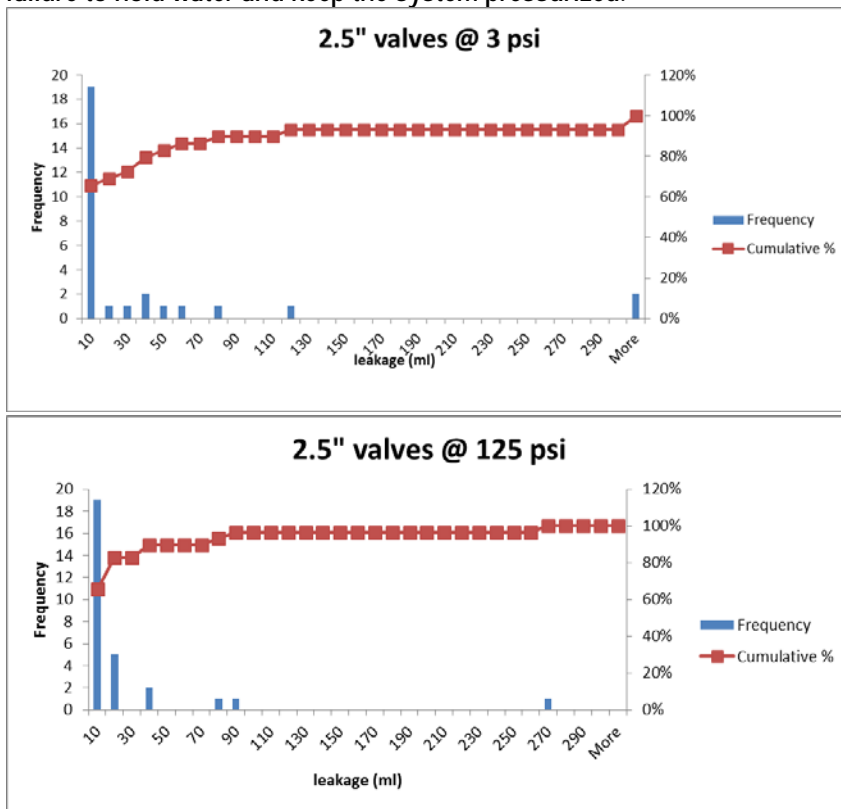
Figure 1 - Frequency of 2.5" footvalves leakage (ml). Leakage valves > 1000ml were considered complete failure to hold water and keep the system pressurized.

About 35% to 40% of the 2.5" foot valves we tested leaked, but none failed completely under pressure. Leakage from the 2.5 inch footvalves was similar to that observed in the 1.5 inch valves in that some leaked very little, some at lower pressure and some at the higher pressure (Table 3; Fig. 2).

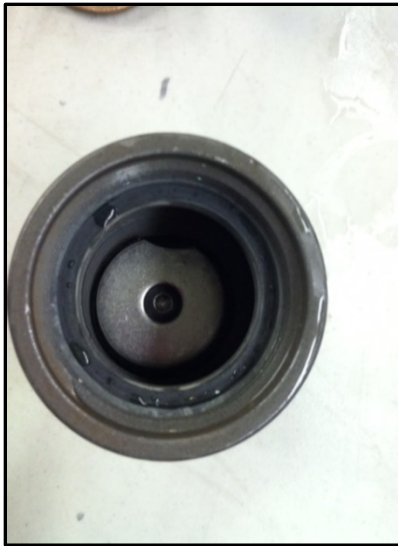
- Manufacturing defects –
 - casting of the valve housing where grooves or burrs remain and O-ring does not seat well (Photos 3, 4 and 6)
 - washer that seats the O-ring is defective, i.e., bent or misshapen
- Wear and residue –
 - O-rings in poor condition,
 - debris such as grass, sticks or rocks lodged between O-ring and housing (Photo 5)
 - poor connection between foot valve and housing (Photo 7)

Footvalve defects and leakage photos: washer inside valve not completely circular (top left), o-ring frayed or internal circular washer is bent (top middle), debris embedded underneath the o-ring causing water to leak thru (top left), body casting flaw allowing water to seep between the O-ring and housing (bottom left), leakage at connection within footvalve to thread (bottom right)

However, valve leakage can be minimized through best management practices regarding footvalve installation. Because some leaks were correlated with debris, ensuring clean valve sealing surfaces is vital. Some leaks were caused by manufacturer defects (metal burrs, bent washers) and worn parts, so inspection of valves pre-incident would be effective. Some new valves leaked because O-rings were not seated properly, and shaking the housing to reset the ring eliminated leakage. This action could perhaps be added to valve BMPs.
