# **Chimney Rocks Fire Burned Area Response Accomplishments in FY-2018**

***DEPARTMENT OF THE INTERIOR  
NATIONAL PARK SERVICE  
Big South Fork National River and Recreation Area  
Kentucky and Tennessee***

***September 10, 2018***

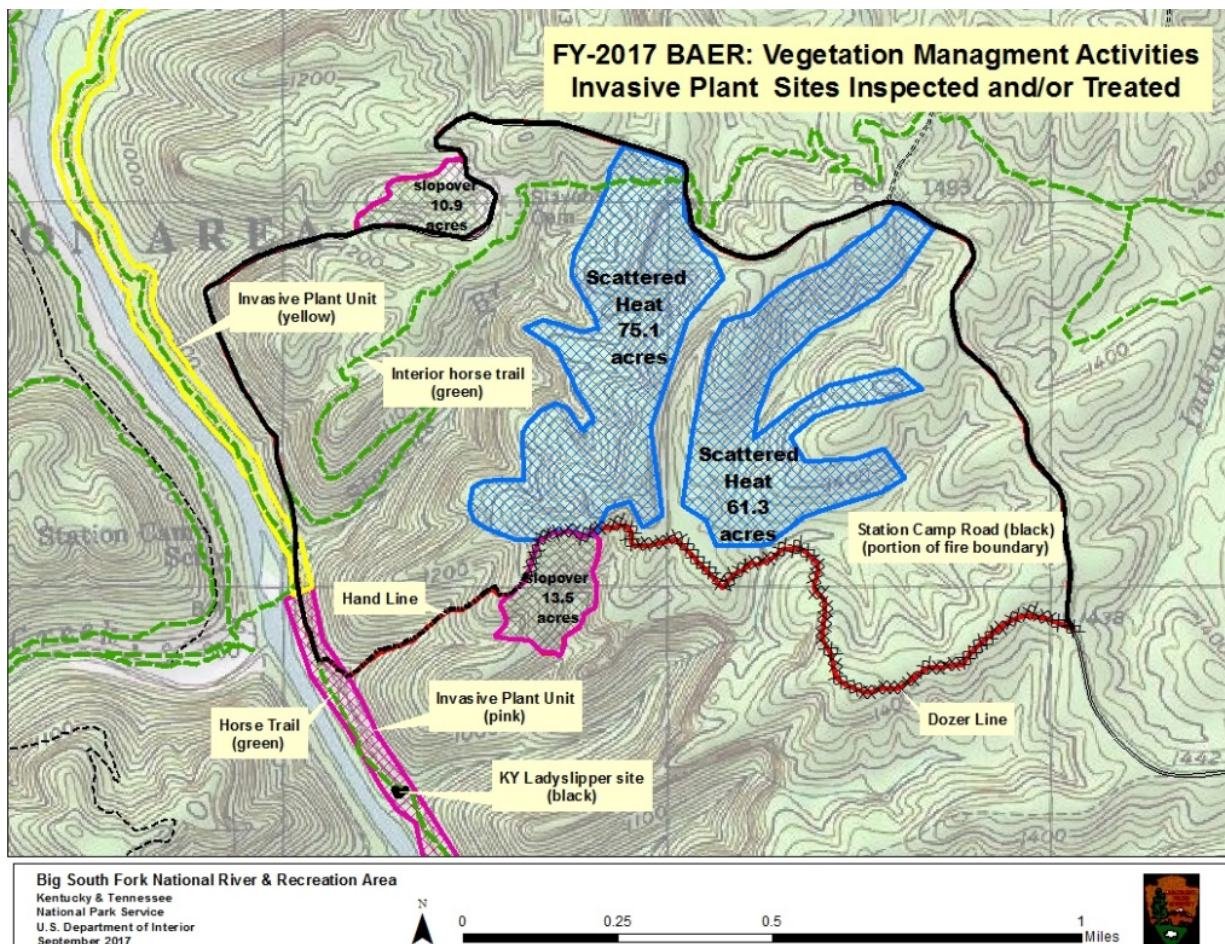
Map 3.. Chimney Rocks Fire non-native plant management areas inspected and treated in FY-2017.

In FY-2018, invasive plant control was focused on monitoring and retreating, as needed, sites treated in FY-2017 (Map 3). Specific actions taken for individual target areas are described further, below.

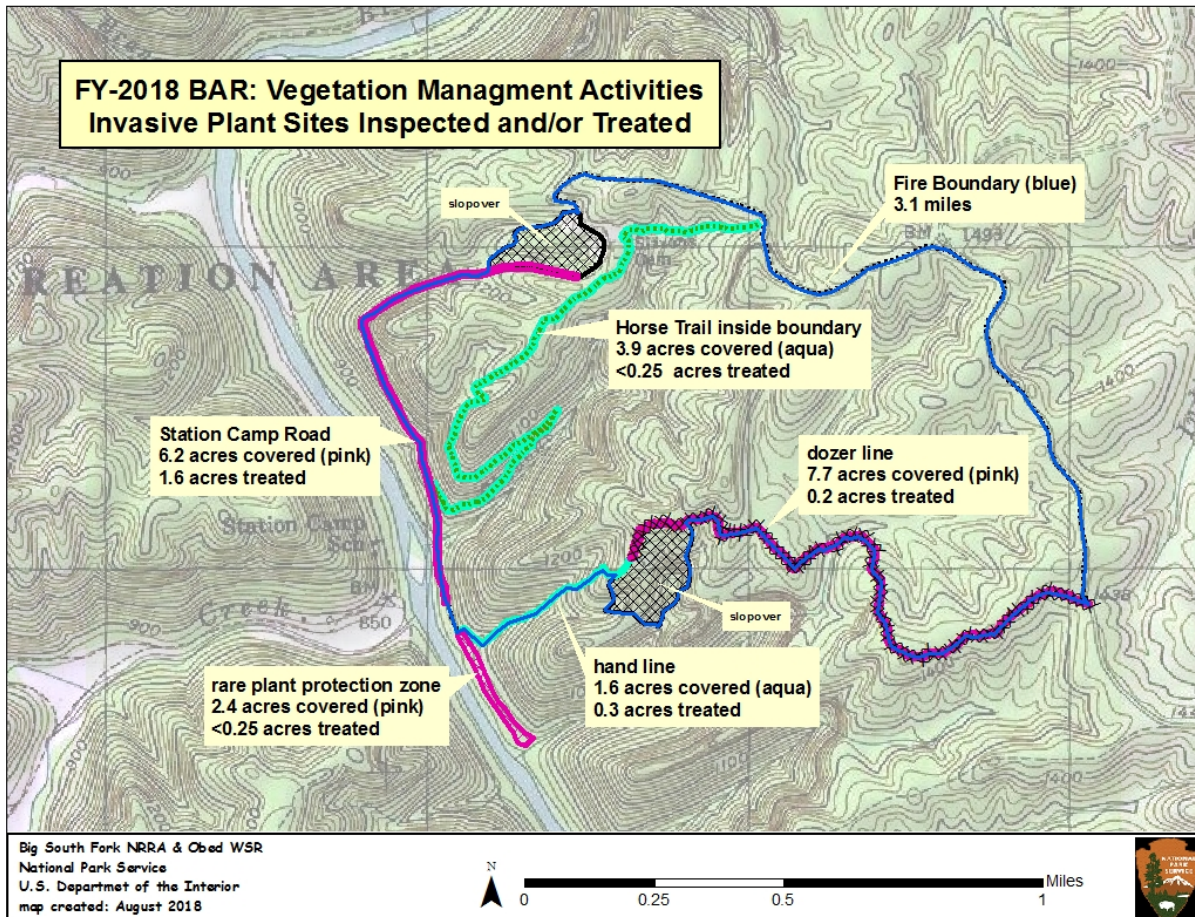
Map 4.. Chimney Rocks Fire non-native plant management areas inspected and treated in FY-2018.

Overall, 9.6 acres were treated in FY-2017 compared to 2.6 in FY 2018. Of 9.6 acres treated in 2017, approximately 1 acre required retreatment, thus indicating that areas treated in 2017 were successfully controlled. Areas along the fire perimeter where secondary target species were treated make up the additional 1.6 acres treated in 2018. Monitoring and treatment of these sites will be conducted, as needed, over the next 5 years. Map 4, below, illustrates further the areas monitored and treated in FY-2018.
