Coyote Fire Burned Area Rehabilitation Plan

Guadalupe Mountains National Park

Coyote Fire

BURNED AREA REHABILITATION PLAN

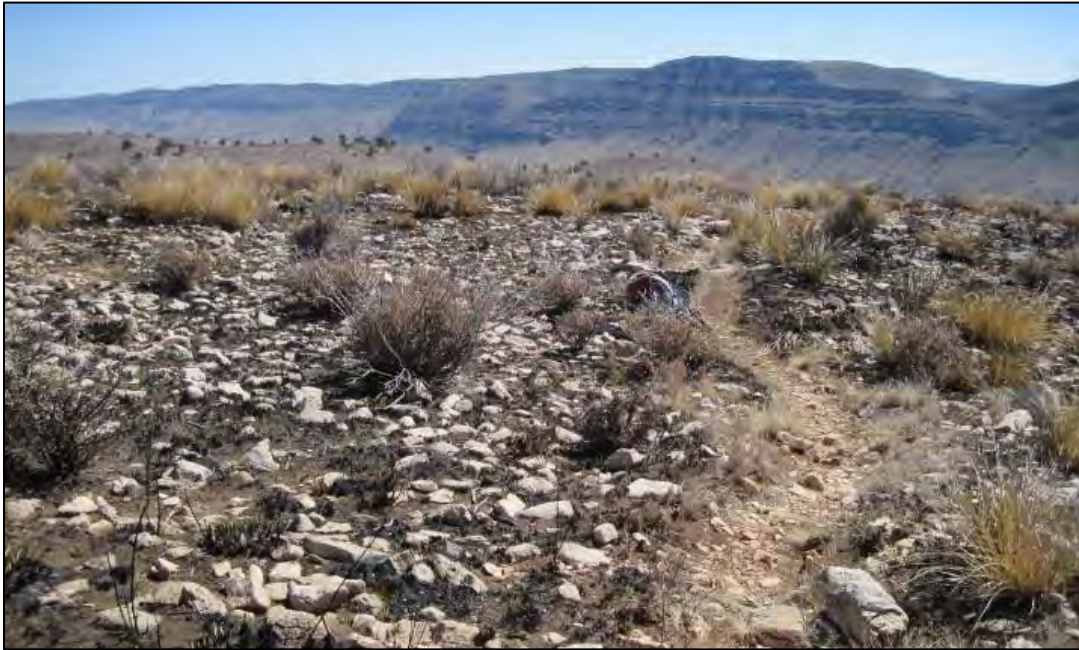
Site is a prehistoric lithic scatter located on a ridge top; the site burned with low intensity. The site was visited in 2010 after the Cutoff Fire; at that time the recorders noted that only one flake was found. The current condition is the same as previous assessments. No stabilization or further work other than periodic monitoring is needed.

Figure 1: 41CU252 overview facing north.

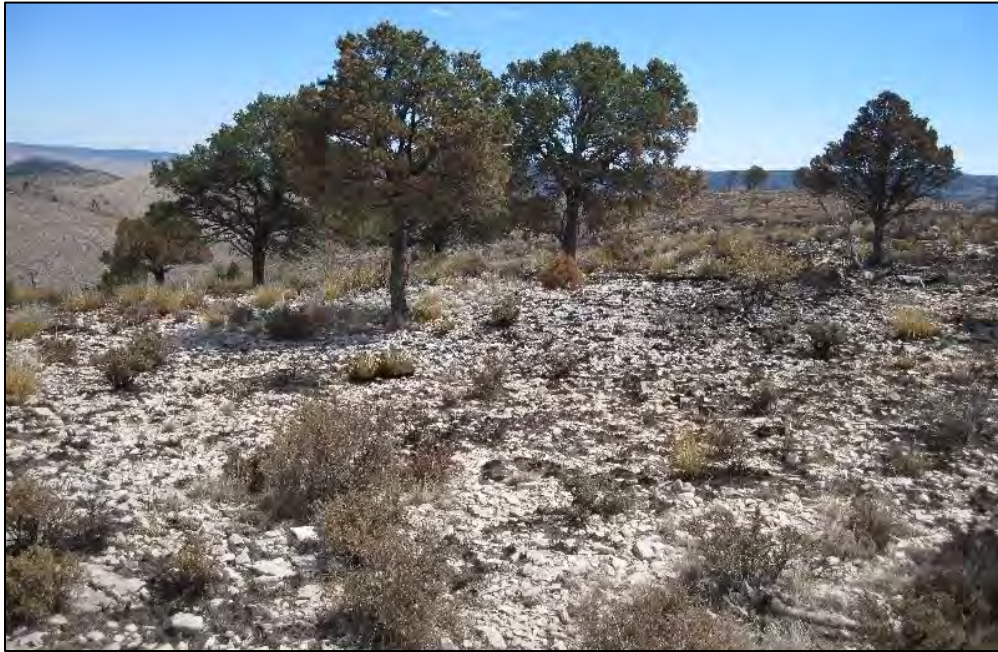
Site is a prehistoric lithic scatter and ring midden located on a ridge top. The site was found to be as described after the Cutoff Fire. The south side of the site burned with moderate intensity, while the north side burned with low intensity. The site is stable due to grasses, shallow soil and low slope angle. The ring midden has a 60 cm head cut on the northwest side that should be monitored for future erosion; this erosion will not likely be enhanced as a result of fire effects. The site is stable, in good-fair condition (due to head cut), and no further work is recommended.

Figure 2: 41CU139 overview facing north.

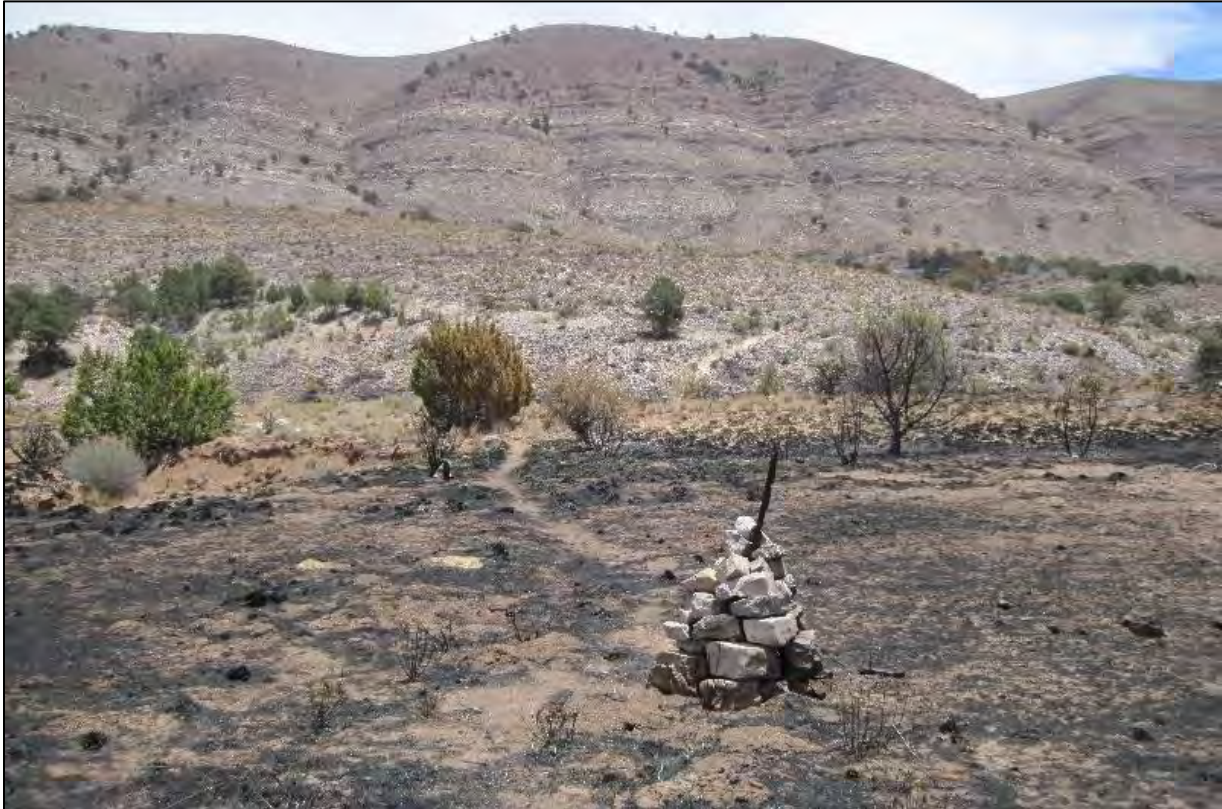
Site is a sparse lithic and seven rock middens. The historic component consists of an earthen dam and campsite. In its current condition, the site appears as recorded in 2011. As stated in the original documentation, erosion is the main threat to this site. See Specification V-2 for recommended work to stabilize this site to minimize future erosion.

Figure 4: 41CU781 overview facing north.

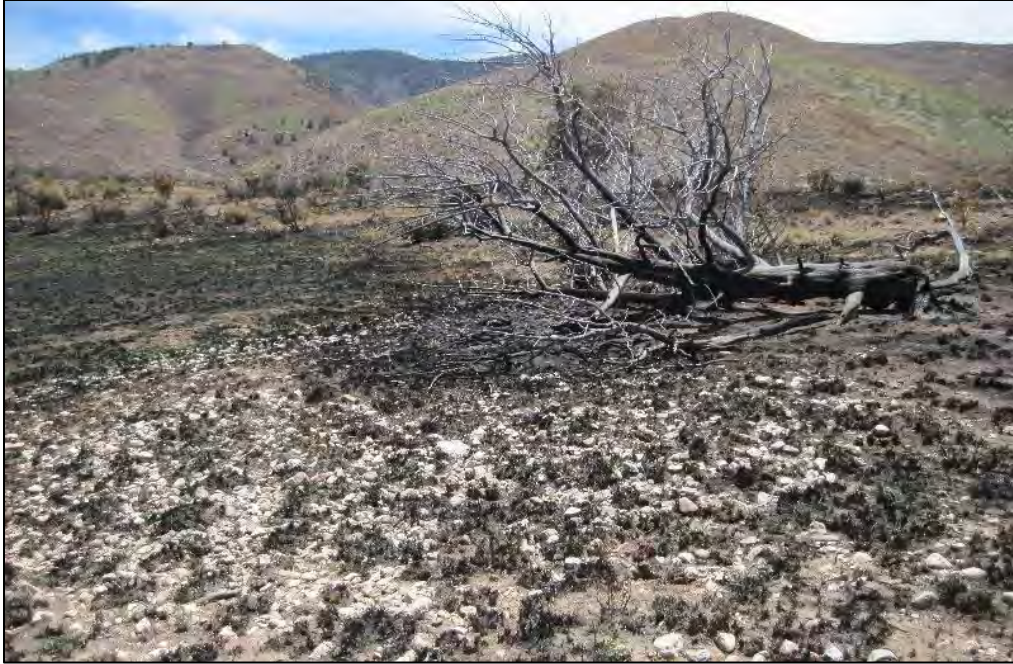
The site was found to be as described. Site is in danger due to flash flooding exacerbated by the Coyote Fire. The site needs to be re-recorded to modern standards, and monitored within the next 6 months, preferably before monsoon. A data recovery plan should be made for the second roasting pit that includes charcoal samples, soil samples, pollen samples, and residue samples.

Figure 8: 41CU151 Feature 1, ring midden.

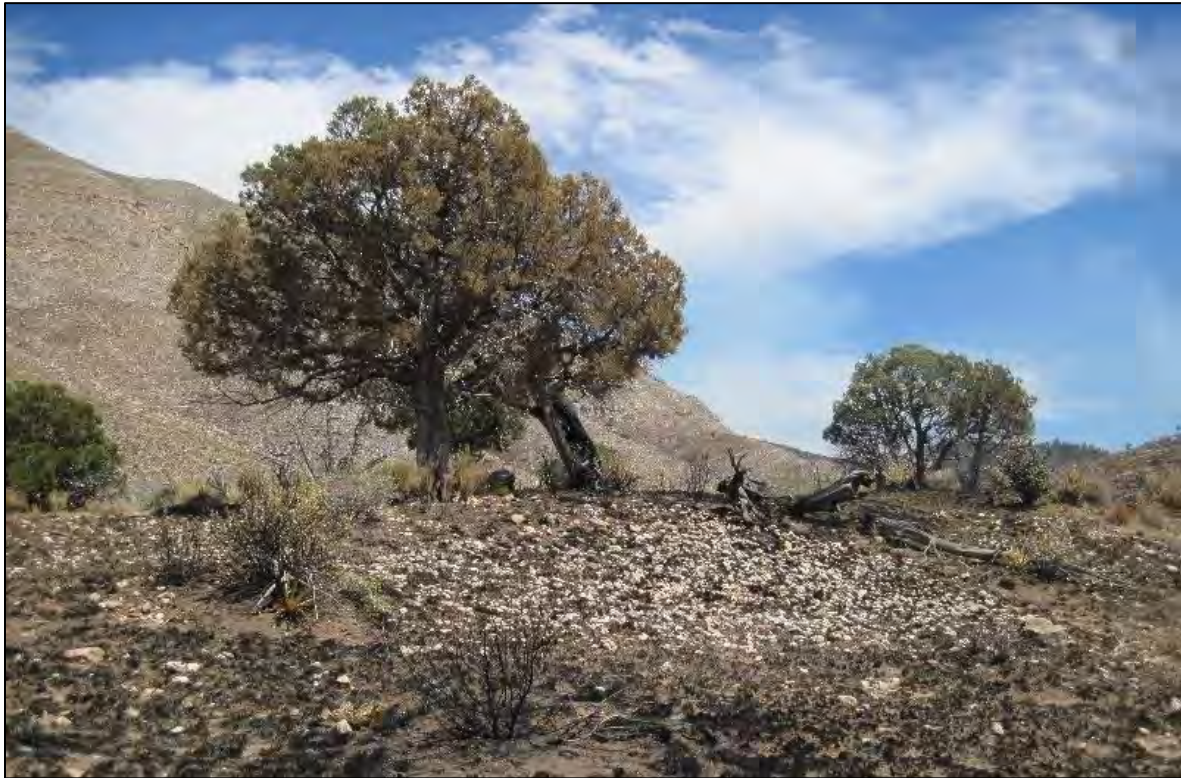
Site is a multicomponent site consisting of ring middens, lithics and an historic campsite. The site is as recorded. Previous records indicated that future erosion and site damage may take place due to already eroded trail. Trail maintenance will alleviate the problem. The site is in good and stable condition however, due to the risk of flooding from the Coyote Fire site should be monitored after or during the monsoon.

Figure 10: 41CU791 Feature 4.

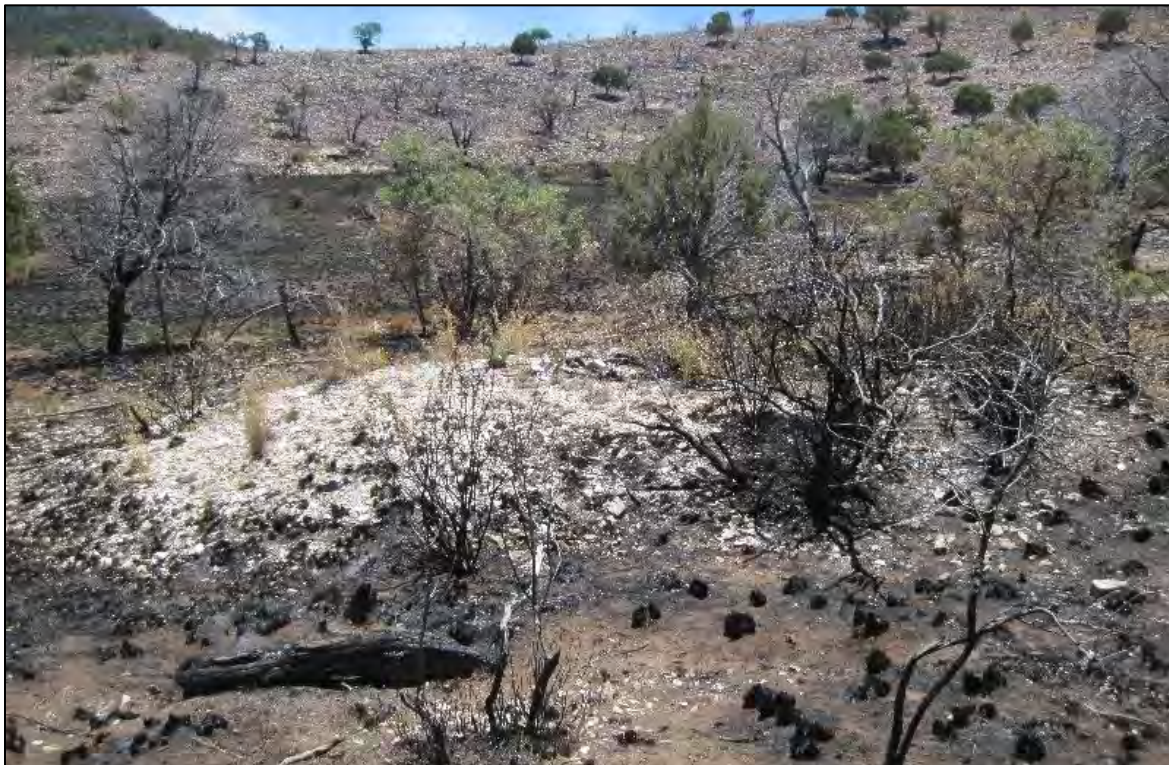
This site is an excellent example of a ring midden or roasting pit. The ring is intact and stands out against its environment. The midden retains its integrity and research potential. The site is stable and in good condition. An updated map is suggested. A cut bank on the south side of the site may pose a threat if flash flooding occurs, this should be monitored regularly. If erosion due to flooding becomes an effect to the site, a data recovery plan should be made.

Figure 15: 41CU98 overview facing south.

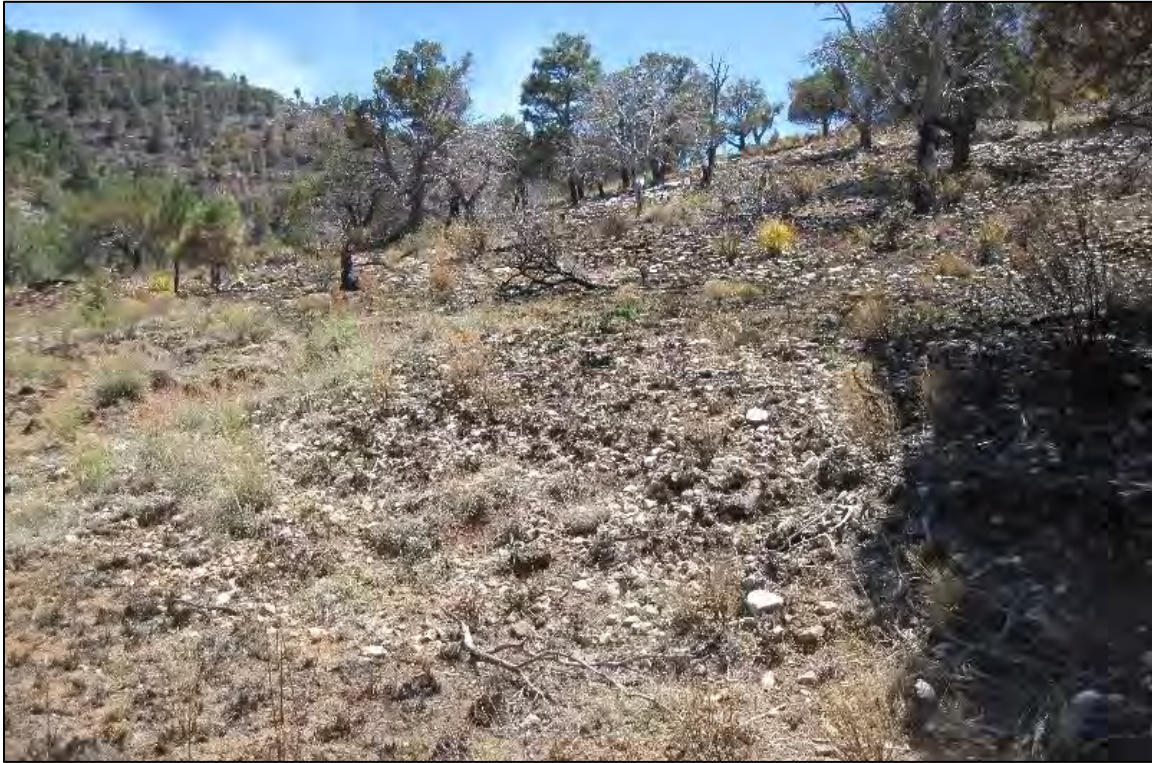
In conclusion, the site is in stable and good condition, with the exception of Feature 3 and a gully forming in the goat rocks meadow that must be stabilized. Feature 3 is already impacted by erosion and trail and possesses no integrity. The remainder of the site is stable but needs to be recorded to modern standards.

Figure 20: 41CU96 Feature 7 facing south.

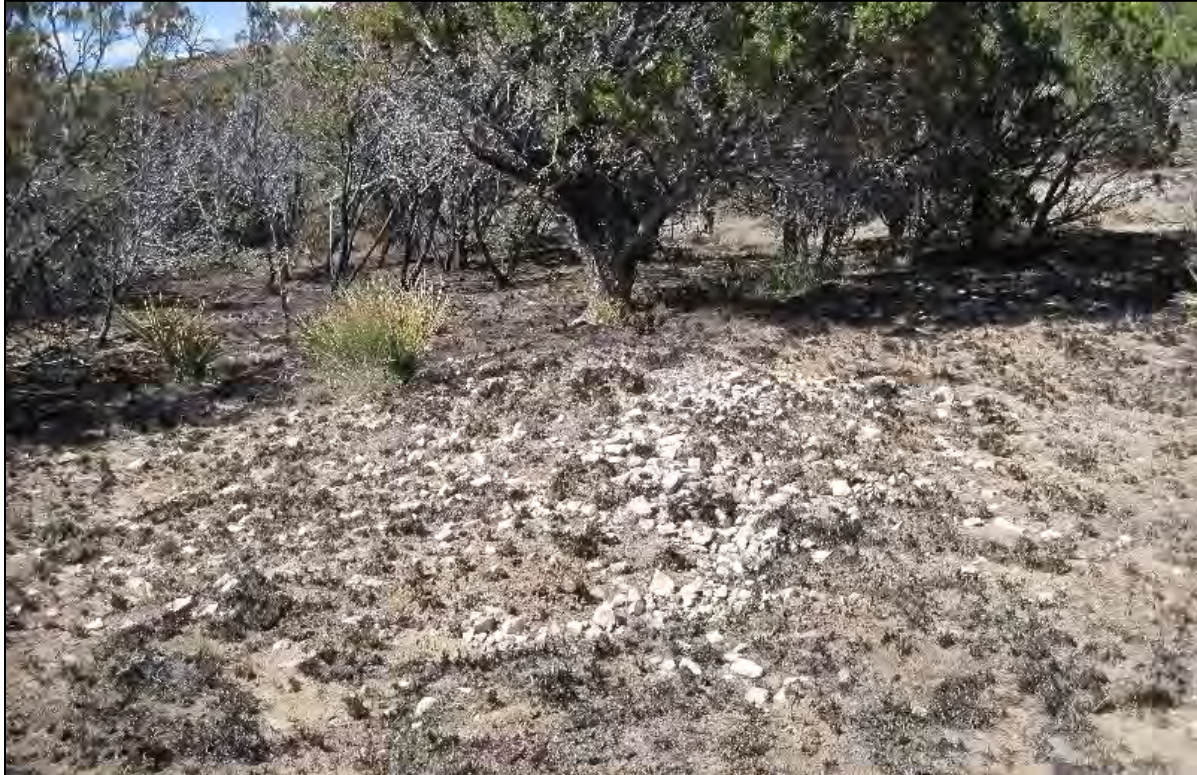
The site consists of two ring middens separated by a shallow gully. The site has not been formally recorded and a site map is not included in the documentation. Some erosion may occur in the gully separating the middens due to effects from the Coyote Fire. The gully could be stabilized using dead tree limbs and shrubs rather than Jute matting due to its location in wilderness. Site is in good condition although we recommend stabilizing the site.

Figure 42: GUMO-2009-38 overview of feature facing north.

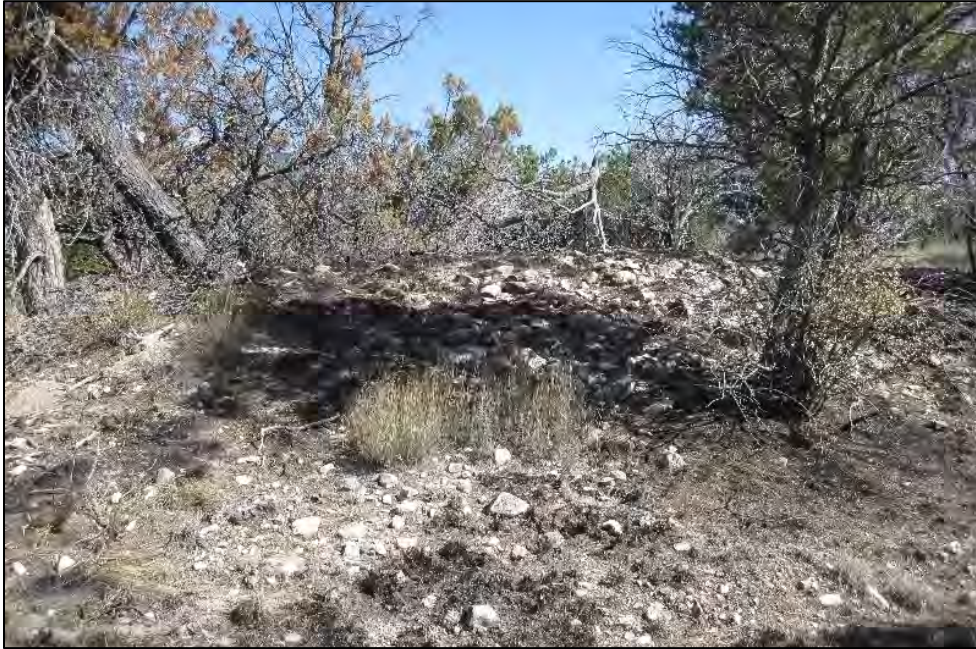
Site consists of a ring midden originally recorded in 1973. Since that time, the site has not been monitored and no map is included. The site is in good condition; a gully on the north side of the site should be monitored for increased erosion.

Figure 43: 41CU172 possible feature facing south.

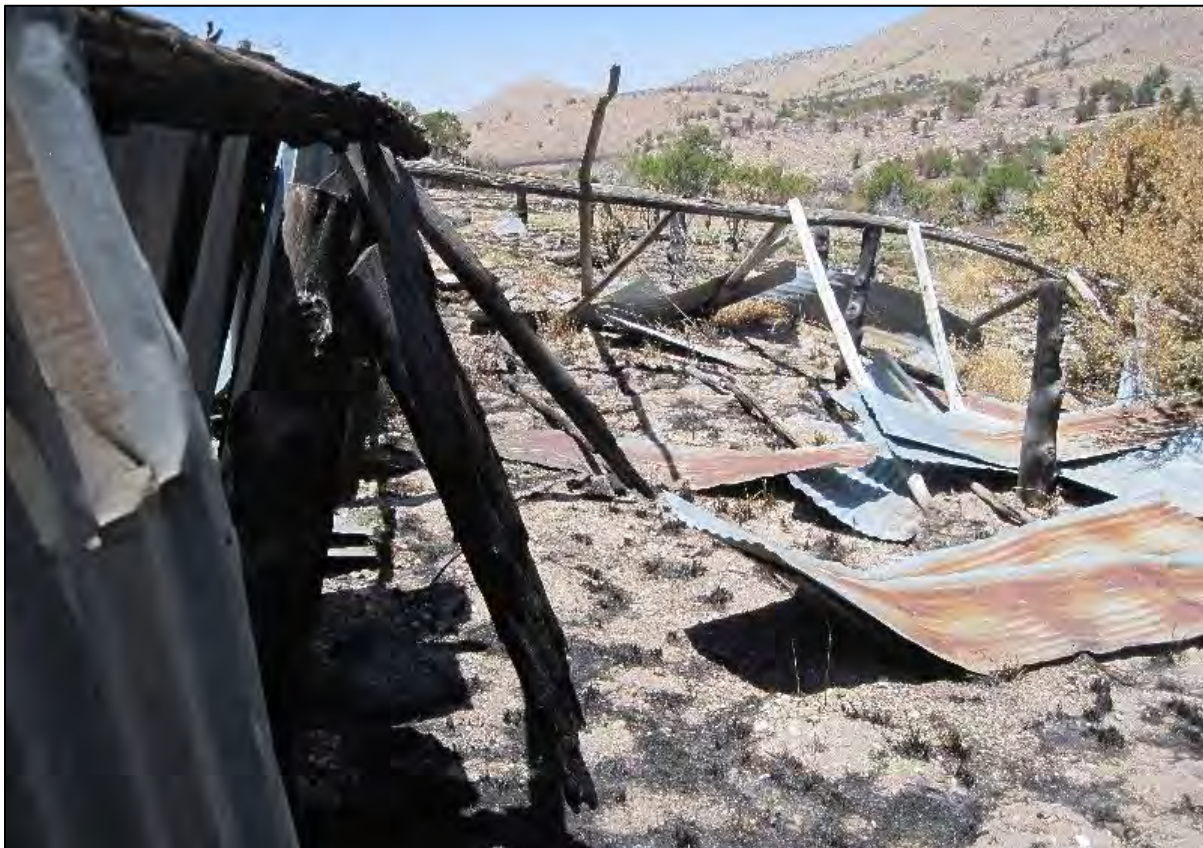
Overall, site is in poor condition.

Figure 45: 41CU150 burned wall supports in barn.

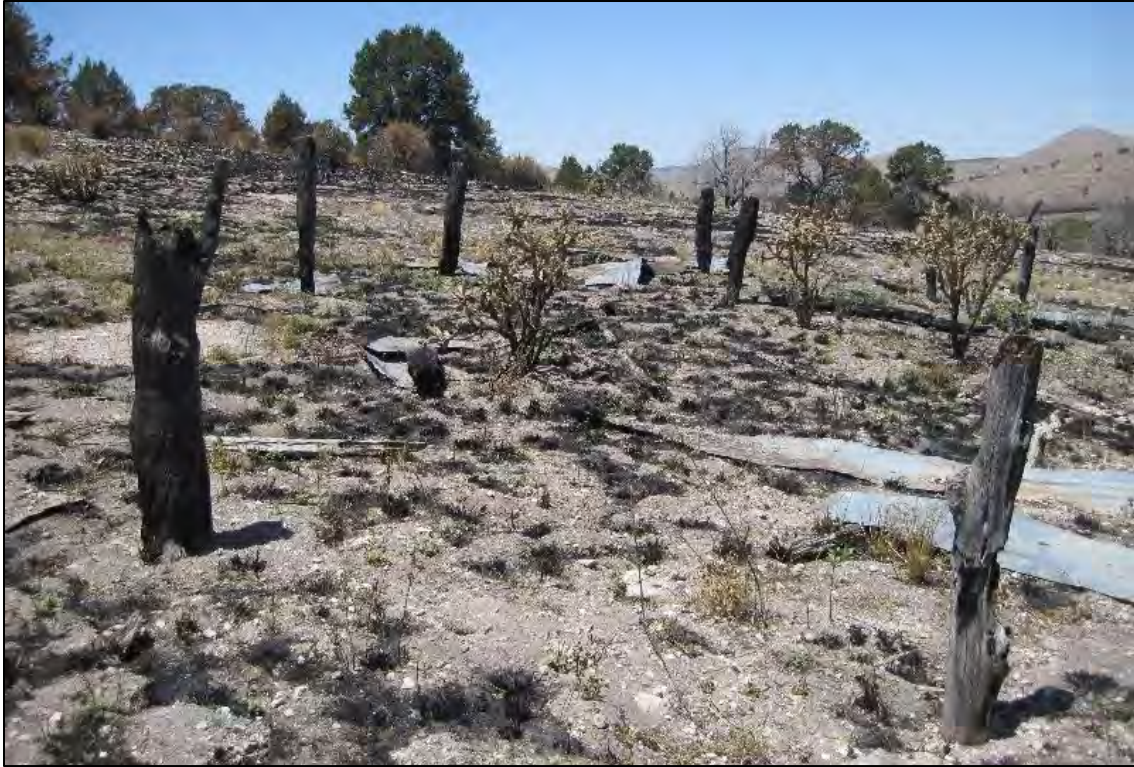
Figure 46: 41CU150 burned corral.

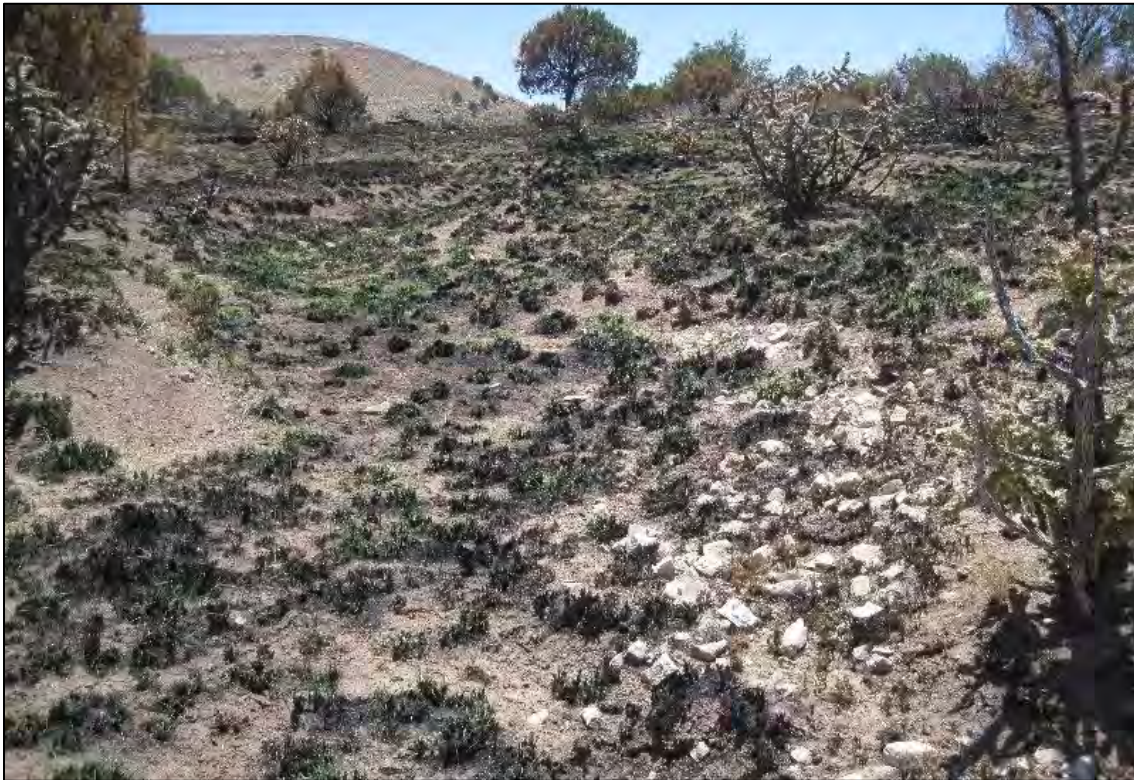
Figure 47: 41CU150 ring midden in gully needs data recovery.

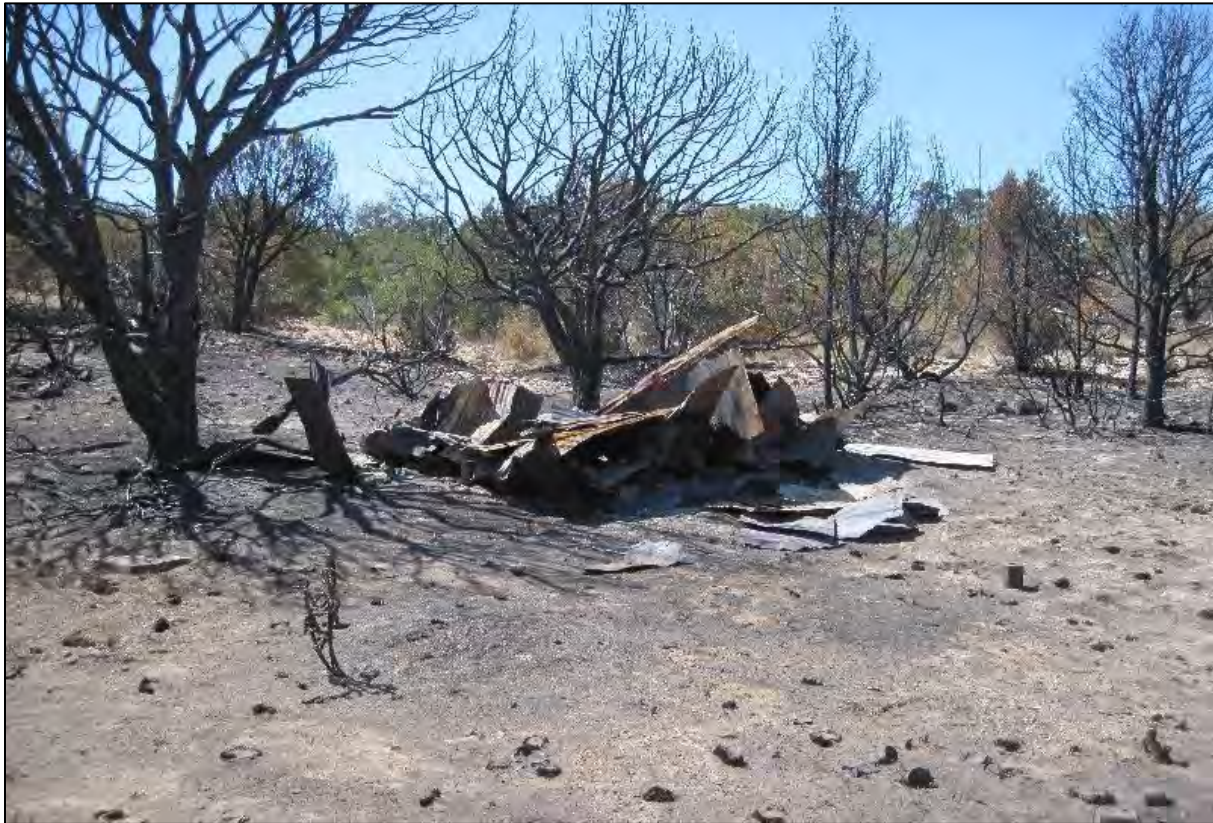
Site is the historic Cox Cabin. At the time of monitoring, it did not appear that the site has been previously recorded. If the site has a Smithsonian number already, use this documentation as an update. Site appears to be a cabin dating as early as 1935 (Can opener opened cans) to as late as the proclamation of the park (1972). The collapsed structure is made from galvanized corrugated metal sheets, with a stone floor, wood stove, and associated glass can scatter. Evidence is present of visitation from hikers. Site is in poor condition. We recommend fully recording and researching the site.

Figure 48: GUMO-2016-2 Cox Cabin.

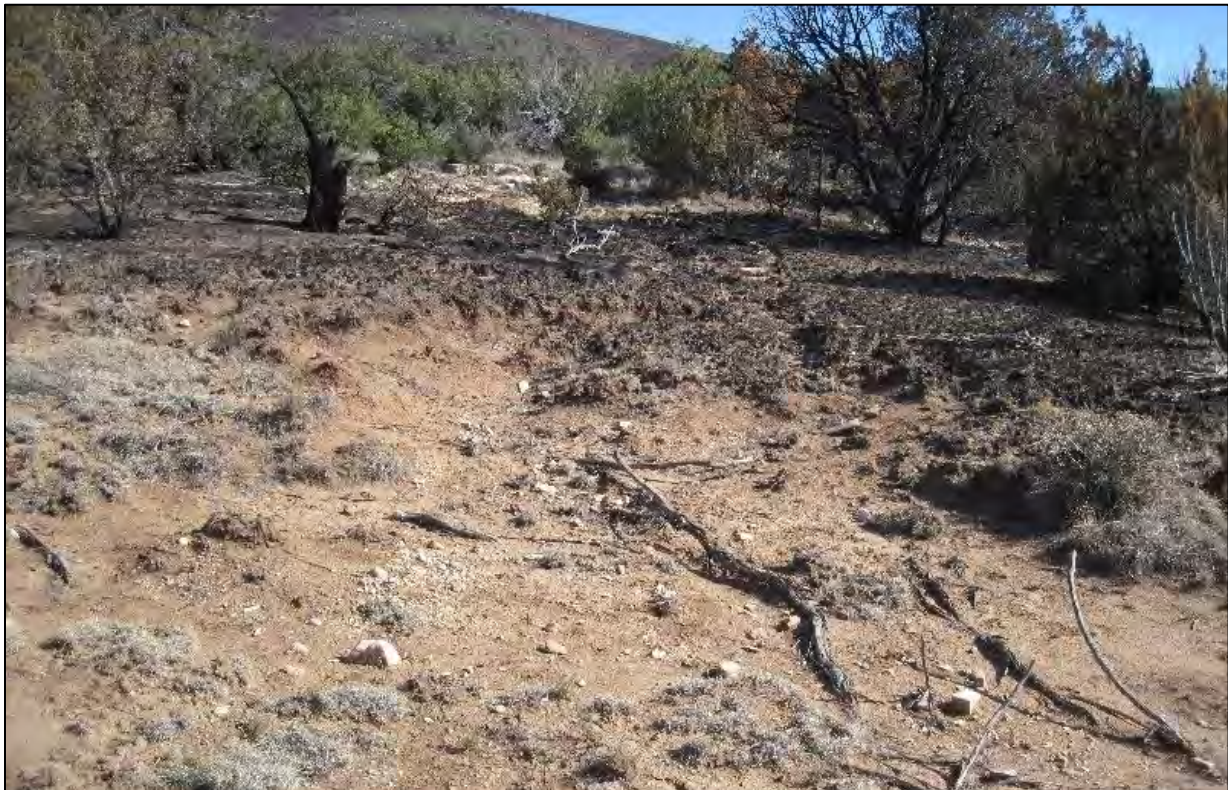
Figure 52: GUMO-2011-1 overview of sheet erosion.

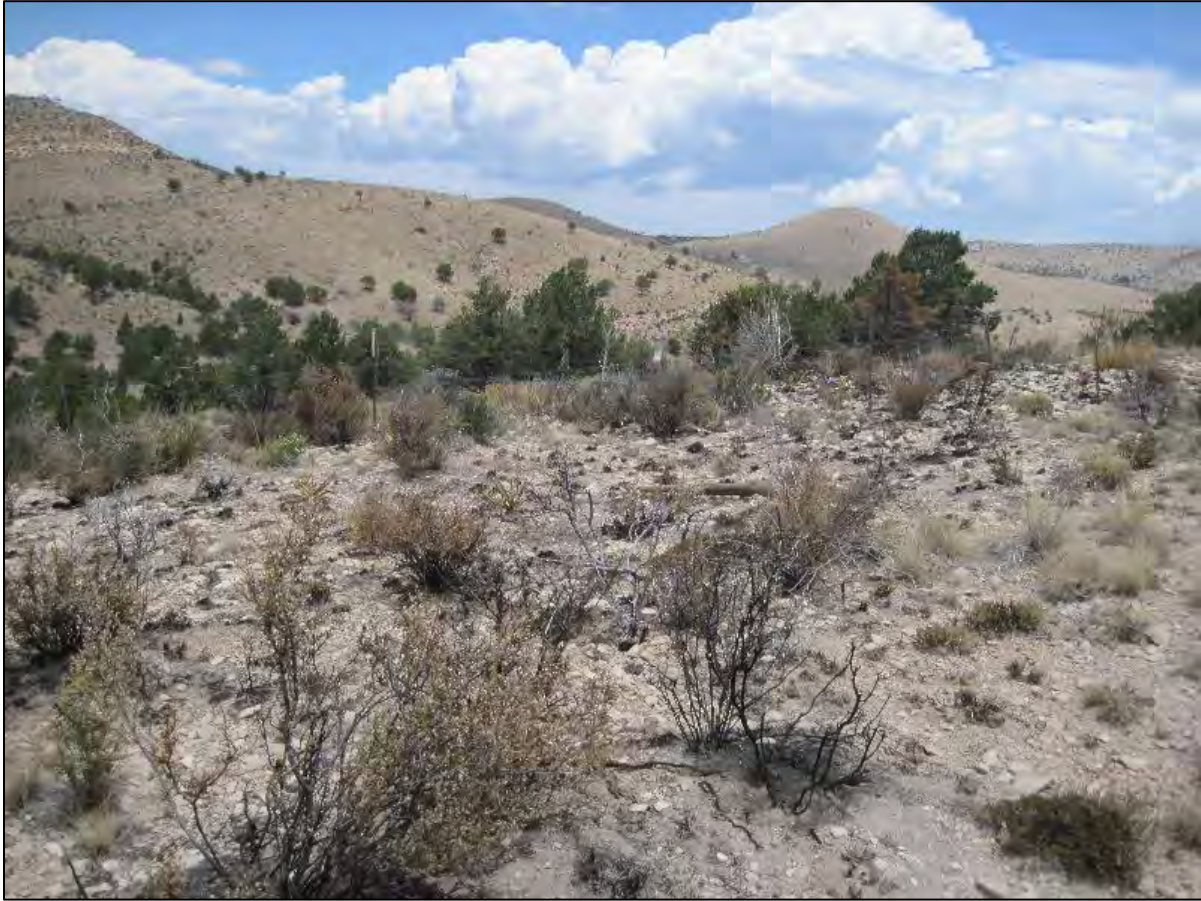
Figure 712: 41CU789 overview facing north with UTV tracks.

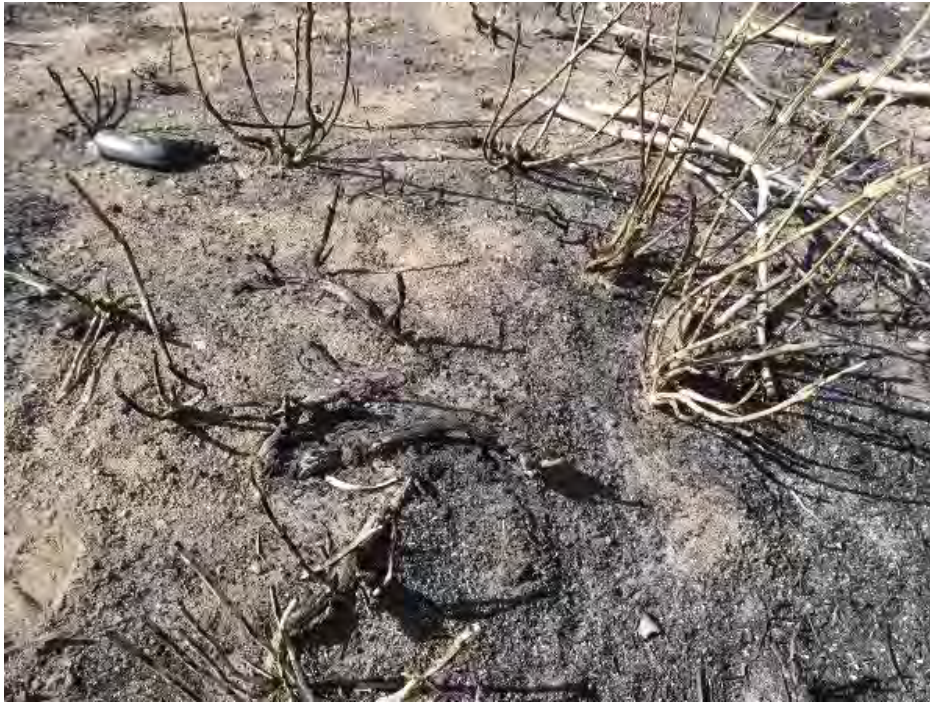
Figure 1. Burned horehound remnants in a tributary to West Dog Canyon (stone dam impoundment).
