NWCG Equipment Technology Committee

Equipment Advisory: 22-01

January 3, 2022

Subject: Inspection of 3,000 lb. Cargo Nets

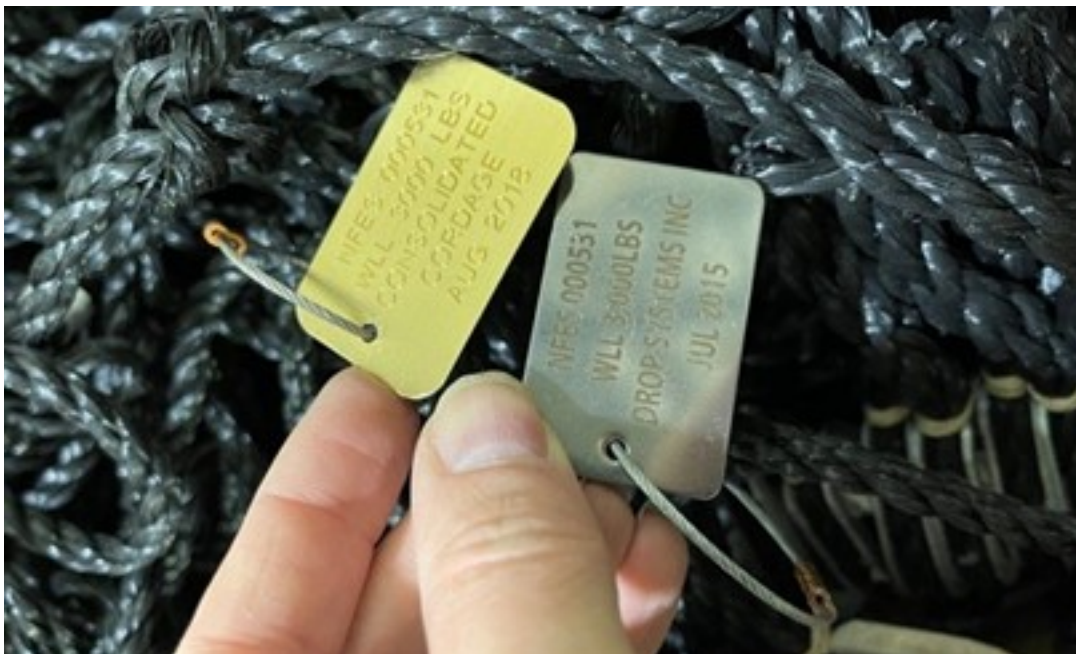
- A single “Consolidated Cordage” tag, or
- Two tags – One tag which states “Consolidated Cordage.” The other which states “Drop Systems” (Figure 1).

Figure 1—Sample image of a cargo net with two tags from different manufacturers.

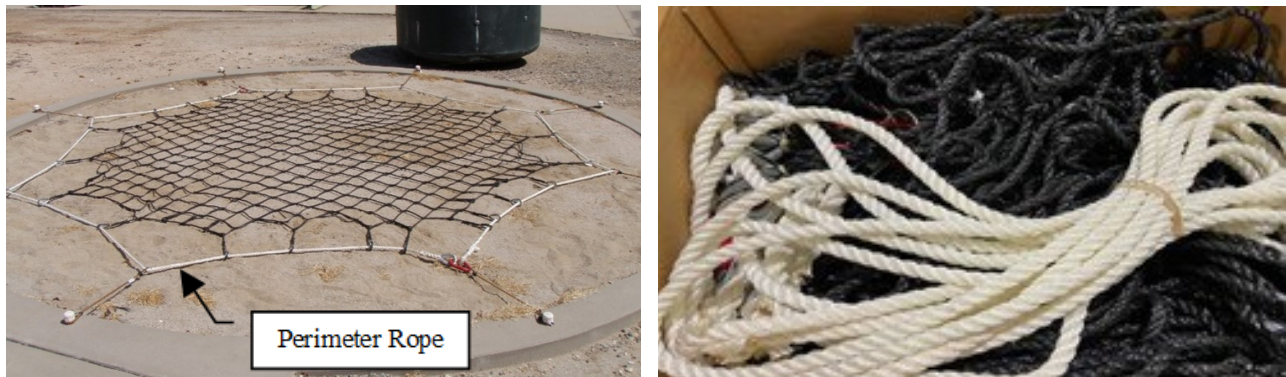
1. Verify that nets have perimeter ropes installed. Perimeter ropes are twisted white nylon with two pear links (Figure 2).

Figure 2—Sample of NFES #000531 cargo net with perimeter rope attached correctly.

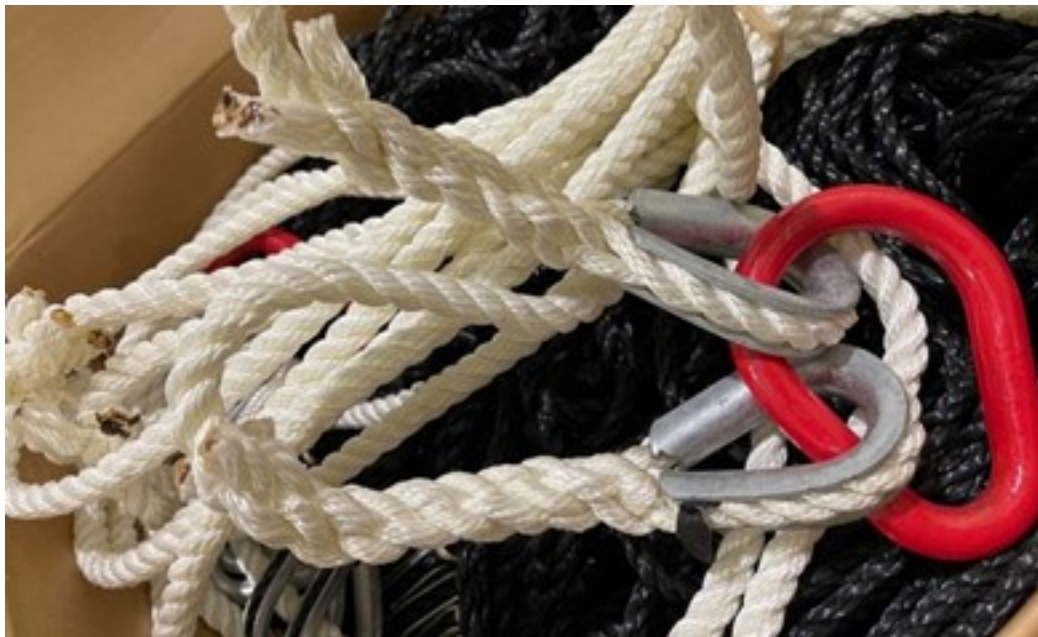
2. Verify that nets show indication that the perimeter ropes have been treated with a polyurethane coating. Perimeter ropes with the poly coating should be hard to the touch and rigid throughout the entire length.
3. Verify that perimeter rope terminations have been “heat cut” to eliminate fraying (Figure 3).

Figure 3—Sample of a correctly manufactured net with perimeter rope strand ends “heat cut” to eliminate fraying.

5. If the inspection reveals problems with the perimeter rope as described in steps 1 – 3, remove from service, and use the following procedure to notify DLA and return affected units to the DLA Depot:
 - a. If non-conforming nets are found, email Barry Smith at barry.smith@dla.mil.
 - b. Submit a Supply Discrepancy Report (SDR) requesting credit and disposal instructions. Do not send the cargo nets to the depot until instructed to do so in the SDR reply from DLA.
 - c. Return the material to the following address:
