NWCG Equipment Technology Committee

Equipment Bulletin: 25-002

5/5/2025

Subject: Chaps, Chain Saw, M-2020, Nonconformities affecting use, appearance, and serviceability.

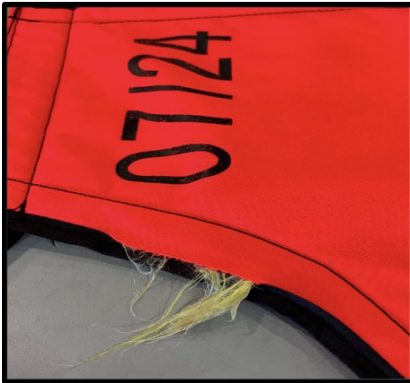
Background: In February 2025, the National Technology and Development Program (NTDP) was notified of chain saw chaps returned to the Southern Area Incident Support Cache with the binding tape pulled free from the outer shell, exposing the protective Kevlar pads (Figure 1). The failure occurred after minor use. An additional pair of chain saw chaps (new, in packaging) was found at a separate cache with the binding tape stitching missing the outer shell layer, exposing the inner protective pads (Figure 2).

Figure 1: Binding not capturing inside shell, right leg.

3. Remove chain saw chaps from service if the binding does not fully capture the outer shell layers.
4. Return any chaps with incorrectly sewn binding to the nearest cache. As stocking allows, caches will exchange for serviceable product. Cache locations can be found at:
<https://www.nwcg.gov/publications/pms449-1/nfes-national-interagency-support-caches>.

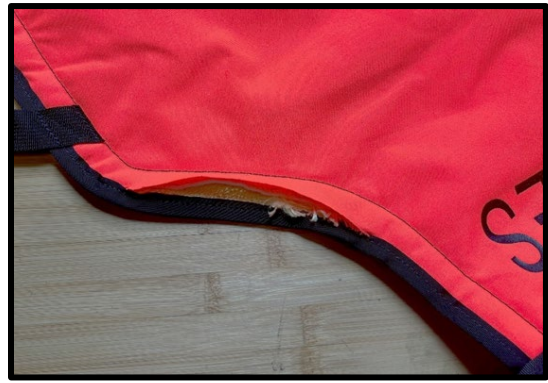
Figure 2: Binding not capturing outside shell, right leg.

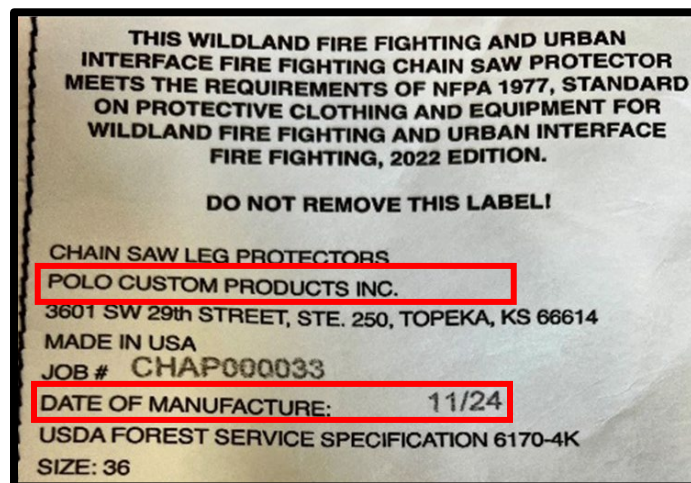
1. Confirm chaps were manufactured in 2024 or 2025 by Polo Custom Products Inc., see NFPA label on the inside of the left leg (Figure 3).

Figure 3: NFPA label.

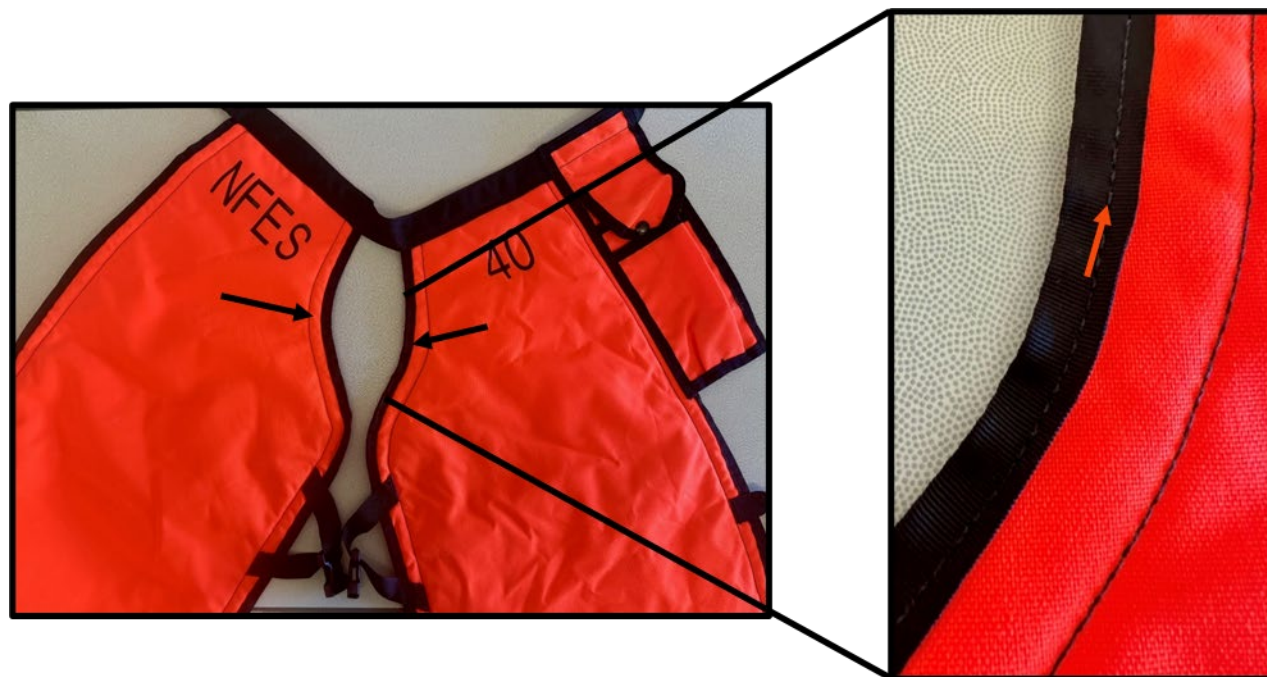
2. Inspect all binding tape to confirm the binding stitch line securely captures both the **front** and **back** shell (Figure 4), paying close attention to the curved inner leg. Lift the edge of the black binding tape to confirm the outer orange shell layers are captured by the stitching.

Figure 4: Front side of chain saw chaps. Black arrows showing the area of concern on the inner curve of leg. Orange arrows showing stitch line securing the binding tape.

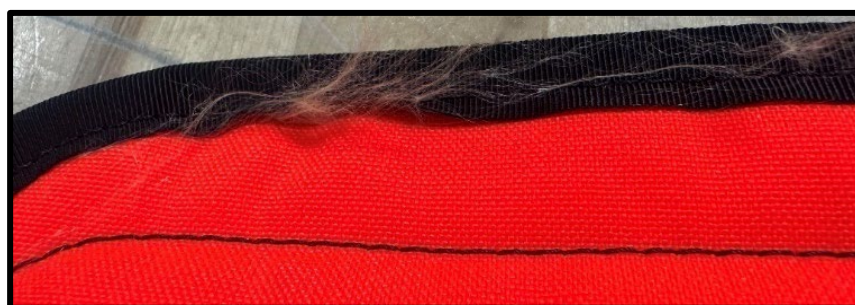
Note: Kevlar fibers were found captured in the binding during preliminary inspections (Figure 5). These fibers are easily removed and will not affect the performance of the protective pad. This does not indicate a nonconformity if the binding tape has fully captured the outer shell layers.

Figure 5: Kevlar fibers captured in binding.
