LAUDER FIRE  
ACCIDENT INVESTIGATION REPORT  
SEPTEMBER 29, 1987

Dennis Lee Cullins Death  
Four Employees Seriously Burned

## I. ACCIDENT SUMMARY

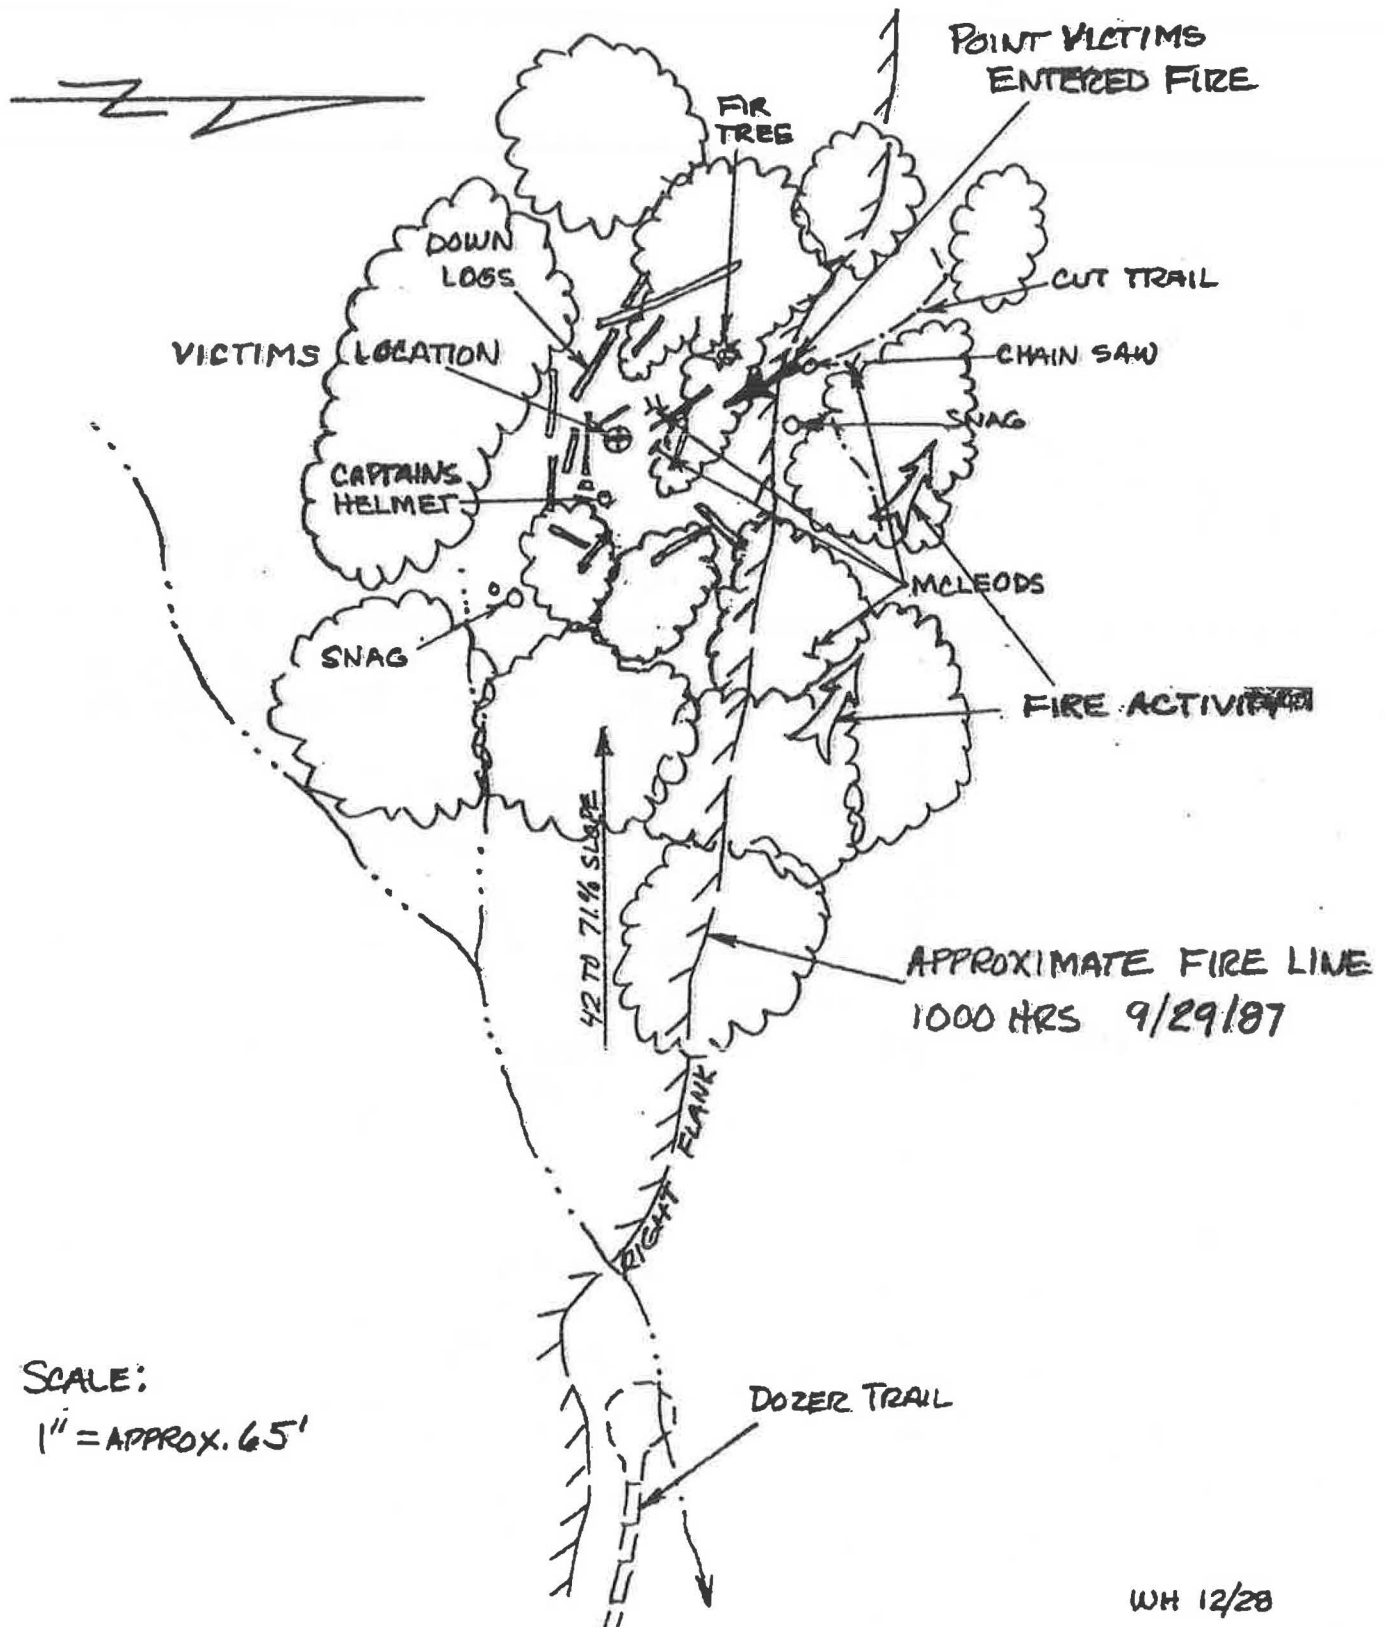
# LAUDER FIRE ACCIDENT SITE DETAIL

The crew entered the burn approximately 70 to 80 feet in a southeasterly direction. Because of large, burning old down logs and the intense heat, they turned back momentarily and deployed their shelters in a small opening. The heat was much too intense and all received burns before shelters were deployed. All had difficulty in
