# NWCG Logistics/Equipment Management Committee

Equipment Advisory: 26-001

**Subject:** Potential Front Driveline Joint Failure on 2018 and Earlier Ram Pickups

TSB NUMBER:  
03-002-21

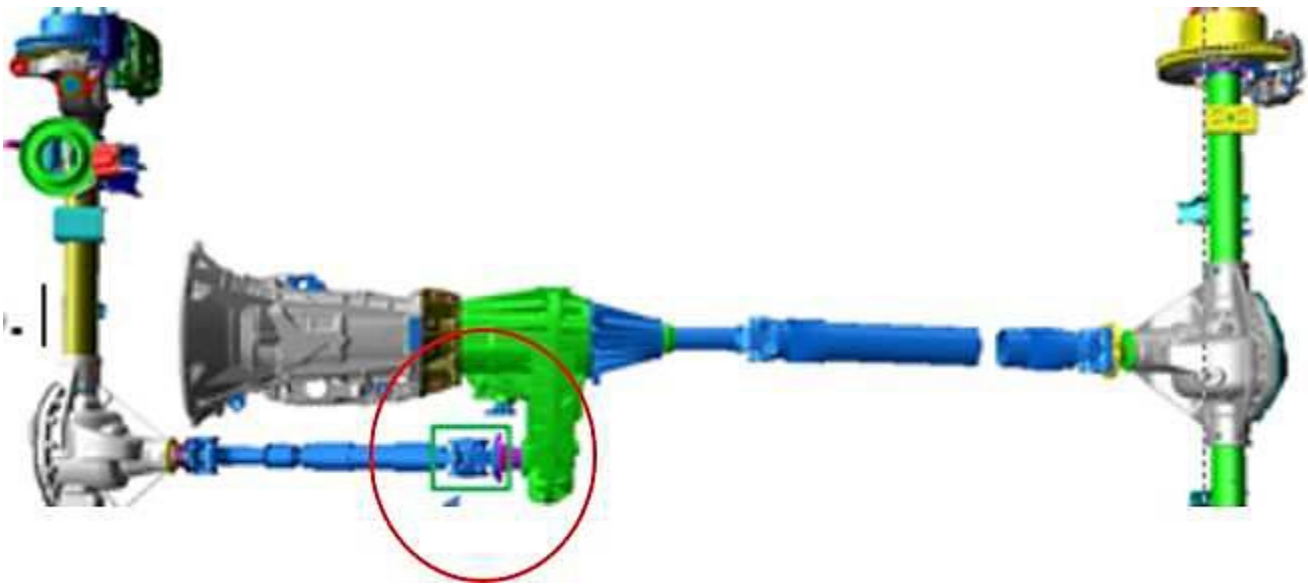
Due to lack of proper maintenance, failures of the ("u-joint") have occurred on some heavy duty Ram front drive shafts double cardan universal joints.

*Figure 1: Image of the front drive shaft double cardan universal joint.*

The double cardan joint is equipped with a low-profile needle point grease fitting. The needle point greasing adapter tool is included in the MOPAR Express Lane tool kit and is readily available through other tool providers. Inspect the double cardan joint near the transfer case front output shaft during service. Check for signs of distress include gaps in the bearing area and rusty powder on the yoke surfaces and repair as necessary.

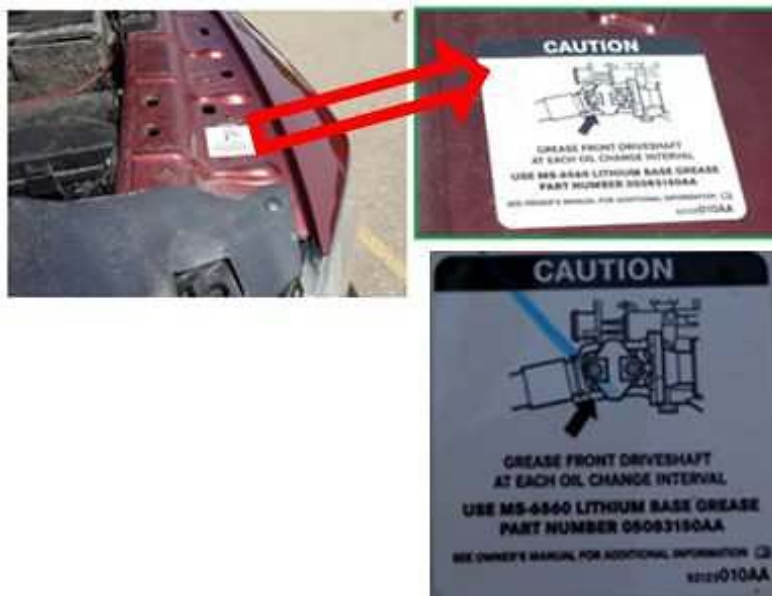
*Figure 3: Images of the under-hood reminder sticker.*

Lubricate the double cardan joint per the maintenance schedule using MOPAR type MS6560 lithium-based grease or an equivalent. Lubrication requirements are detailed in service information and the owner's manual. There is an under-hood reminder sticker on the left front fender.

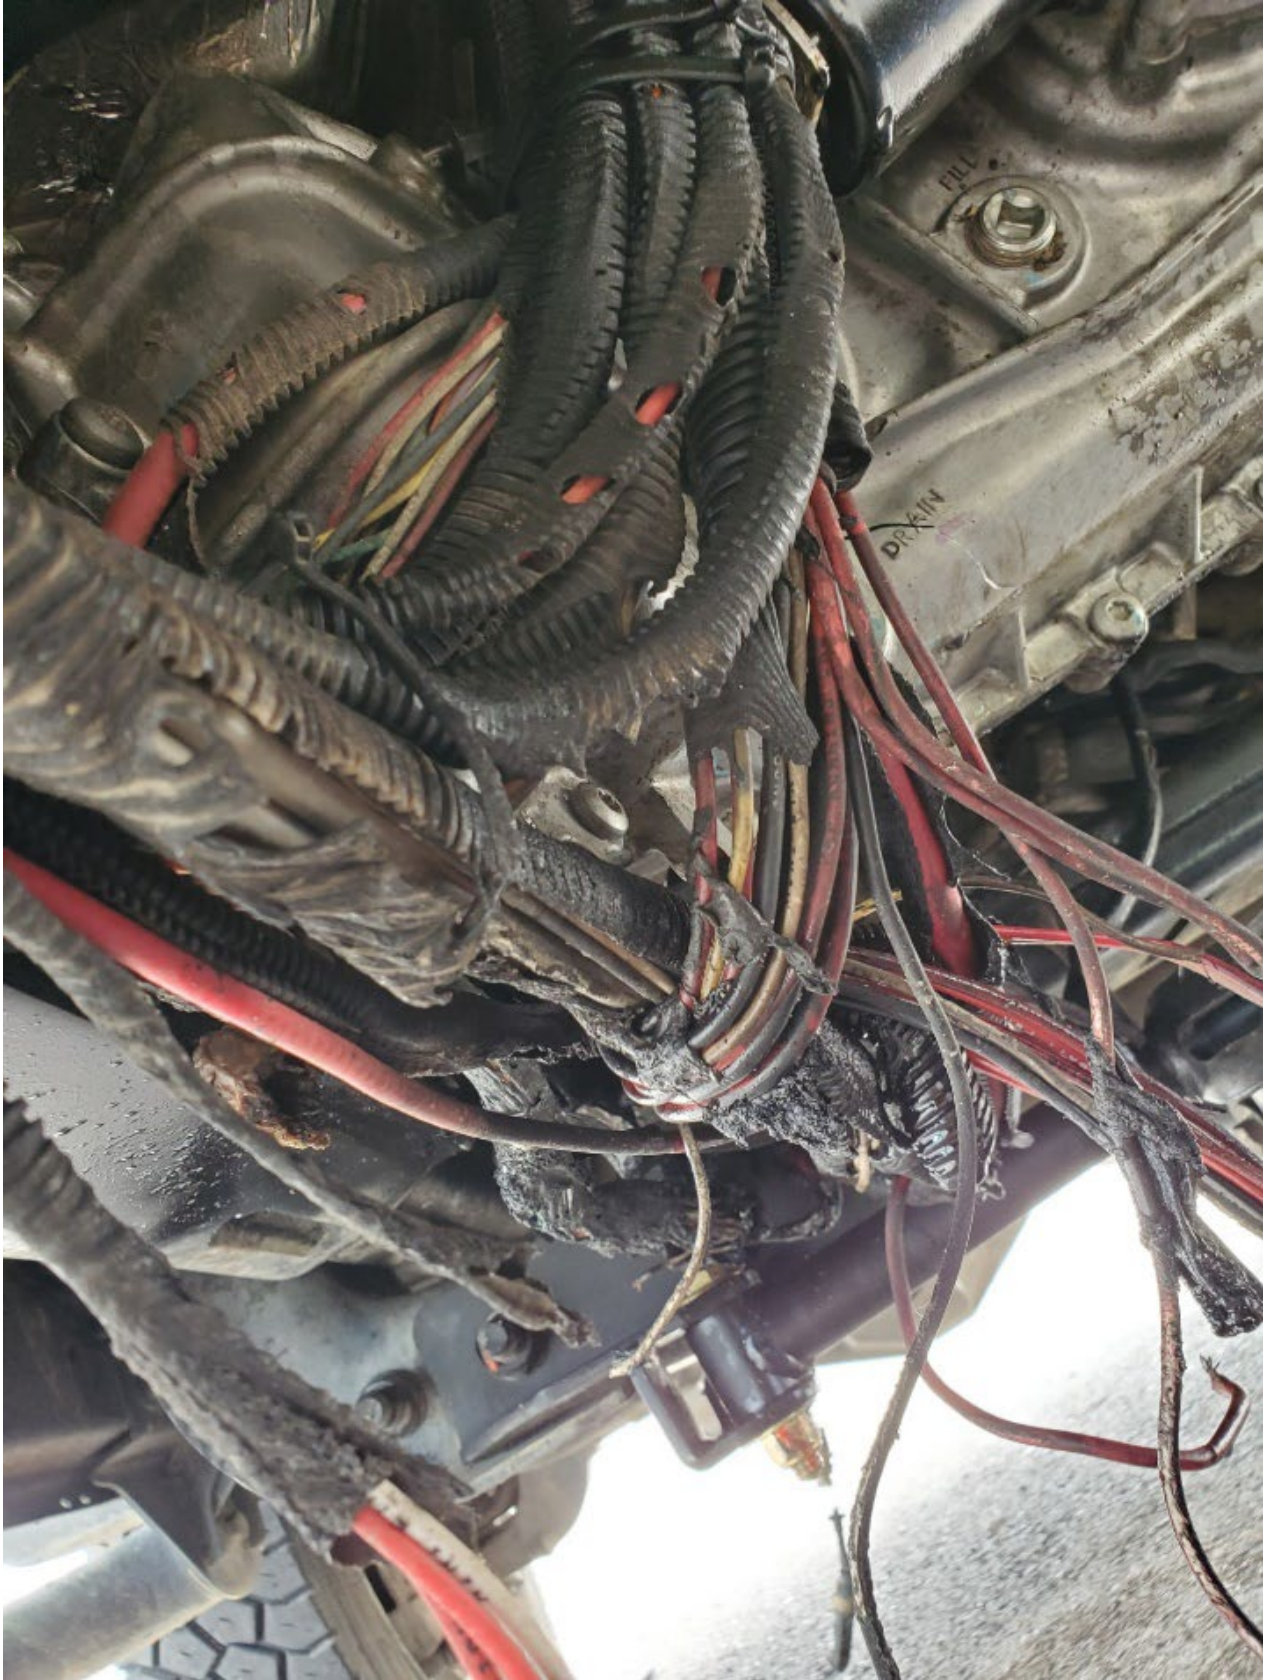
Multiple U.S. Forest Service regions have reported front driveline double cardan joint failure incidents during operation. These failures have caused extensive damage to chassis components, including severed brake lines resulting in loss of braking. At least one incident resulted in a post-failure vehicle fire.

*Figure 4: Photo of damage after driveline joint failure.*

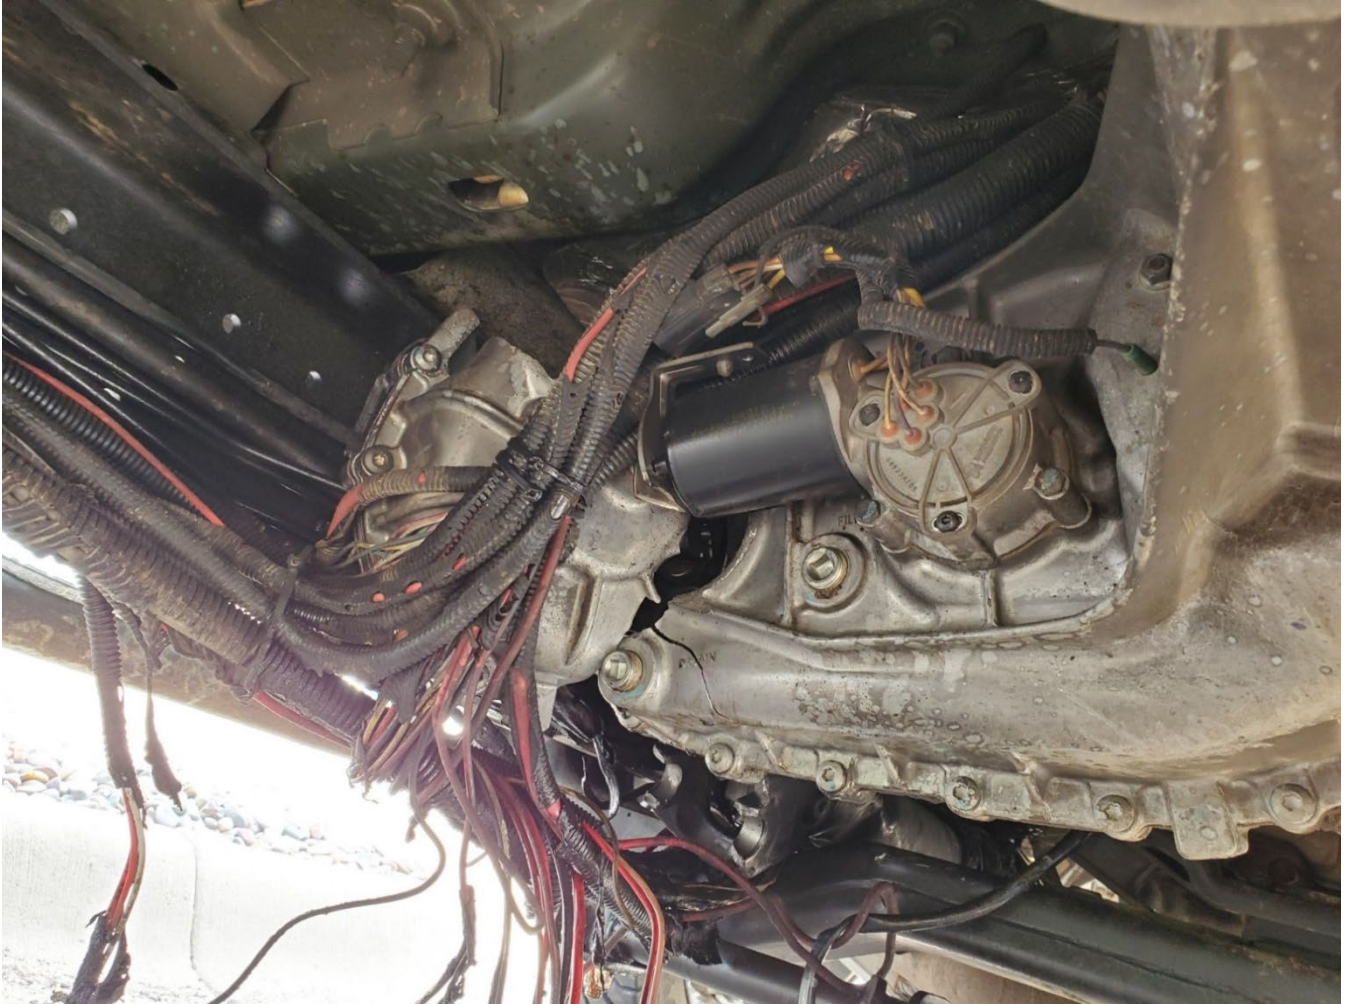
*Figure 5: Photo of damage after driveline joint failure.*

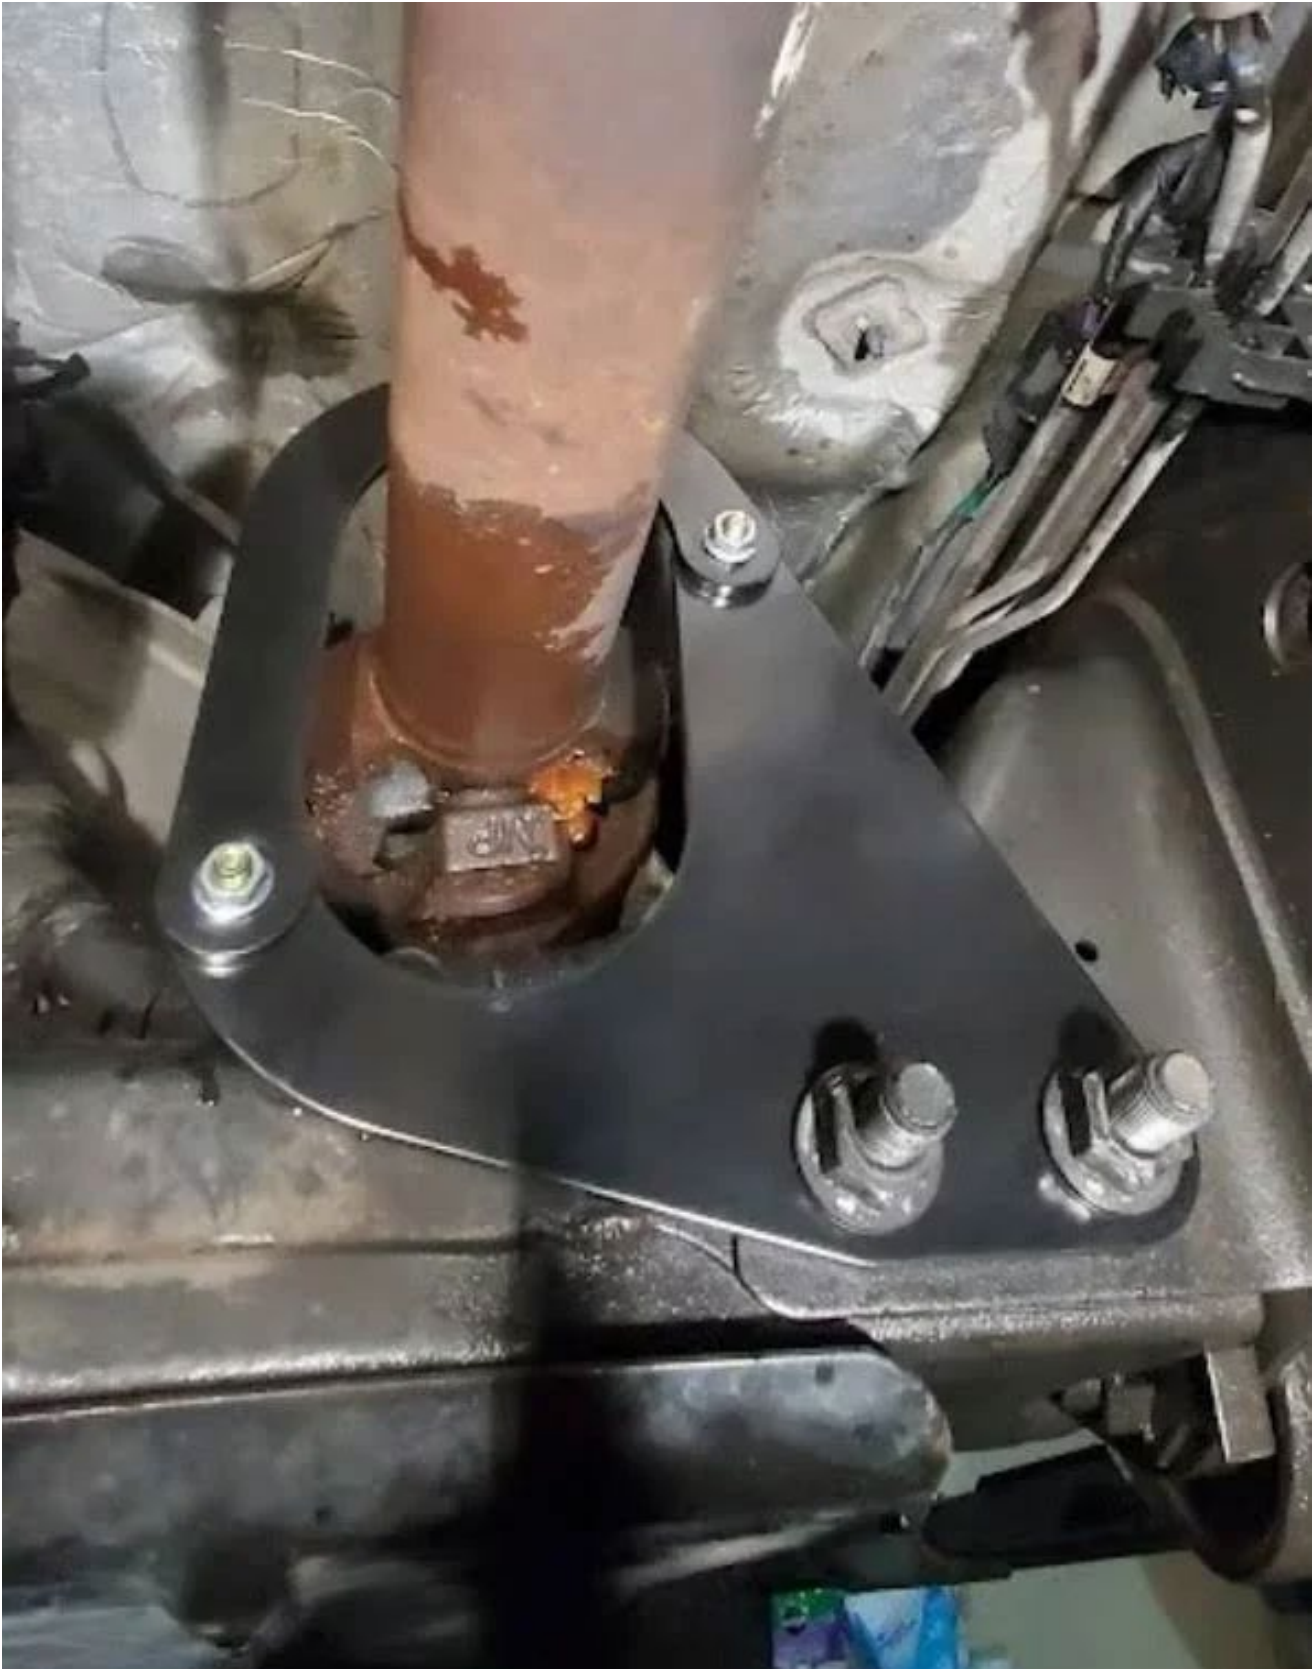
*Figure 6: Driveline loop kit example (Five Nine Fabrication).*

Follow all Ram-issued inspection, maintenance, and service guidance for front driveline joints. As an additional risk mitigation measure, consider installing a driveline loop. A driveline loop can help contain the driveline in the event of joint failure and reduce the likelihood of secondary damage to critical vehicle components. Coordinate with fleet managers and service providers to determine the most appropriate driveline loop kit for each vehicle.

Both universal and vehicle-specific driveline loop kits are available to help reduce collateral damage in the event of a driveline joint failure. Fleet managers and maintenance personnel should evaluate available options to determine the most appropriate installation for their fleet.
