Cache Memorandum: 25-01

4/28/2025

Subject: Chaps, Chain Saw, M-2020: Nonconformities affecting use, appearance, and

serviceability.

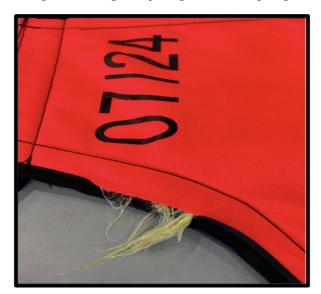
Figure 1: Binding not capturing inside shell, right leg.

Action: Interagency Support Caches shall temporarily discontinue the distribution of Forest Service specification chain saw chaps manufactured in 2024 and 2025. Perform inspection of binding on product before initiating distribution.

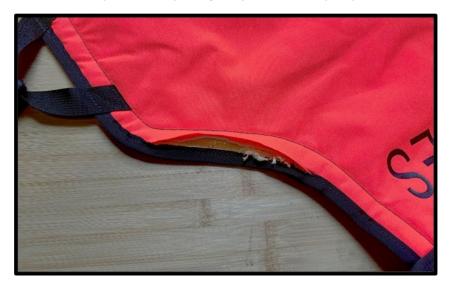
Figure 2: Binding not capturing outside shell, right leg.

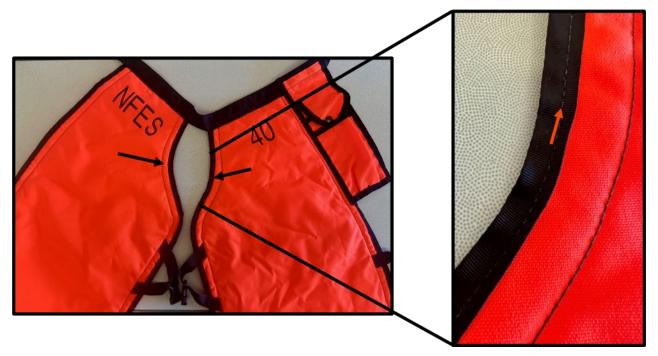
- 1. Remove chap from plastic bag, retaining End User Instructions.
- 2. Confirm chaps were manufactured in 2024 or 2025 by Polo, see NFPA label, figure 3.
- 3. Perform general inspection of both the front and back aspects of chain saw chaps.
- 4. Inspect binding tape to confirm the binding stitch line securely captures both the front and back shell (Figure 4), paying close attention to curved inner leg. Lift the edge of the black binding to confirm the outer orange shell is captured by the stitching.

Figure 4: Front side of chain saw chaps. Black arrows (on left image) show the area of conner on the inner curve of leg. Orange arrows (on right image) show binding stitch line.
