LOCUST FIRE B.A.E.R. ACCOMPLISHMENT REPORT

YEAR ONE: 2011

Project Name: Locust Fire B.A.E.R. Accomplishment Report (Year One: 2011)
Document Number / Version Number: BAER 2011-1/1.0

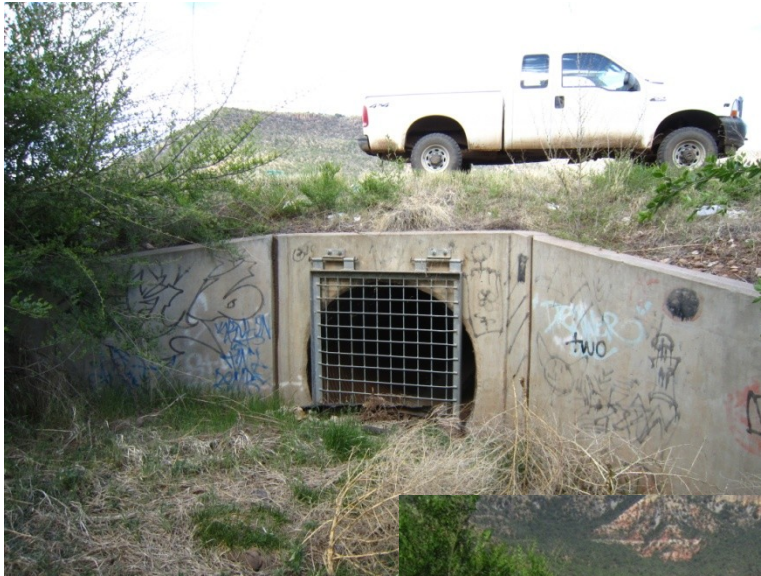
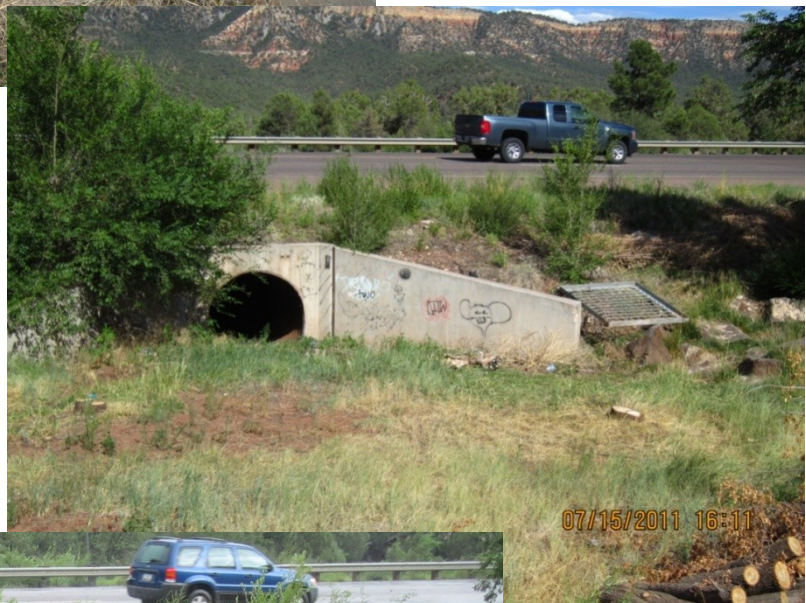
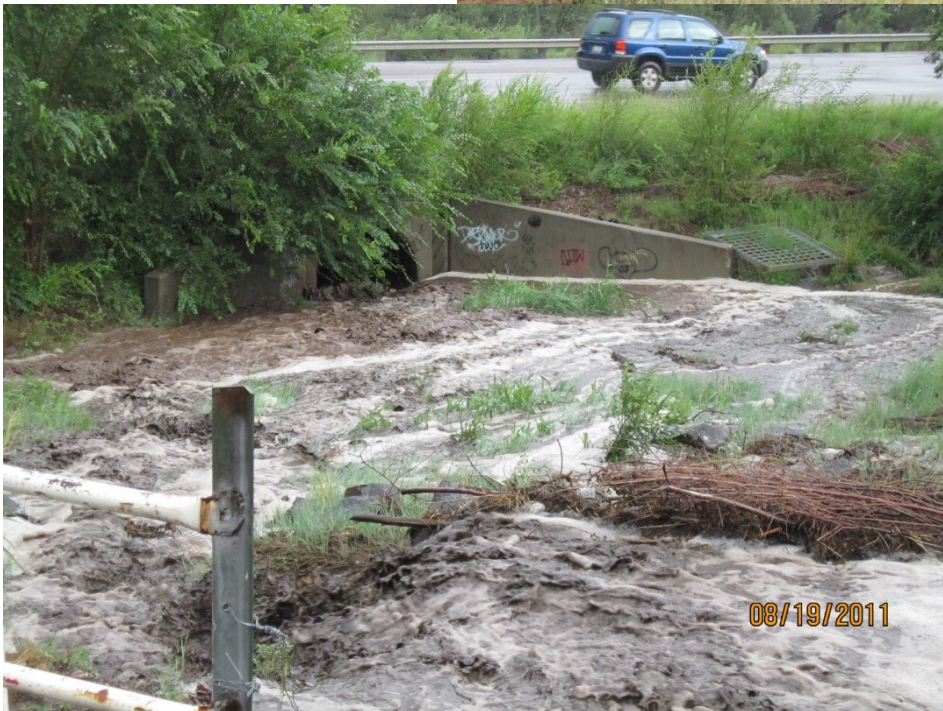
Specification 3

Closed grate would plug with debris if allowed to remain in place.

Culvert grate covering removed
7/15/2011

Culvert under Highway 73 at Mulberry Ave.

On 7/20/2011 and 8/19 & 8/20/2011 flows would have been blocked by grate and resulted in flooding of Highway 73.

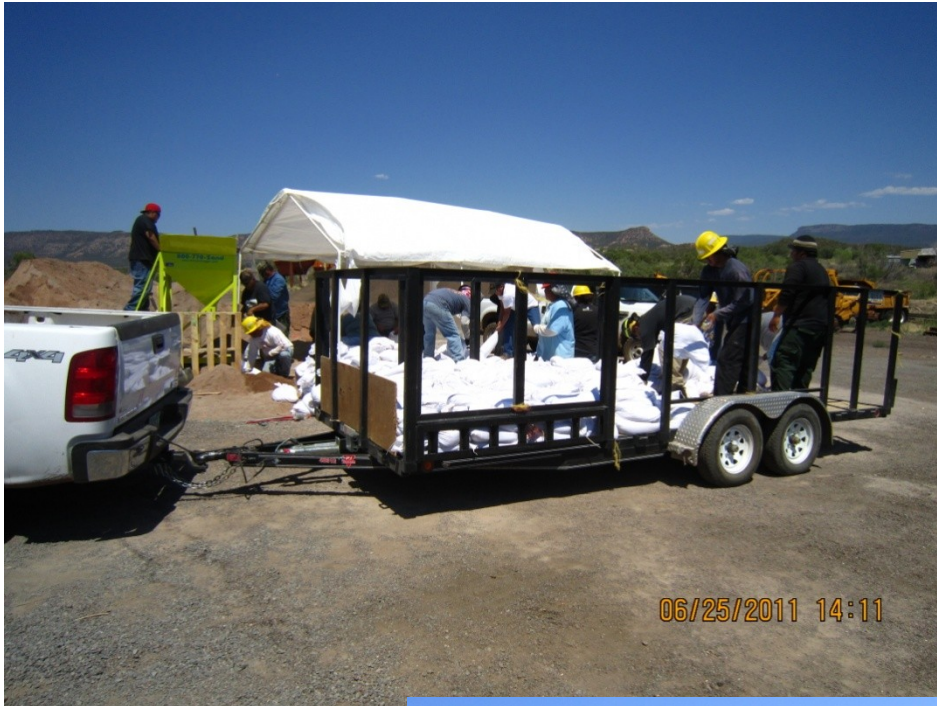
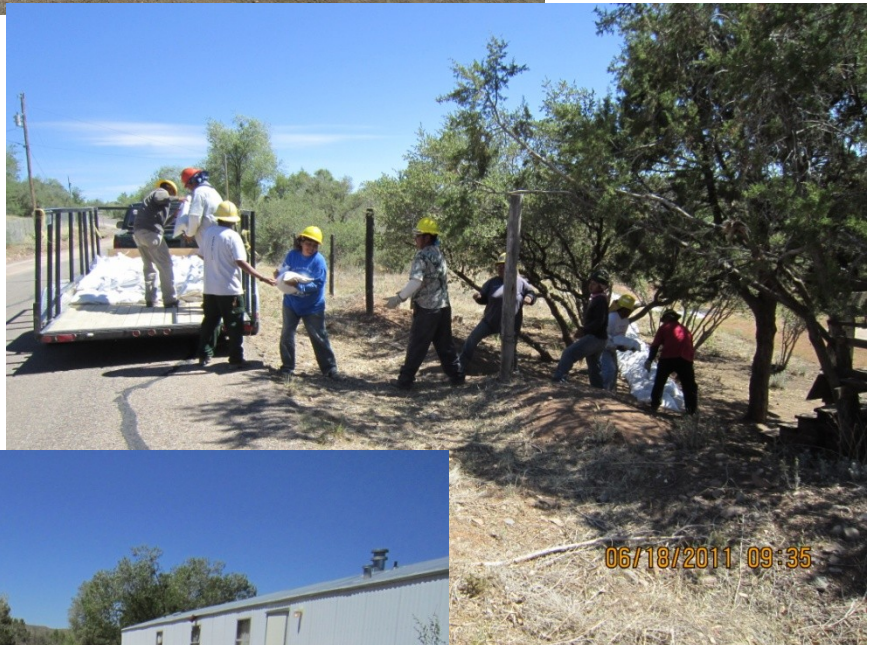
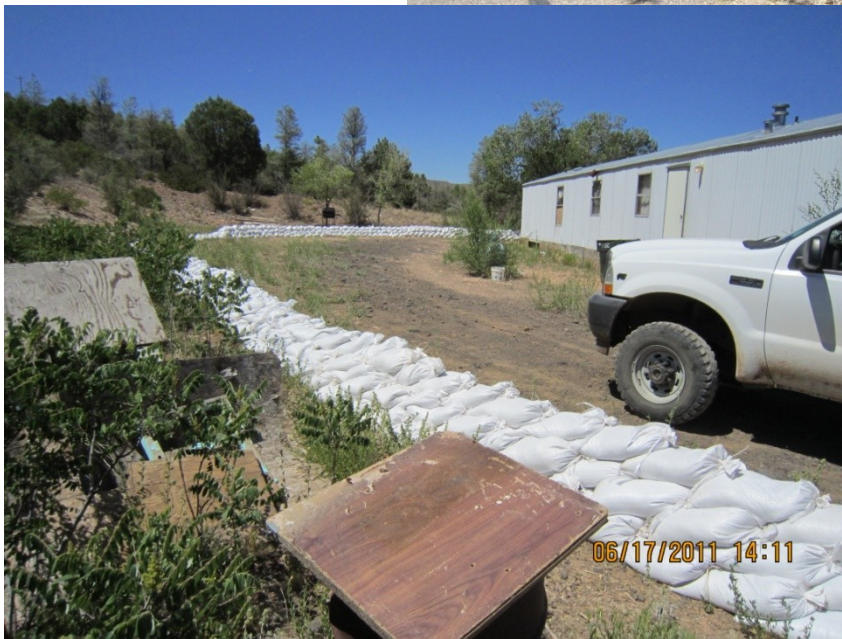
Structural Protection
Sand bagging

Sandbag Damage due to animals, children, and supplier quality.*

The Implementation Leader started the sandbag installation by setting priorities for all properties considered to be at the highest risk of damage should a storm occur before completion. Of the 137 at risk properties 58 were considered vulnerable to damage from water and mud. Gerd VonGlinsky, the Tribal Hydrologist and Locust B.A.E.R. Operations Chief, and I prioritized the 58 properties. Starting with the highest risk properties and working down the list we finished sandbagging on July 15, 2011. Monsoon rains were predicted to begin on July 15th, however, the rains actually began on July 1st. There were numerous small rain showers that swept the fire during the implementation phase; however no damages or losses were substained. I believe that the priorities we set were correct and lead to the success of this task.

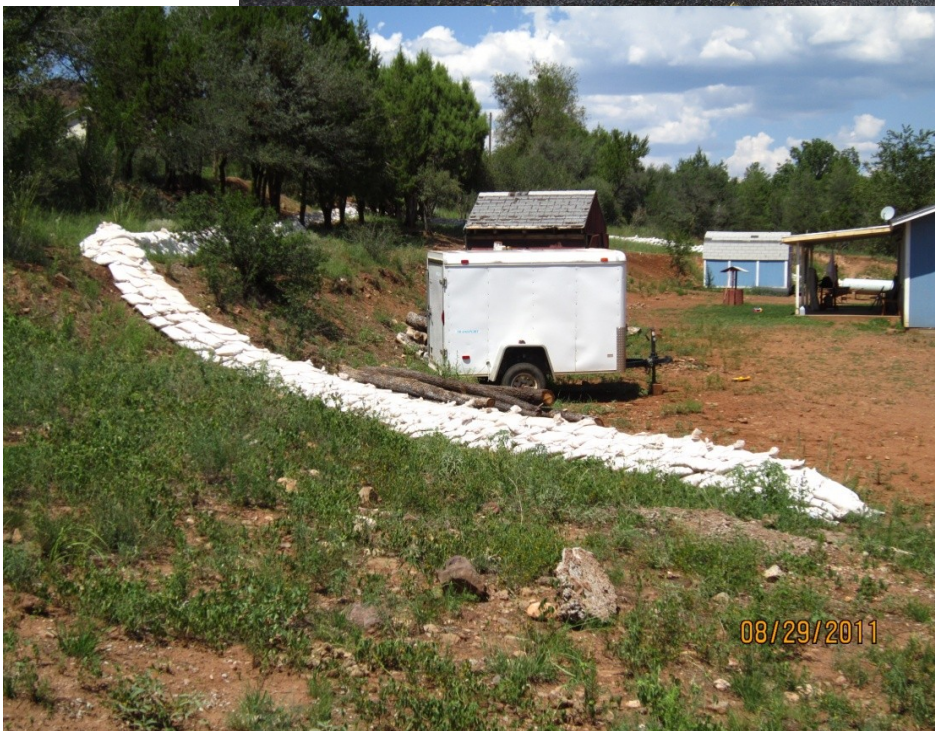
Undamaged bags.

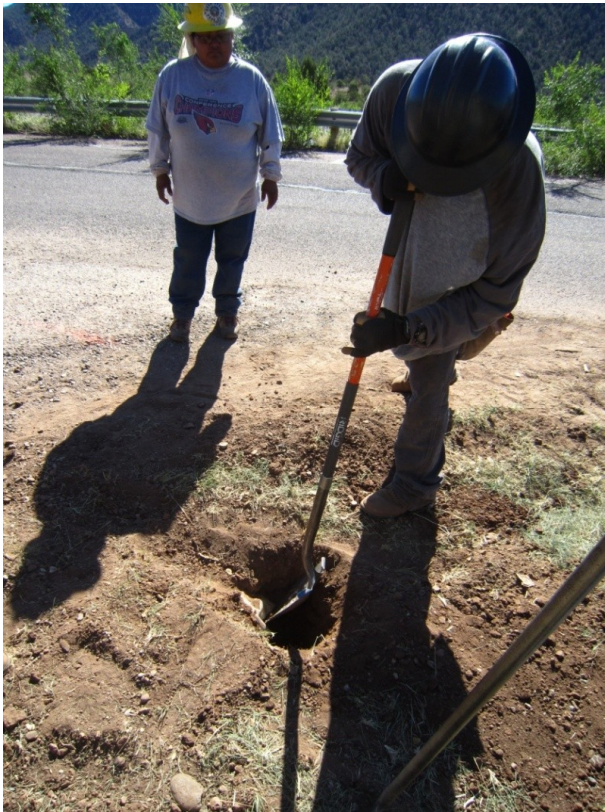
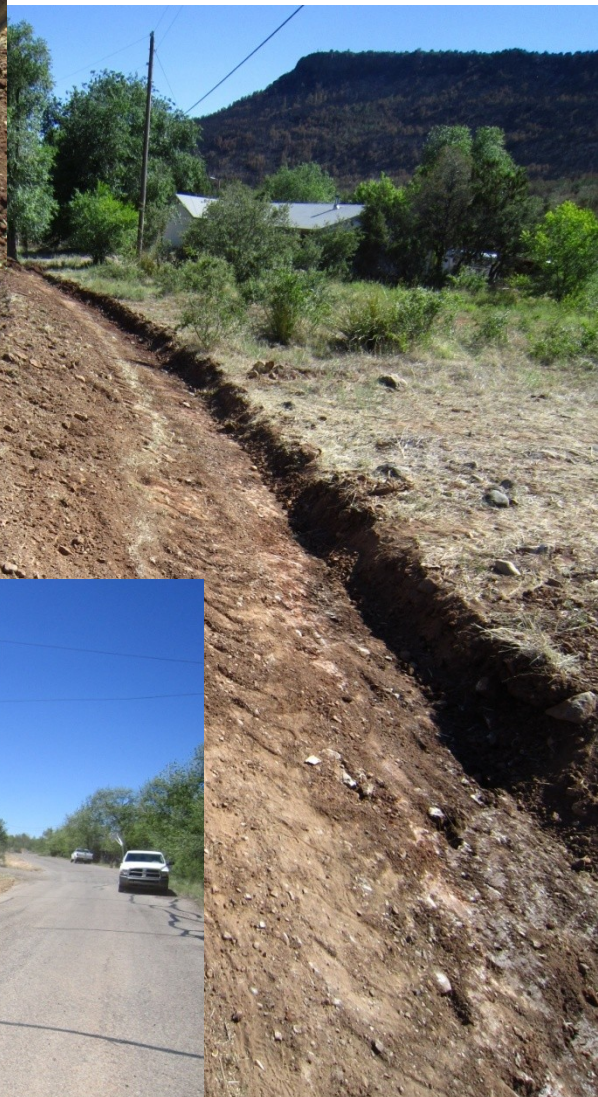
Specification 5 ~ Culvert and Ditch Cleaning (BIA)

Yes...there is actually a culvert at the end of his shovel...!

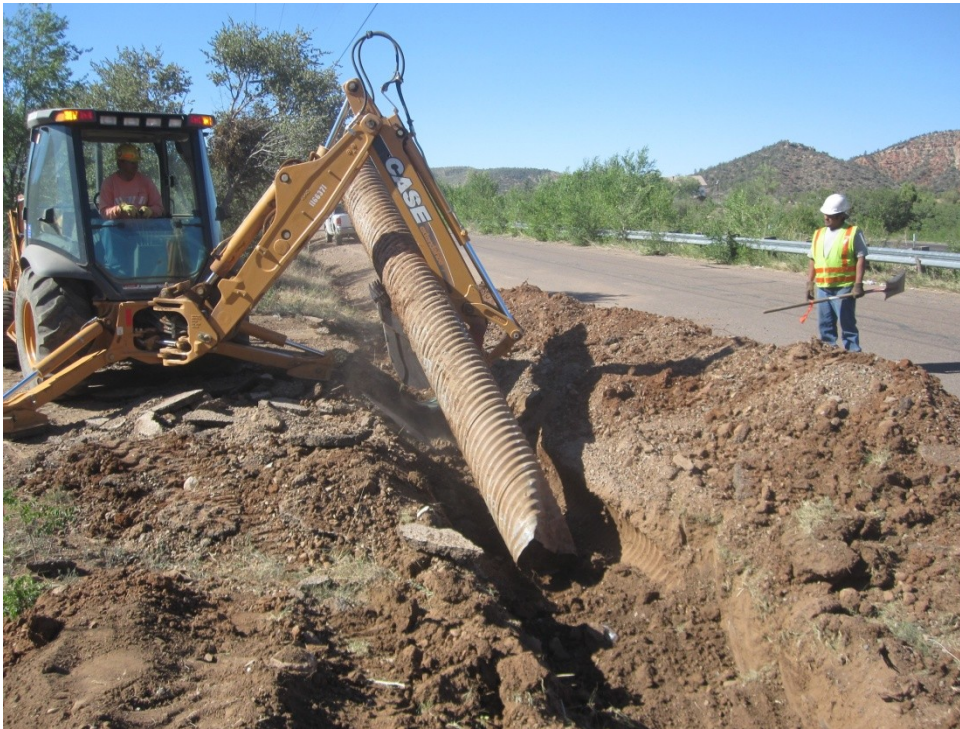
Specification 6 ~ Culvert Replacement

Replacing a culvert...such as the one located at the end of the shovel on the preceding page.

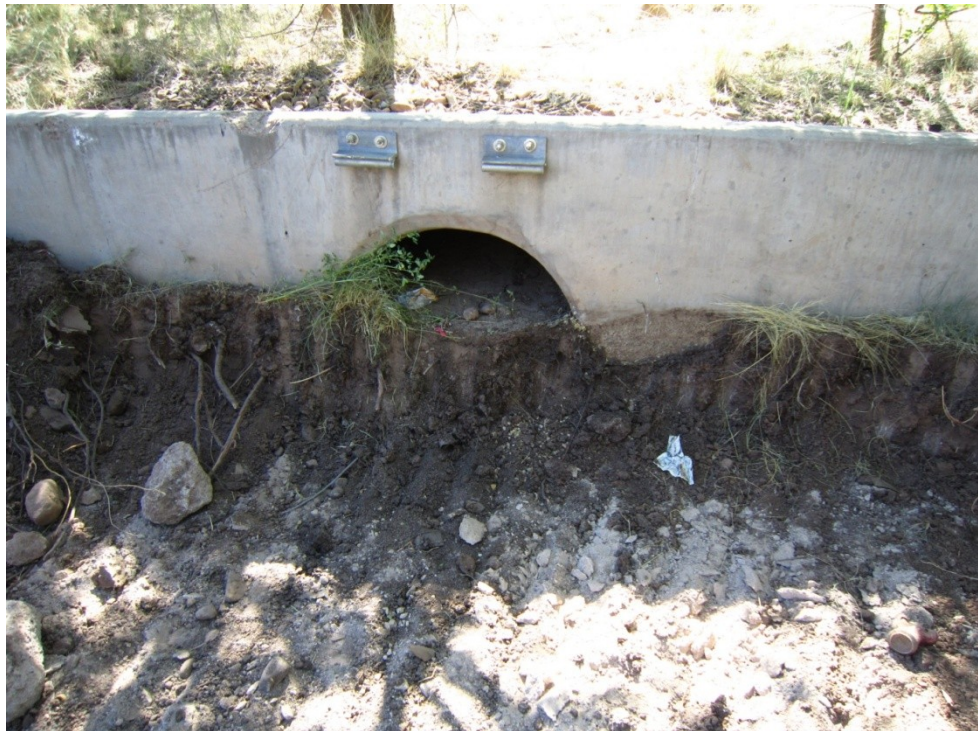
Specification 7 ~ Culvert Cleaning (ADOT)

This 48" culvert under Highway 73 runs from Locust St. down to the river... total run of about 400 feet. This took ADOT contractors three days to clean out.

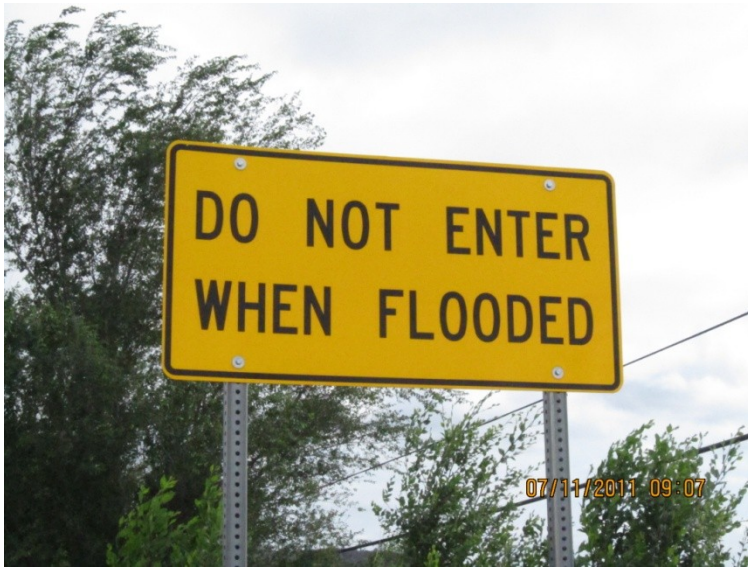
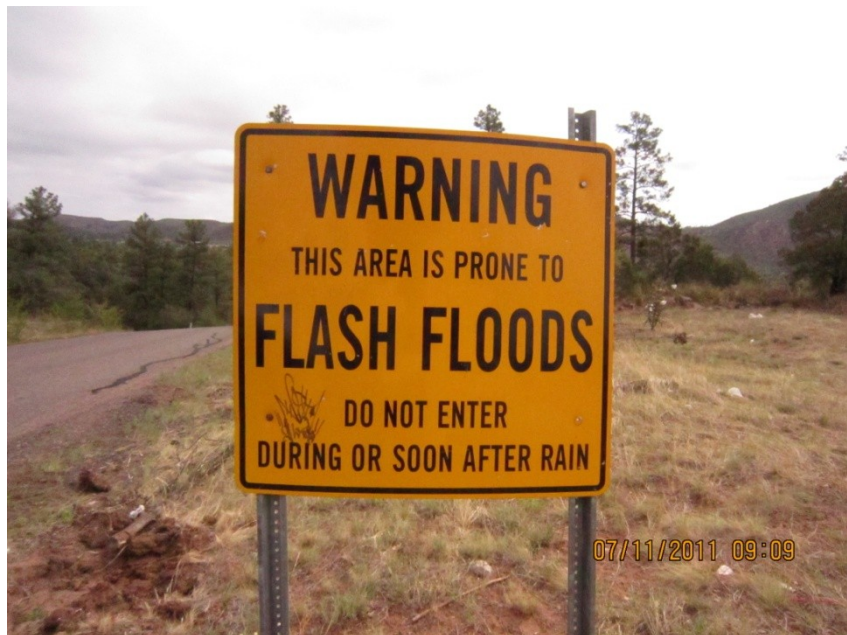
Specification 8 ~ Signage

Existing Highway 73 sign

Example of signs added to the entrances to power line road (minus the graffiti).

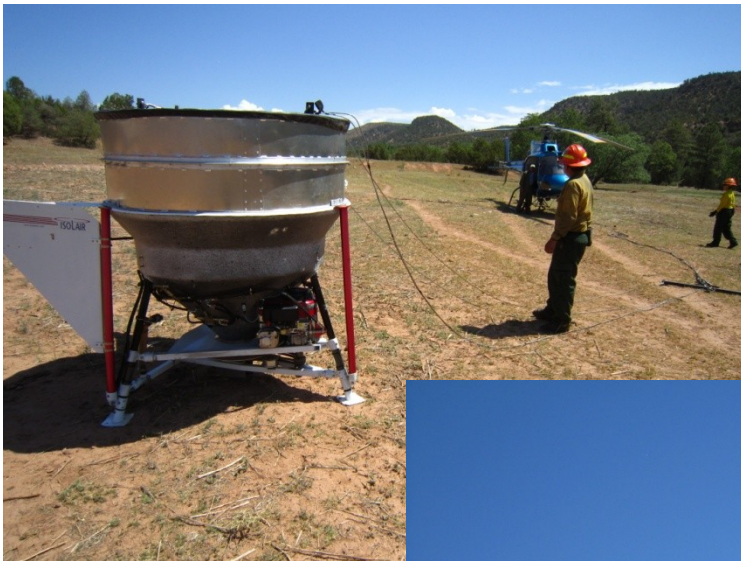
Specification 10 ~ Aerial Seeding

Motorized seed spreader

Note the seed trailing behind the spreader

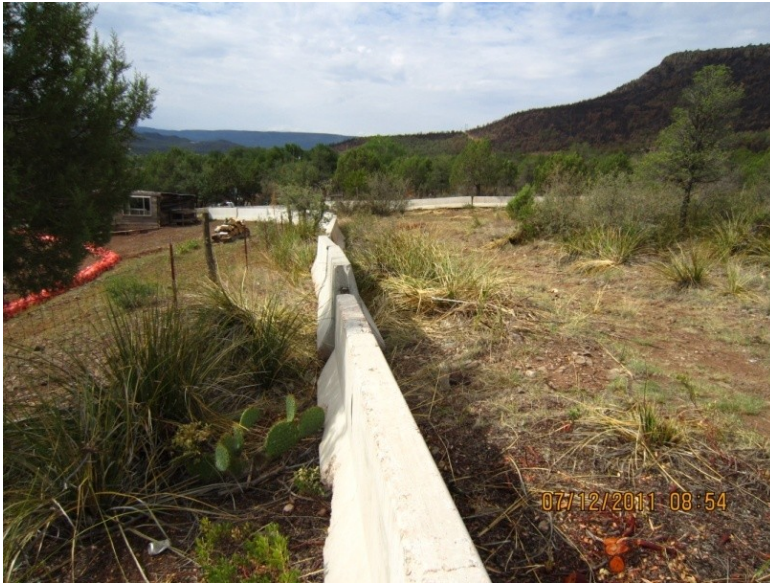
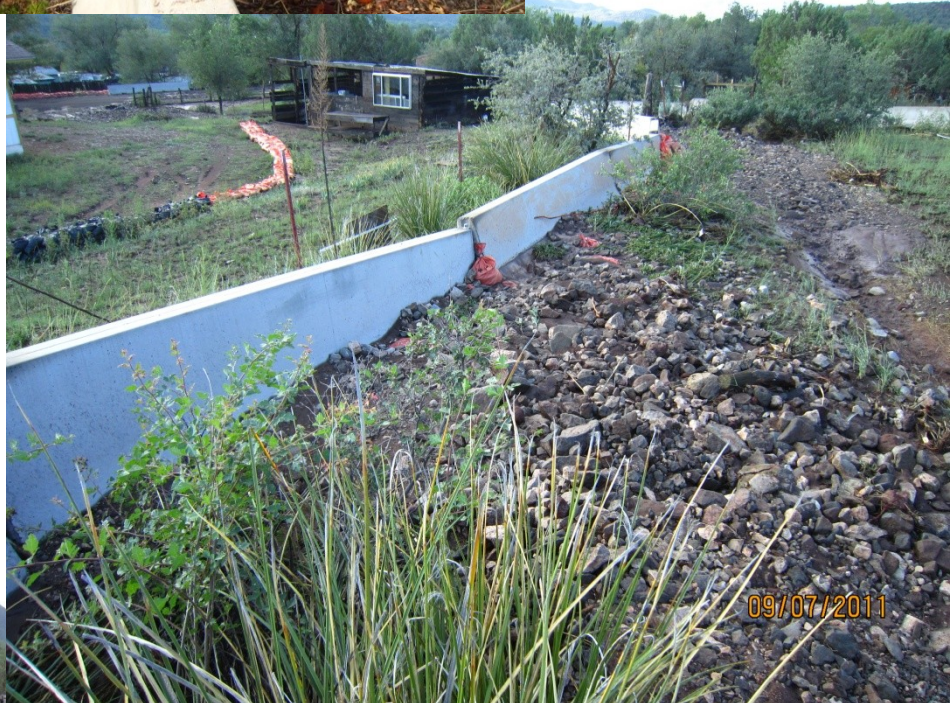
Behind k-rail right after installation

Behind k-rail after 9/6/2011 storm. Too much rock and sediment.

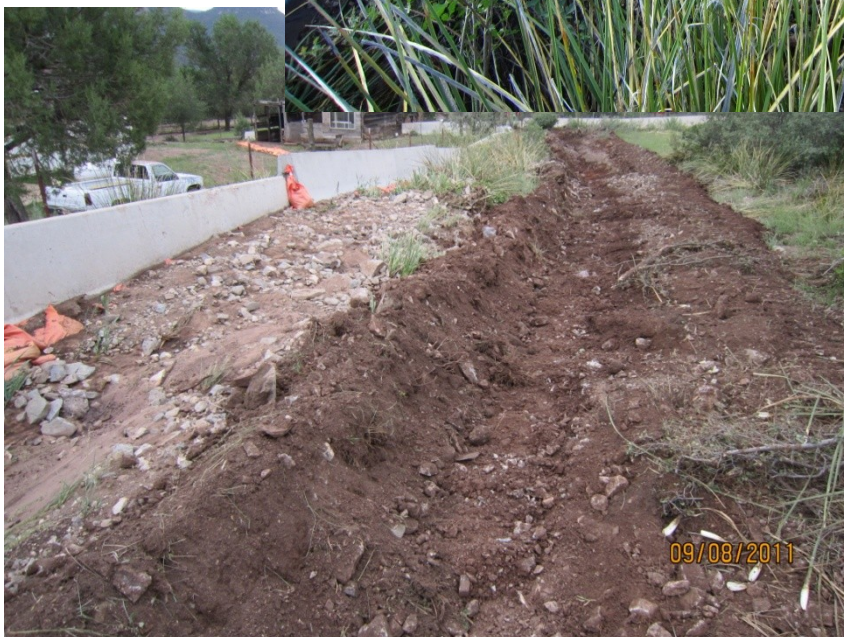
Solution after 9/6/2011 storm to remove rock/sediment and aid in drainage.

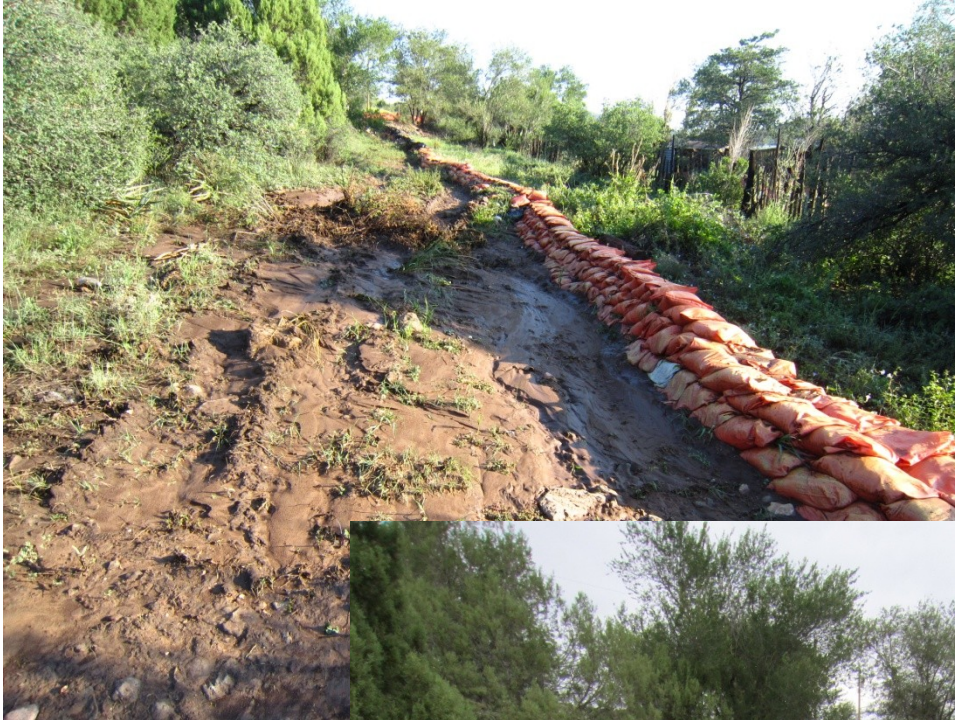
After first three storms too much sediment was building up behind sandbags.

Solution after 9/6/2011 storm was to remove sediment and improve drainage before major flooding occurred.

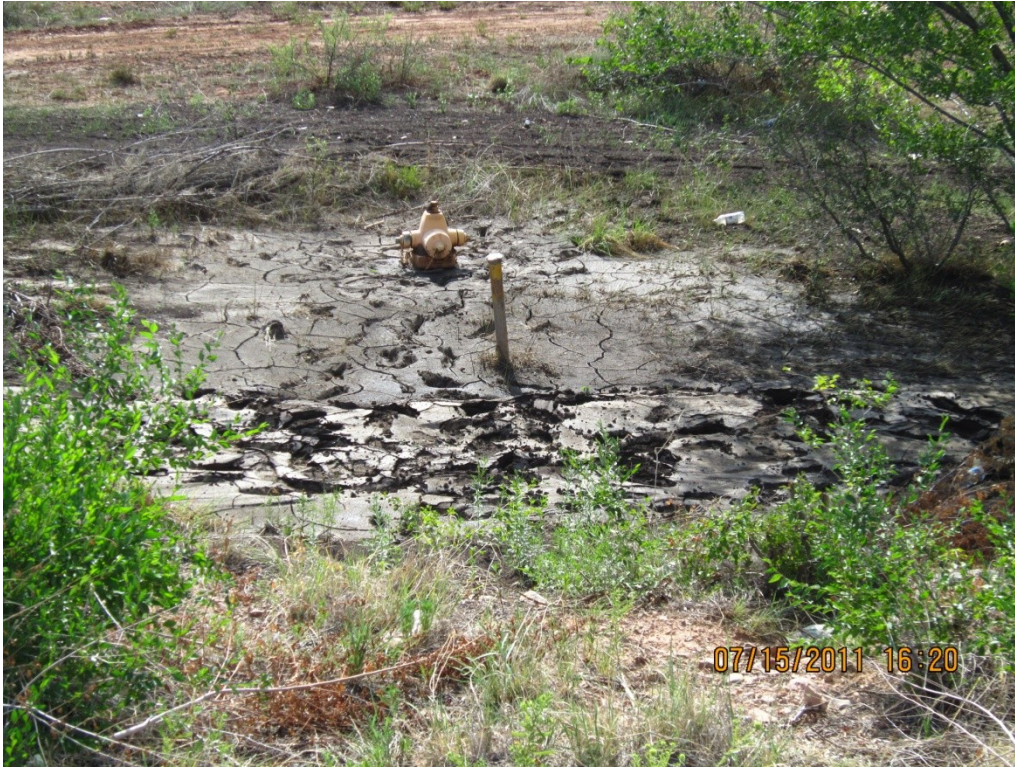
After first small storm: Notice pipe and cap in foreground. Before fire the hydrant was fully visible.

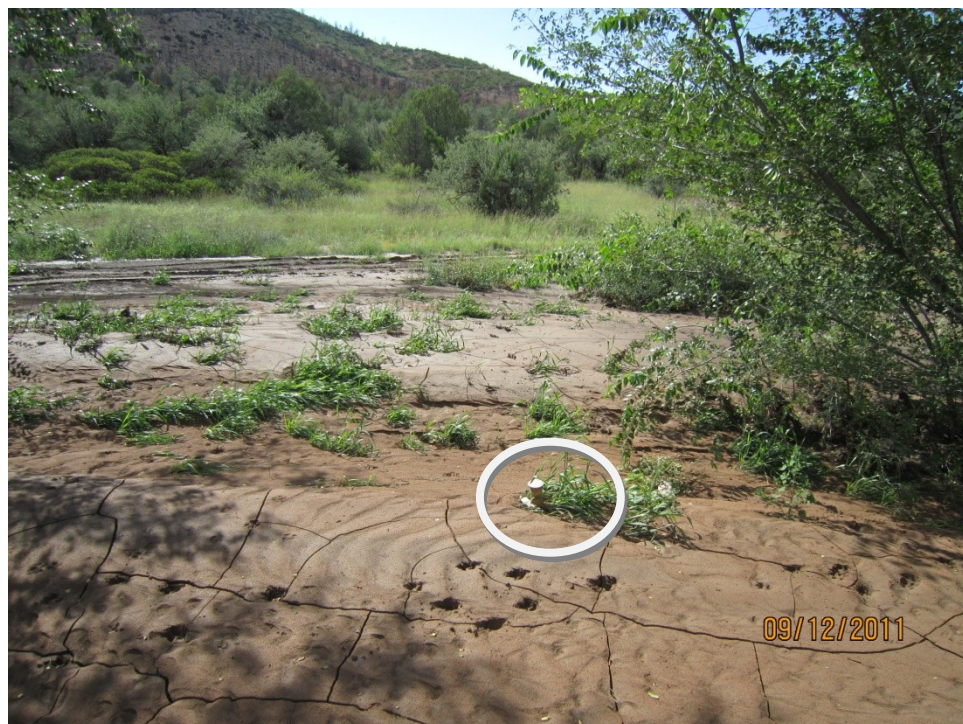
Same location after 4th storm: Note pipe and cap in foreground..but missing fire hydrant under the mud.

On the night of September 6, 2011 there was a 1.2" rain storm (Appendix H) that caused the fourth significant mud and debris flow. Observers said this was the heaviest of the four flows to date. One house on the Southern end of the fire got some mud inside the back door but no other incidences were reported. This storm resulted in very heavy mud and rock flows which challenged the k-rail installs and drainages to their literal maximum. It was necessary to bring in a bulldozer, excavator, and dump truck, plus addition personell to remove mud and rocks from behind the k-rails (several locations the mud/rocks were within inches of overtopping the k-rails). The drainage behind Whiskey Flats was within 3 inches of being compromised. Had this drainage failed there would have been major flooding into the homes of Whiskey Flats. The excavator was used to remove sediment accumulations from this drainage and haul it to the Tribal farm in Canyon Day. I also had the bulldozer install two more "rolling dips" to aid in the drainage of certain problem crossings and to make minor repairs to the powerline road where there was some accelerated erosion ([Appendix F](#)).

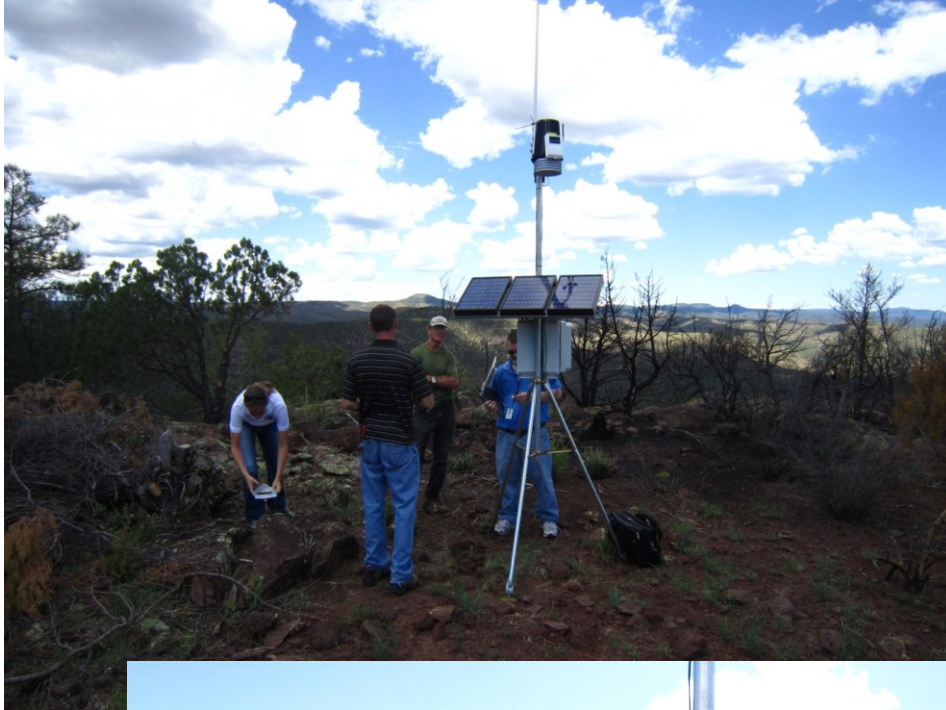
APPENDIX H – NATIONAL WEATHER SERVICE MOBILE STATION

Solar remote NWS station installed on August 4, 2011
