*Flight Performance and Functional Evaluation Report of  
the Pilatus PC-12  
December 10, 2007*

During the week of December 10-14, 2007, a smokejumper flight performance test and functional evaluation was conducted of the Pilatus PC-12 aircraft in Boise, ID. The evaluation results are documented in this report.

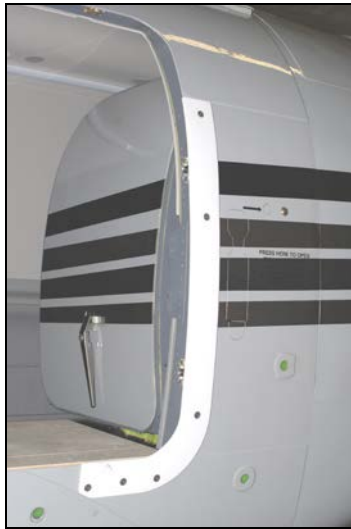
On December 10 in Boise, ID, the following inspection was performed for the preflight static line evaluation. Pilatus had installed a strip of Teflon aft of the jump door that: began about 8 inches below the top of the door, ran vertical to the bottom of the door, and continued forward 8 inches along the bottom sill of the door. The Teflon was about 3/16 inch thick and 3 inches wide. The strip protruded outside of the door edge about 3/16 of an inch. It would be better if this strip extended to the top of the door, but the strip was adequate for the evaluation. The Teflon at the bottom of the door could catch on a jumpsuit or harness, so the Teflon there was smoothed by filing it down an eighth of an inch.

The vertical static line cable used during the evaluation was originally built for the Cessna Caravan. The base plate was modified to fit the floor track in the PC-12. The cable assembly fit well and was positioned correctly to give the proper angle for the static lines. Pilatus engineers also built a platform to bring the jumpers and/or cargo level with the bottom of the door edge. The platform was about 7.5 inches in height.
