Coyote Fire Burned Area Rehabilitation Plan

Guadalupe Mountains National Park

Coyote Fire

BURNED AREA REHABILITATION PLAN

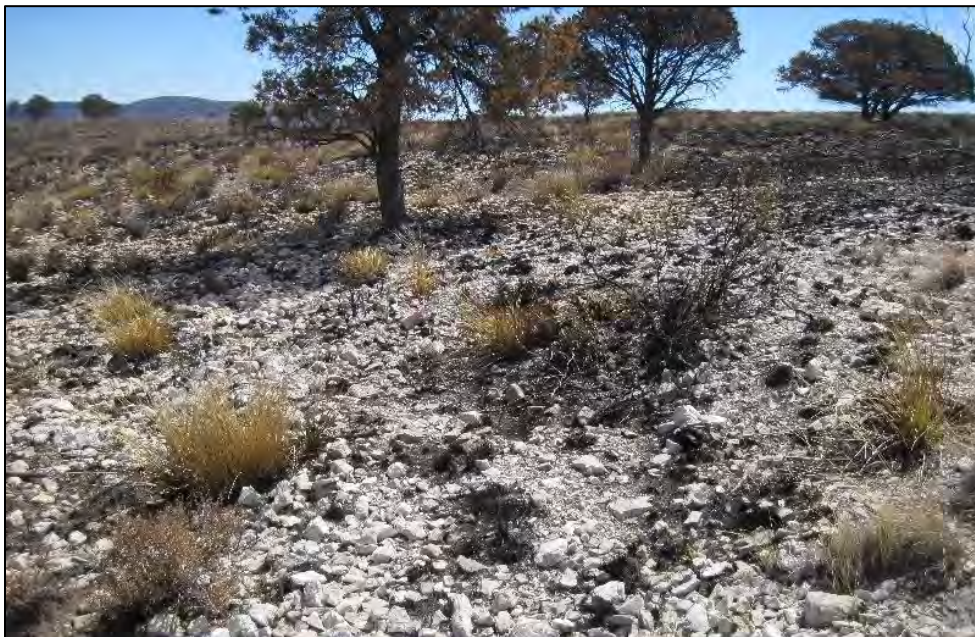
Figure 3: 41CU139 head cut in midden.

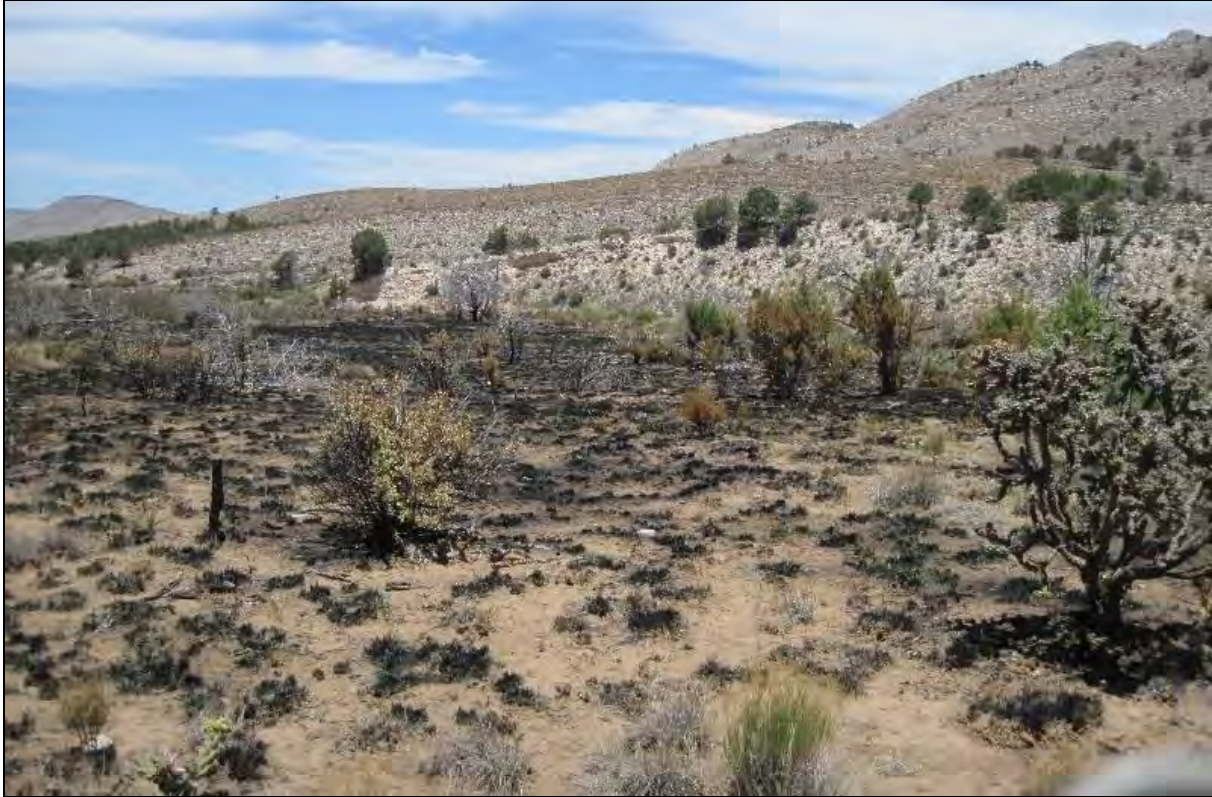
Figure 7: 41CU782 overview facing north.

Site is a multicomponent site consisting of a lithic scatter and associated rock middens, as well as an historic fence and associated historic artifacts. The site is located above the flood plain and is stabilized with natural grasses already growing on site. Features do not appear to be adjacent to the gully. No stabilization work is needed.

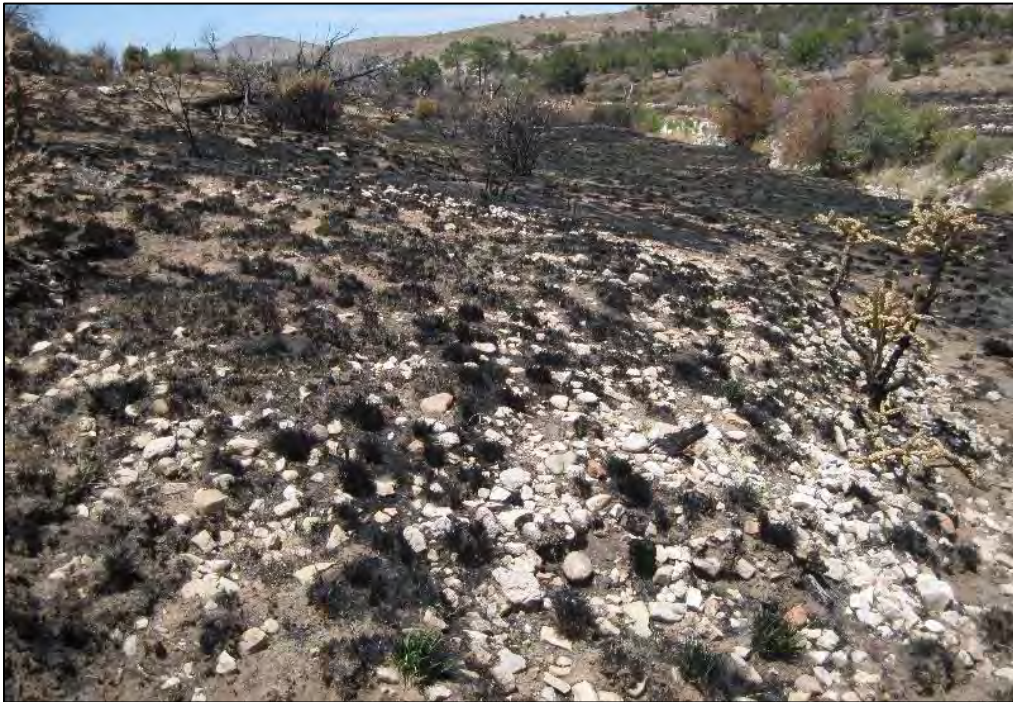
Figure 9: 41CU151 Feature 2 Ring midden in danger of erosion.

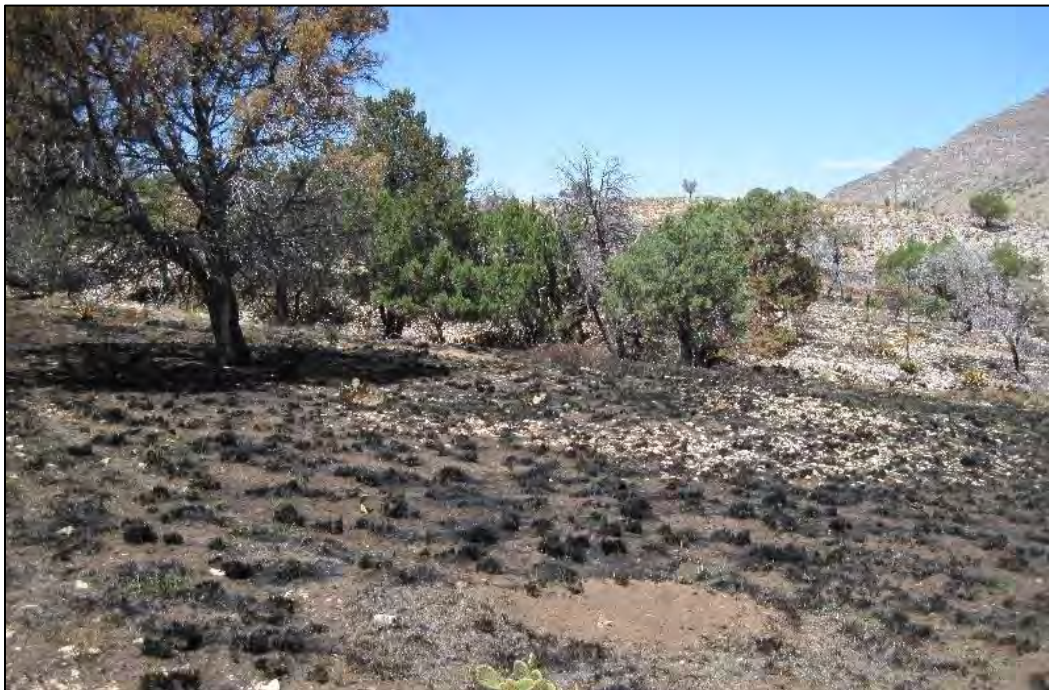
Figure 17: 41CU99 overview facing north.

Site was originally described as a three ring middens and two possible “teepee” or “Wikiup” rings. A site form was not available; only one large, intact, well-preserved ring midden was located. Others features may have been obscured by soil. The site is stable and in good condition. No further work is recommended.

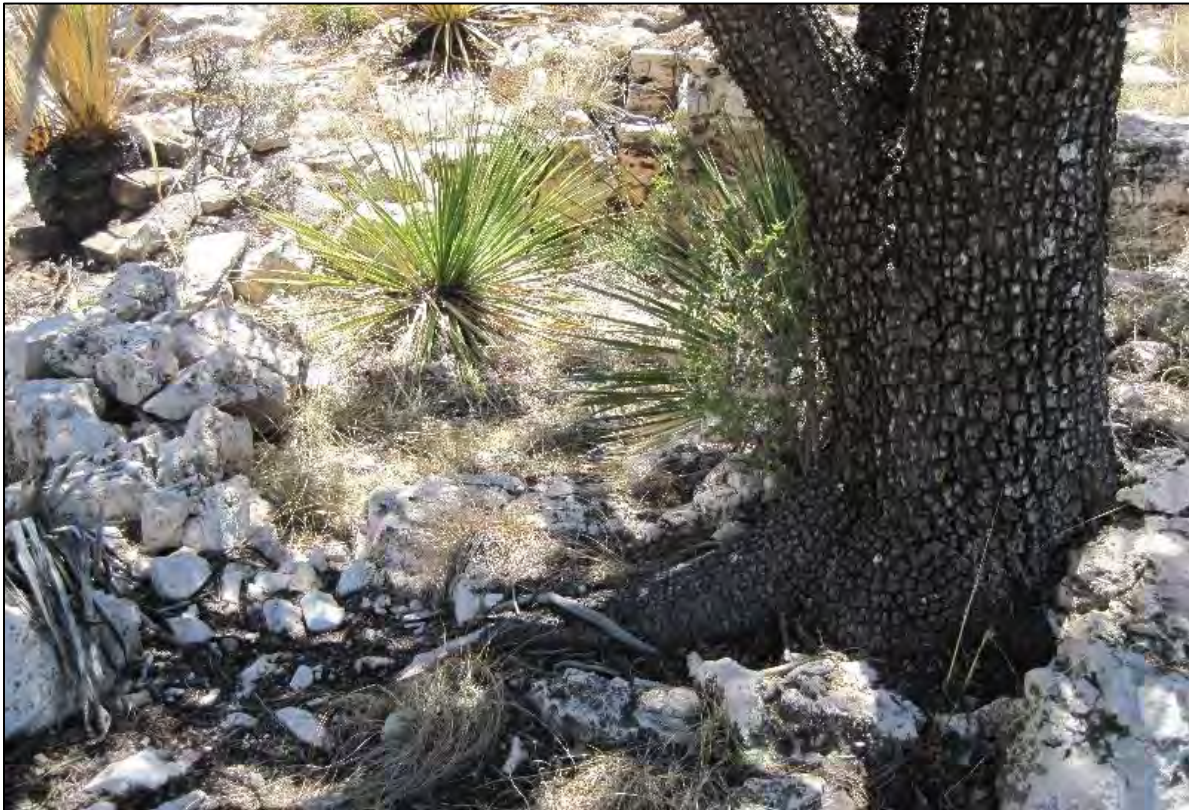
Figure 18: 41CU561 overview facing southeast.

A form was not available at the time of the visit. Site is a 2m-diameter excavated pit with native rock walls 2 courses high. The pit is situated on an overlook above Dog Canyon; it may have functioned as a look out, hunting blind, or food storage. No burned material was noted, leaving me to believe the pit is not a ring midden. Burn severity is low, and the site is in good and stable condition due to thin soils. No further work is necessary.

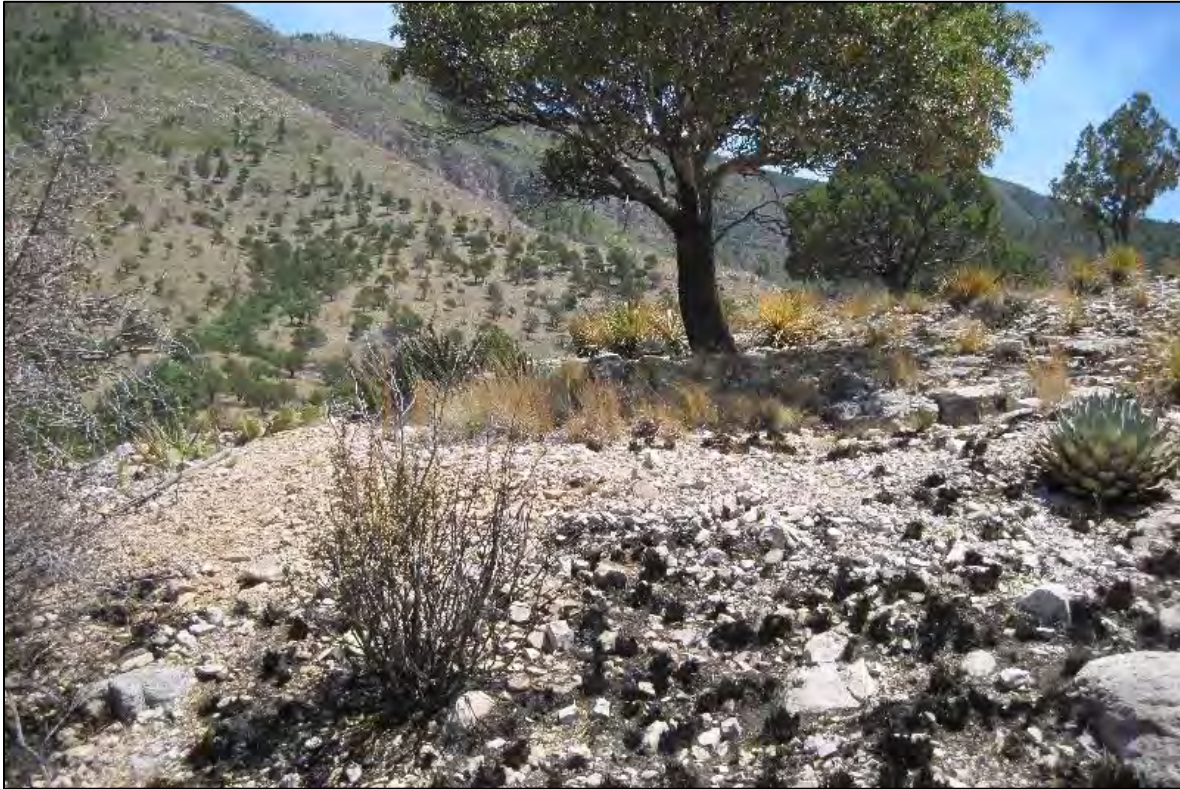
Figure 19: 41CU?? overview facing south.

Site is labeled in GIS as 41CU?? – a site number needs to be added. The site is just north of site 41CU561 and consists of a ring midden. No form was available at the time of visit. The site is in good and stable condition and burn severity is low; no further work is needed.

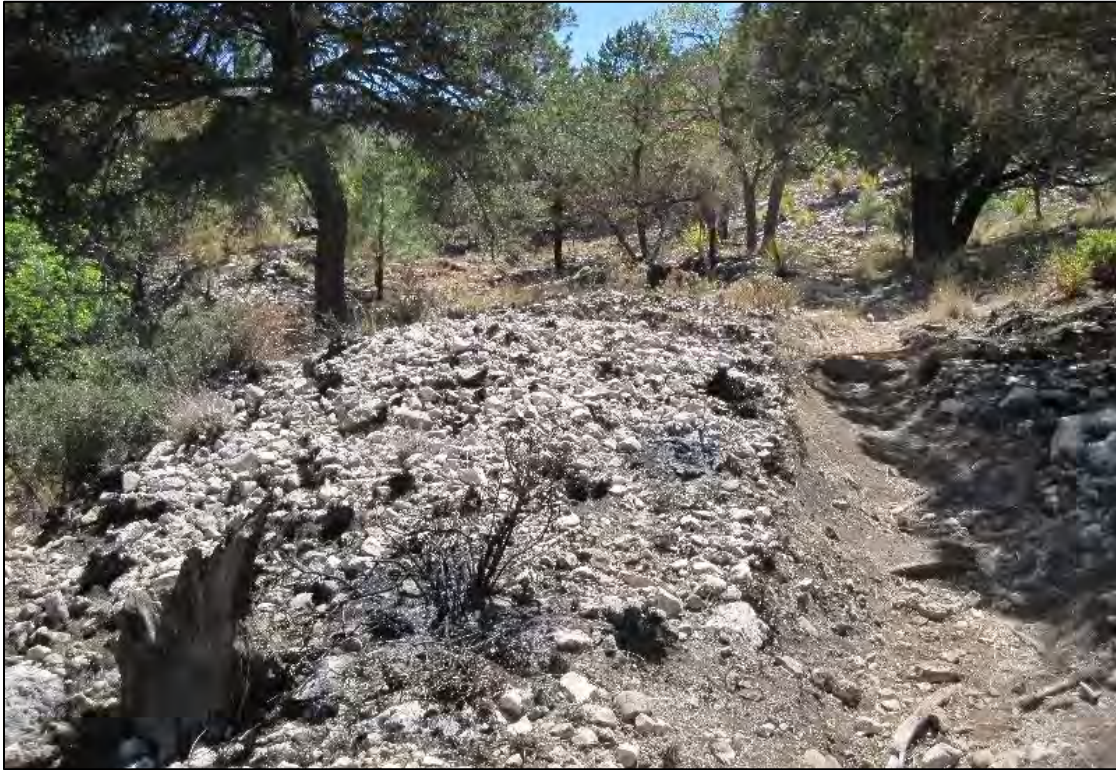
Figure 22: 41CU96 Feature F3 facing west with trail destruction.

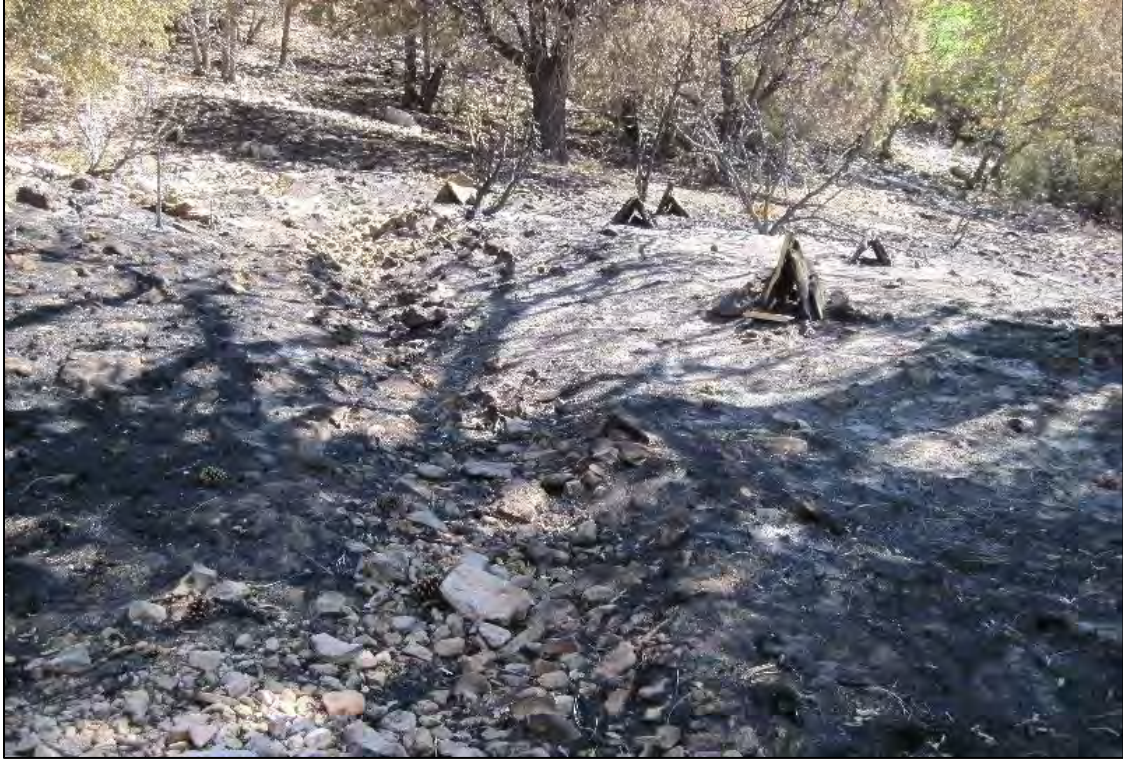
Figure 24: 41CU96 several "kid goat rocks" with channel that needs stabilization.

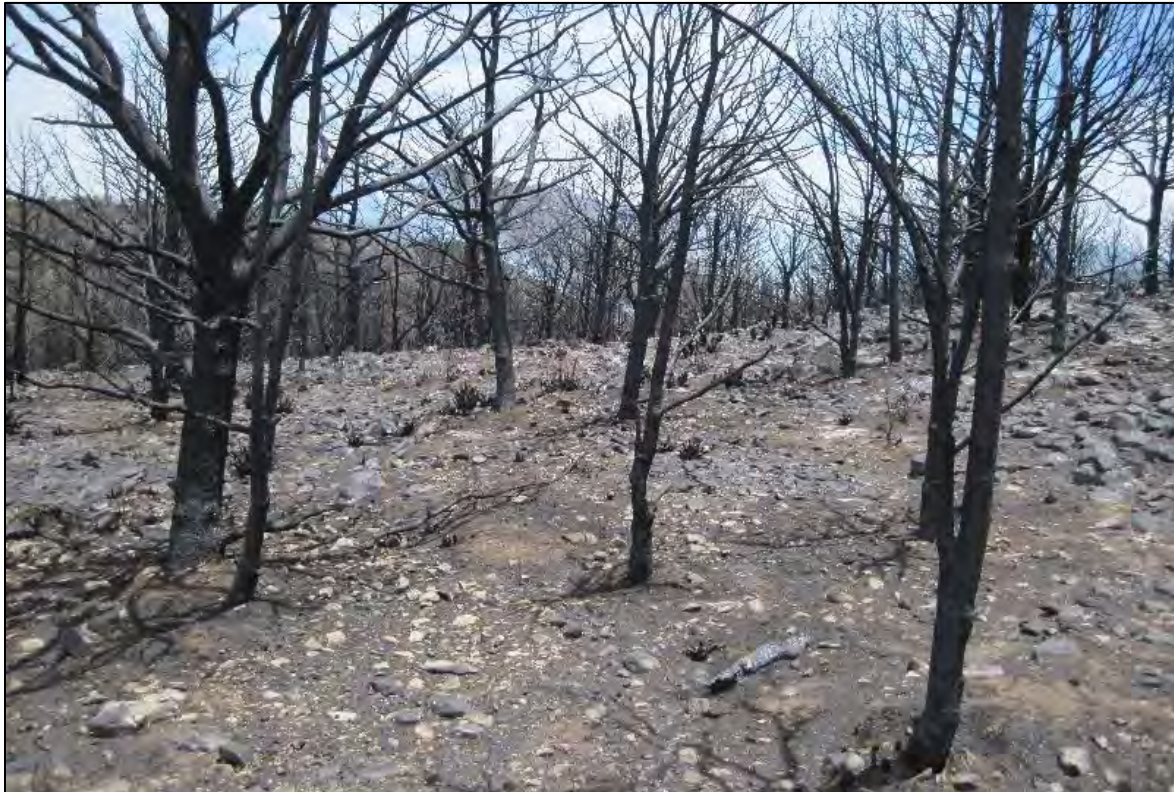
Figure 31: 41CU253 overview facing southeast.

Site is a lithic scatter on a ridge top. A form was not available. The GPS location was found to be incorrect, possibly due to mis-plotting the site's location from a 15-minute map. A new GPS location was recorded. The site is located in a small patch of pinion and juniper. It is stable due to the shallow soils; no stabilization work is suggested.

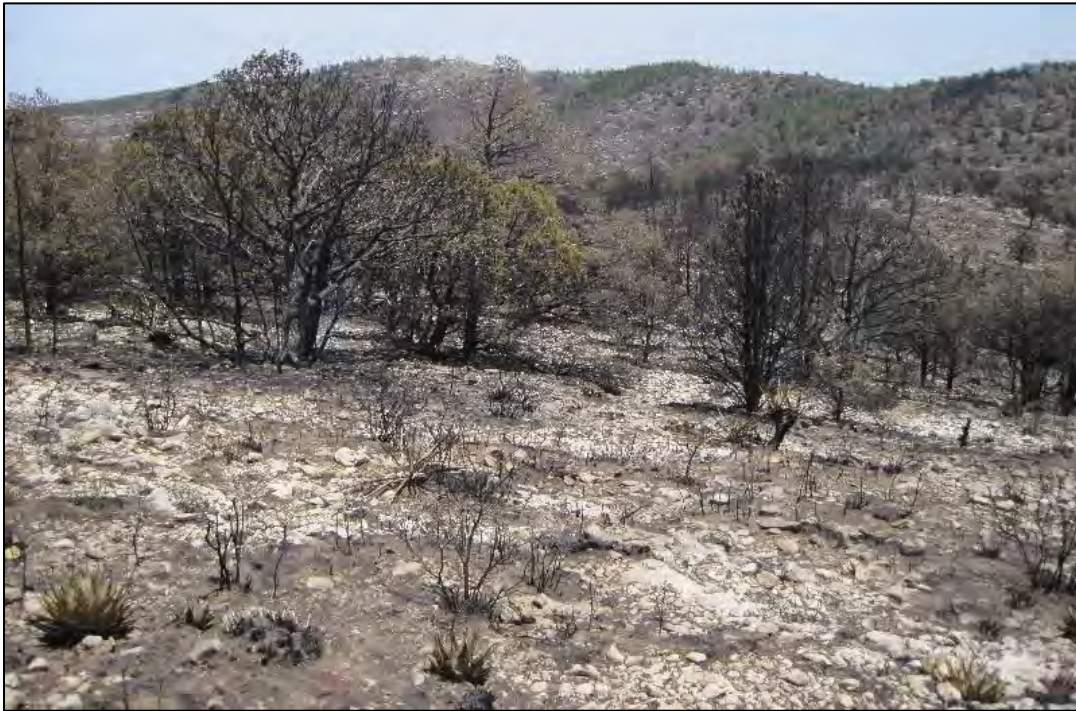
Figure 32: 41CU205 overview facing east.

Site is a lithic scatter, found to be as described in previous recording. Site is stable and in good condition; no stabilization treatments are necessary.

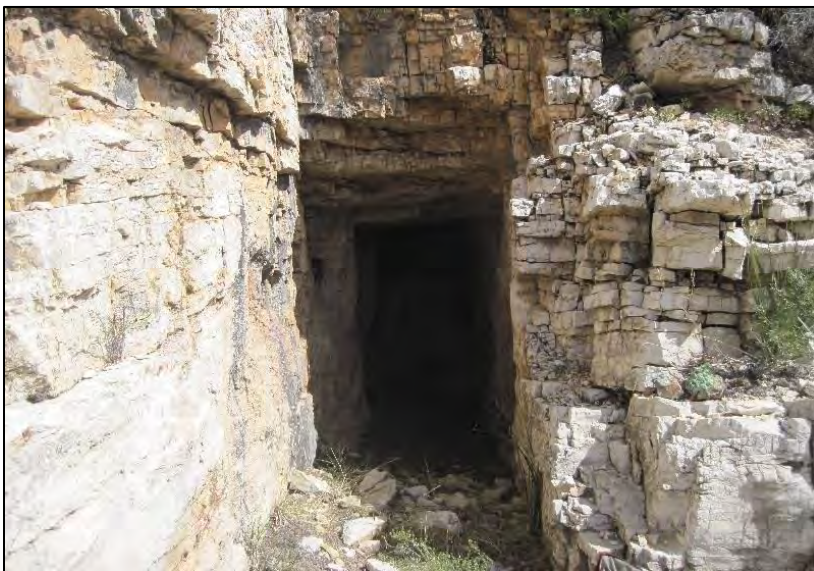
Figure 38: 41CU565 facing northwest.

Site is a historic mine adit that has been filled. Components are bedrock and will not be affected by fire. No stabilization work is needed and there is no need to visit the site after future fires.

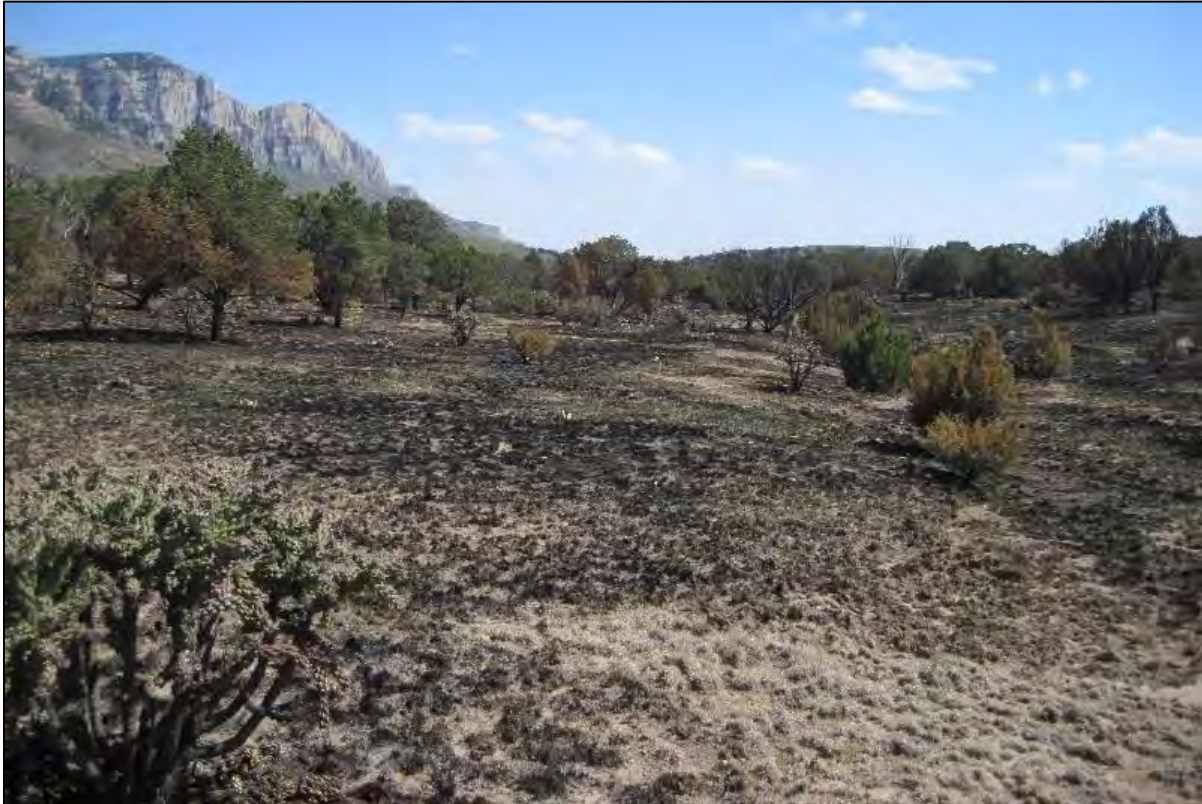
Figure 39: GUMO-2009-36 site overview facing south.

The site has not been formally recorded and a site map is not included in the informal documentation; not all features were relocated. The site is stable and in good condition, there is little chance for erosion and no chance of flooding due to the site's shallow slope and thick grass cover. Additionally, the site is mostly subsurface, further protecting it from effects of sheet erosion. No stabilization work is needed.

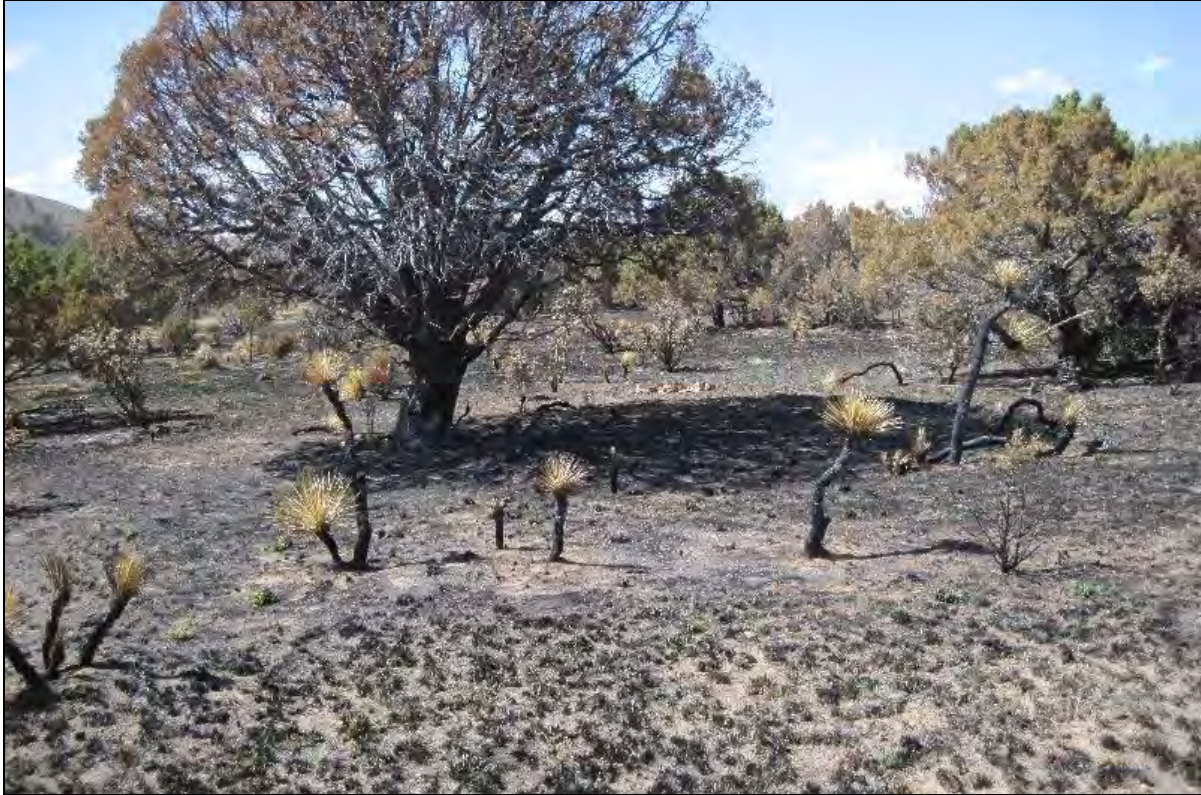
Figure 40: 41CU174 site overview facing north.

Site was originally recorded in 1973 as a sparse scatter of lithics, “but more so than usual for PX flats.” The site has not been mapped, or monitored since that time. PX Flat is a large basin east of Cutoff Ridge that collects windblown dust and sand, allowing cultural material to become subsurface. The site is in good and stable condition, No stabilization work needed.

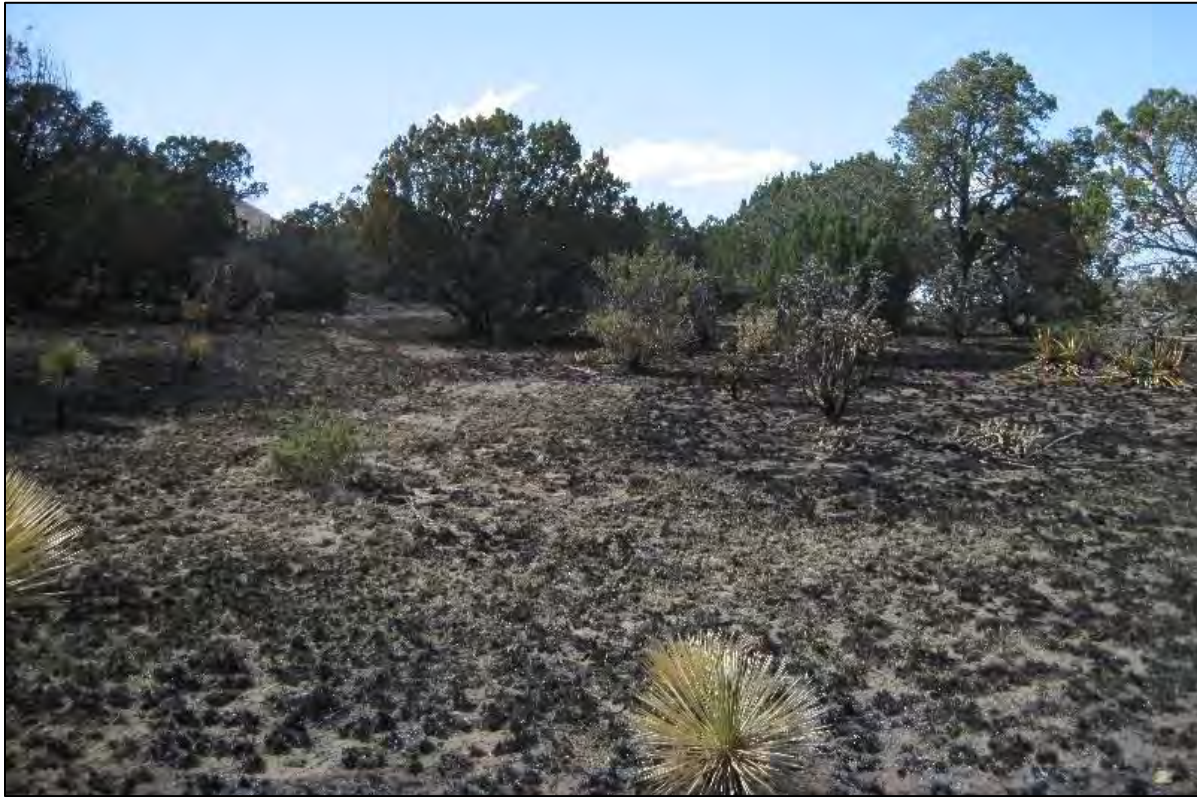
Figure 41: GUMO-2009-37 site overview facing north.

The site has not been formally recorded and a site map is not included in the informal documentation, as such not all features were relocated. The site is stable and in good condition, there is little chance for erosion and no chance of flooding due to the site's shallow slope and thick grasses. Additionally, the site is mostly subsurface, further protecting it from erosive effects of sheet washing. No stabilization work is necessary.

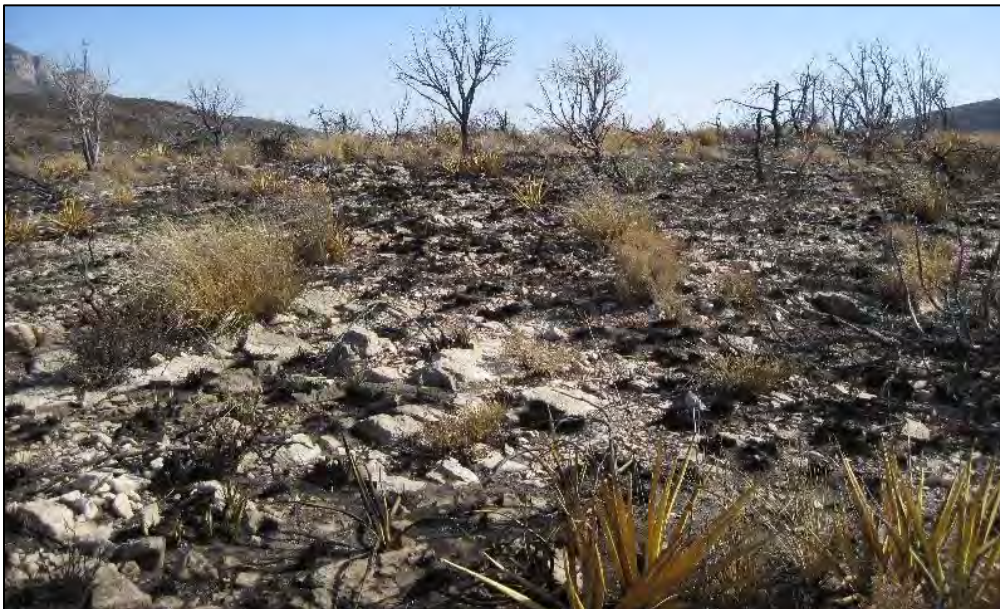
Figure 44: 41CU778 facing north.

Site consists of a prehistoric lithic scatter located on the slope of a ridge. A site form was not available at the time of visit. Site is in good and stable condition; no stabilization needed.

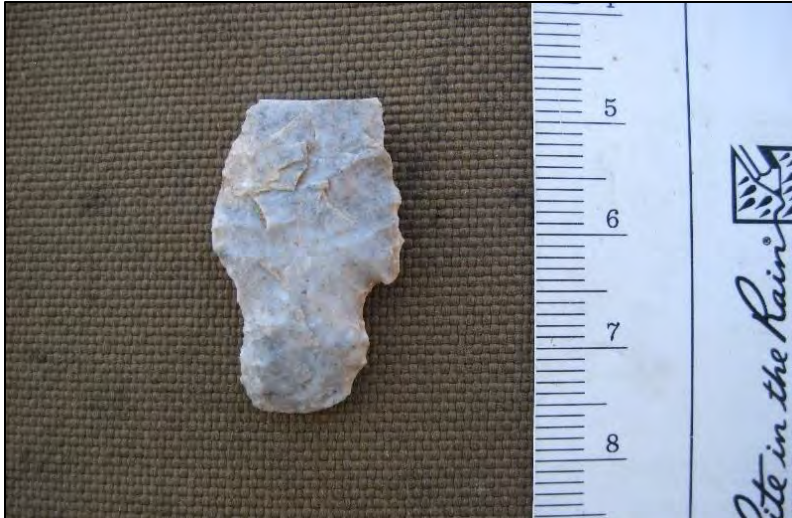
A site form was not available. Site is a lithic scatter primarily subsurface; all artifacts were found in gullies with head cuts 6-12" below surface. Site needs to be stabilized with brush and slash (to protect wilderness character) as site has data potential. Site is in fair condition. Sheet wash is the primary concern and could cause future data loss.

Figure 51: GUMO-2011-1 diagnostic projectile point found 12" below surface in sheet wash.

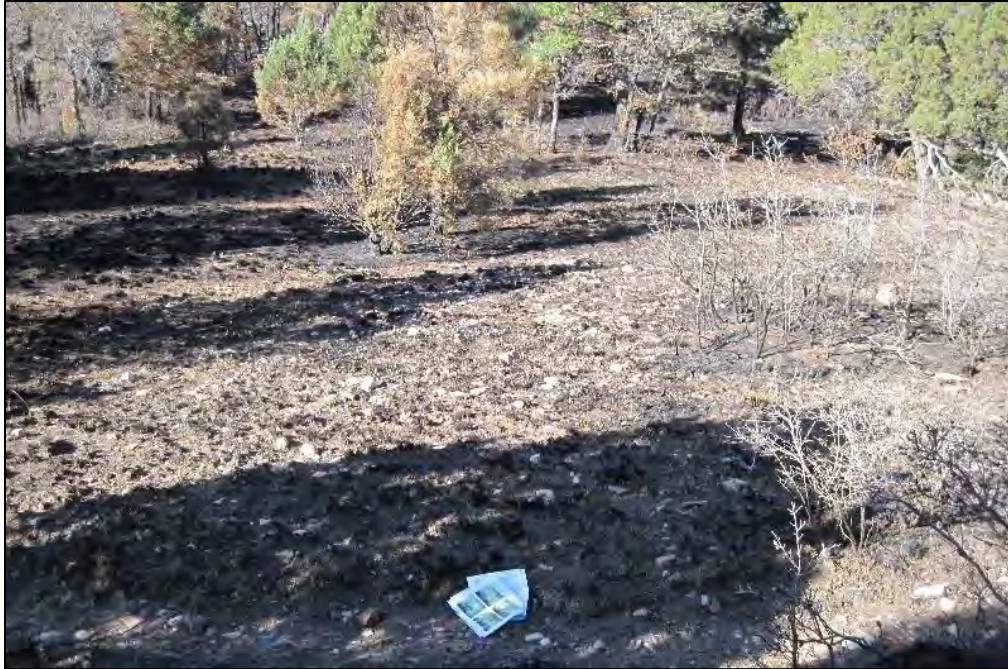
Figure 54: 41CU198 overview facing north.

Site consists of four ring middens and a lithic scatter situated on a saddle along Blue Ridge. Site is in good and stable condition, no stabilization work is needed. In the future, the site may need to be re-recorded and tested to confirm if F1 is a ring midden, and if F2 and F3 are separate middens or one large midden.

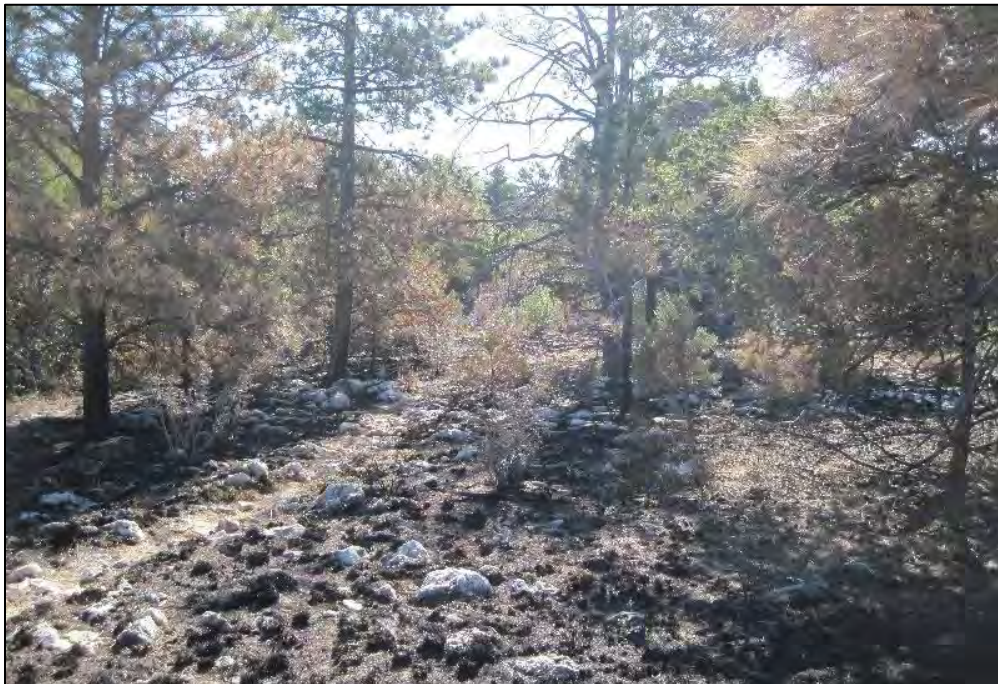
Figure 55: 41CU227 overview facing east.

The original site record describes a lithic scatter located 30 meters from Blue Ridge campground. The area is in good and stable condition, no stabilization work is needed. The site may not have been relocated by the 2009 crew, who only found one flake. During the current visit, only one flake was found as well. It is suggested that the site be relocated based on the original record.

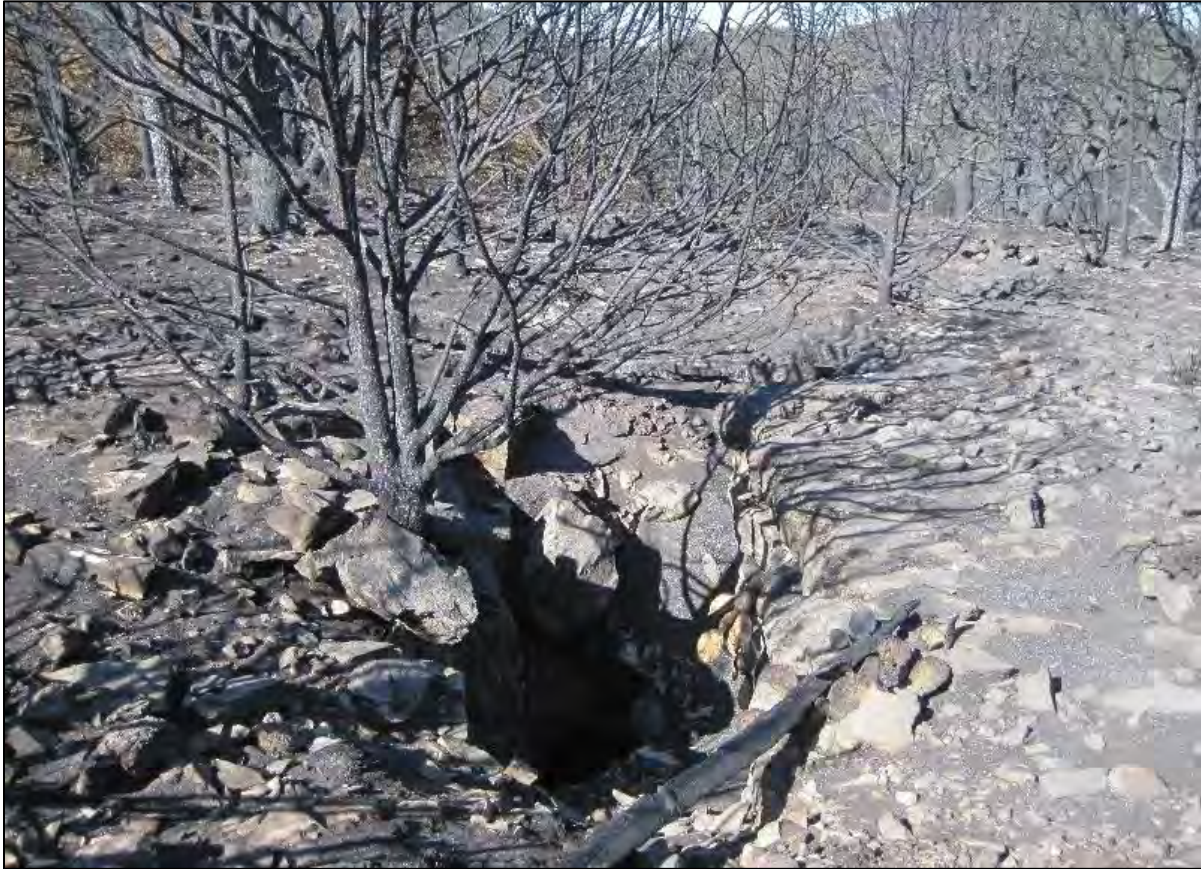
Figure 56: GUMO-2016-3 overview facing west-southwest.

Site is a 3x2 m mineshaft 2-3 m deep. No waste rock or other historic artifacts or debris noted. Site is stable and in good condition, no stabilization work needed.

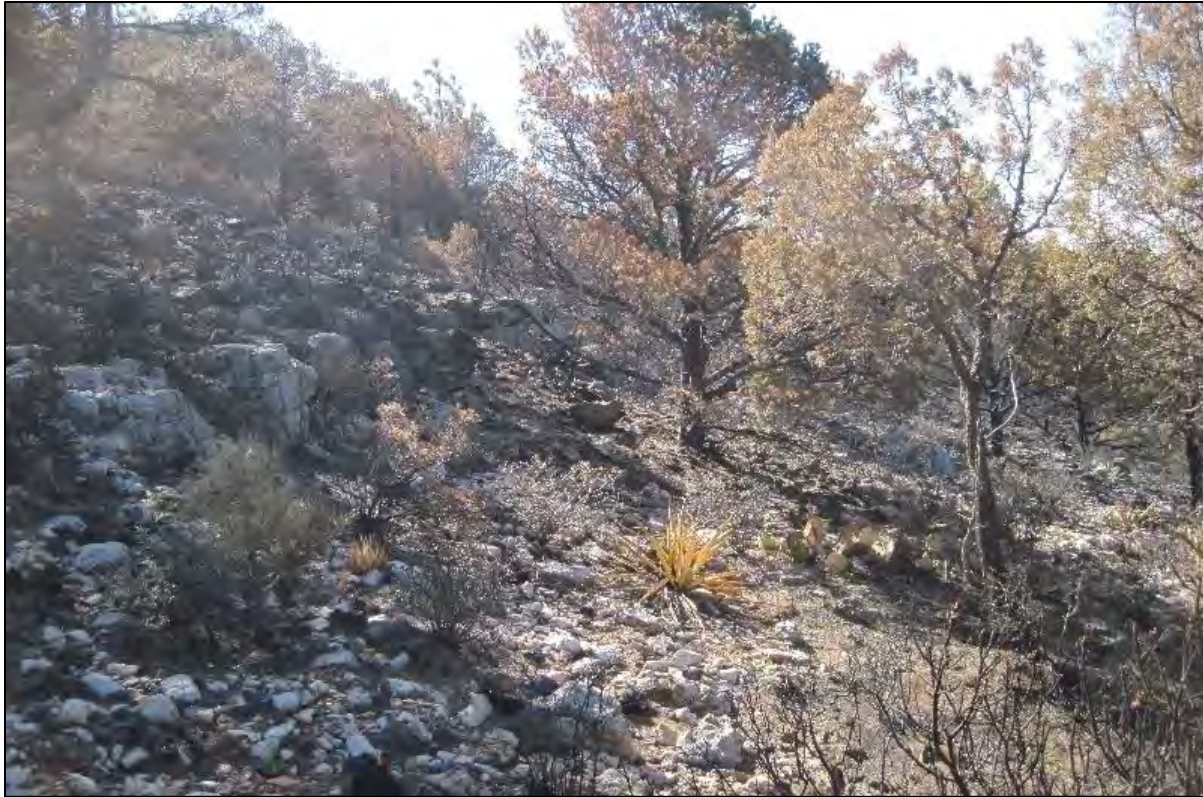
Figure 57: GUMO-2009-34 overview facing southeast.

Site may be a lithic source site. Site form was not available. No cultural material was found, possibly due to duff. Though the site is on a 30 degree south slope, the site is stable due to lack of soil and being near the top of a ridge. No stabilization work. In the future the site should be revisited and re-recorded using modern standards and research.

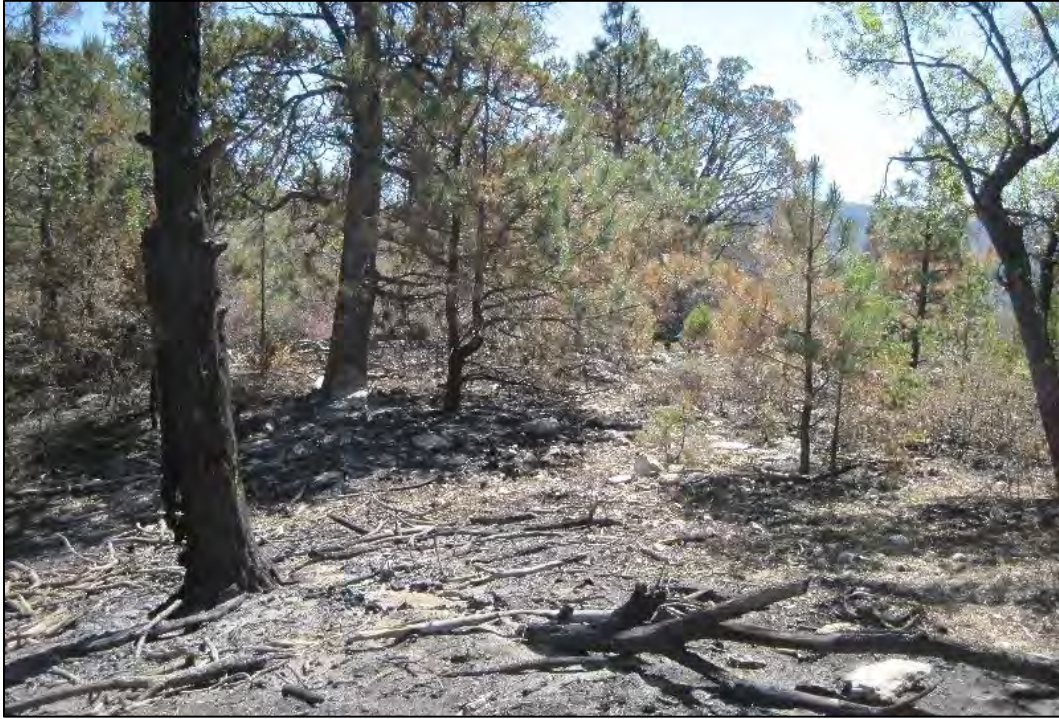
Figure 58: 41CU222 overview facing southeast.

Site is multicomponent, consisting of a small lithic scatter, ring midden bisected by the trail, and historic axe-cut logs. During our visit, the axe cut logs could not be relocated and have likely burned. Ash stain and burned limestone are hard to discern, therefore we suggest that the site be tested to confirm the presence of a ring midden. Otherwise, site is stable and in good condition, No stabilization work needed.

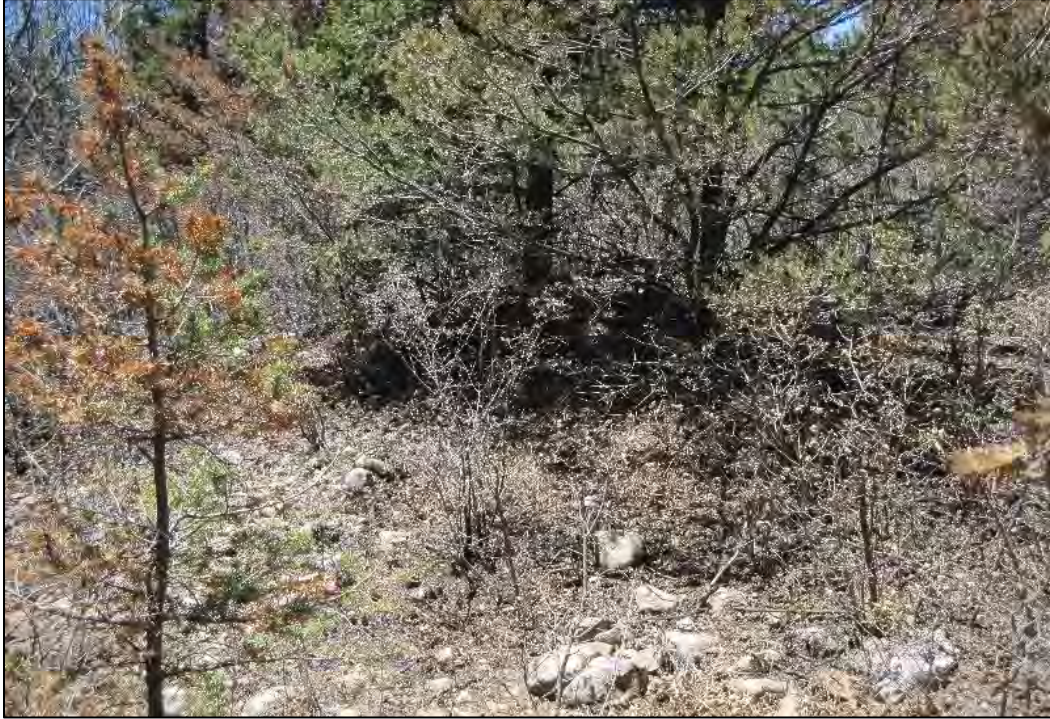
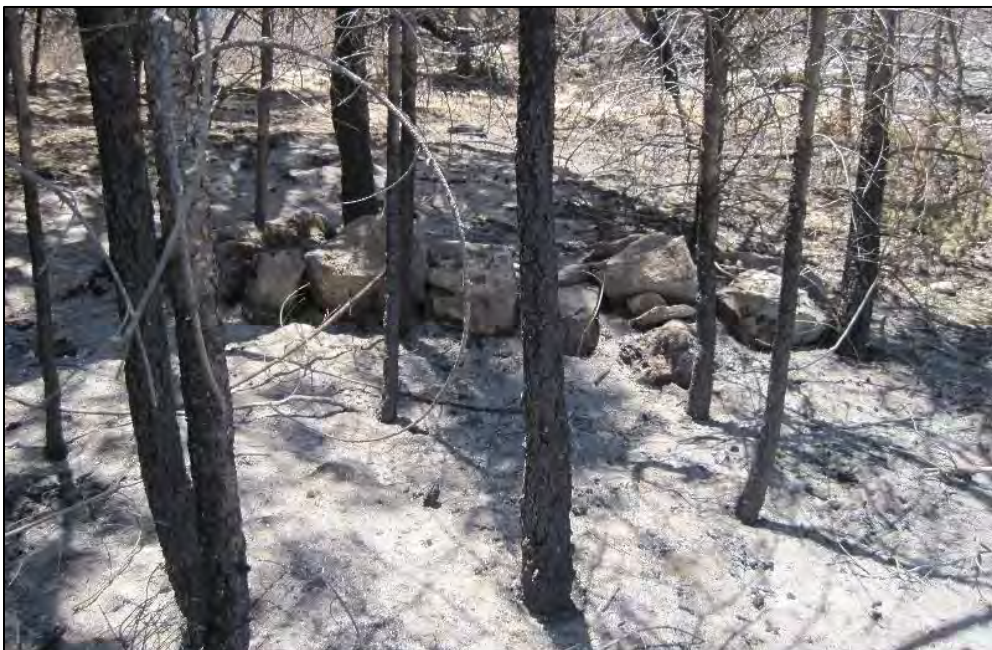
Site is a multicomponent site consisting of a ring midden, lithic scatter, historic can scatter and a low rock wall. The site was found to be as described and in good and stable condition, No stabilization work is necessary.

Figure 59: 41CU224 Feature 1 facing south-southeast.

Figure 60: Low rock wall (historic) facing south.

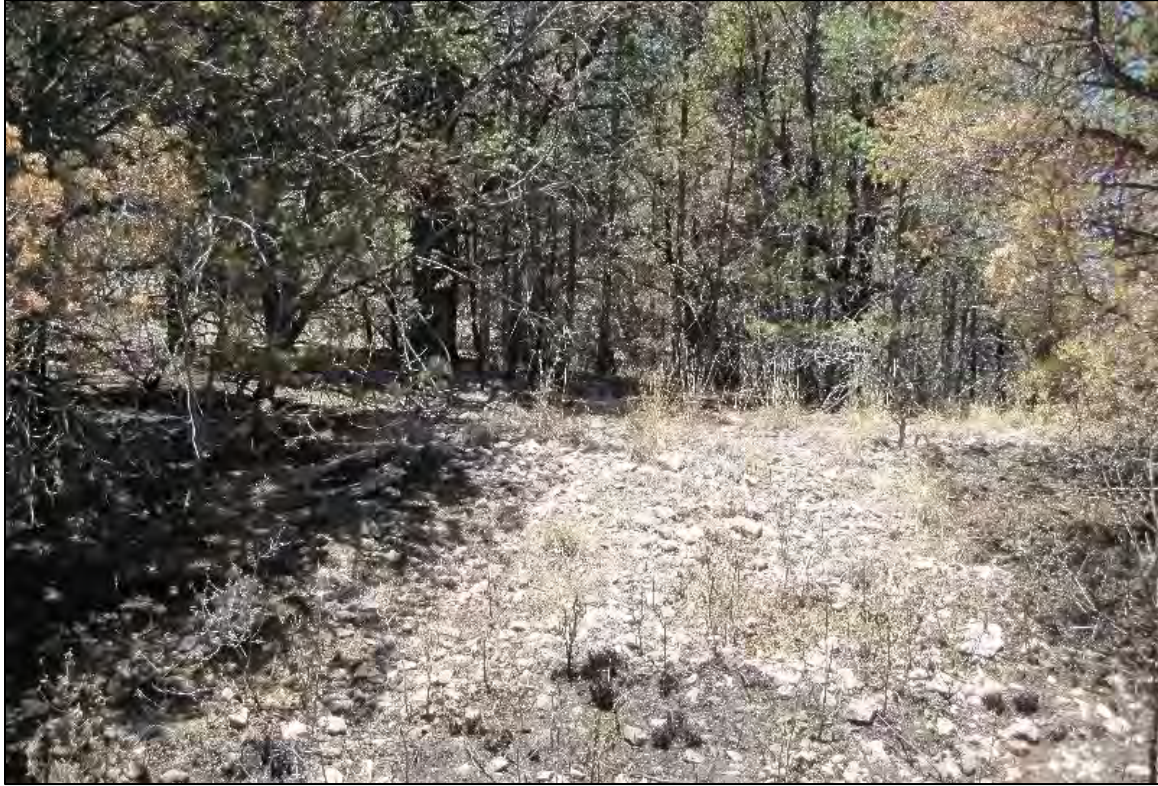
Figure 61: 41CU221 overview facing north.

Site consists of five ring middens, a lithic and ceramic scatter. The site was found to be as described and in good and stable condition, with no stabilization work necessary.

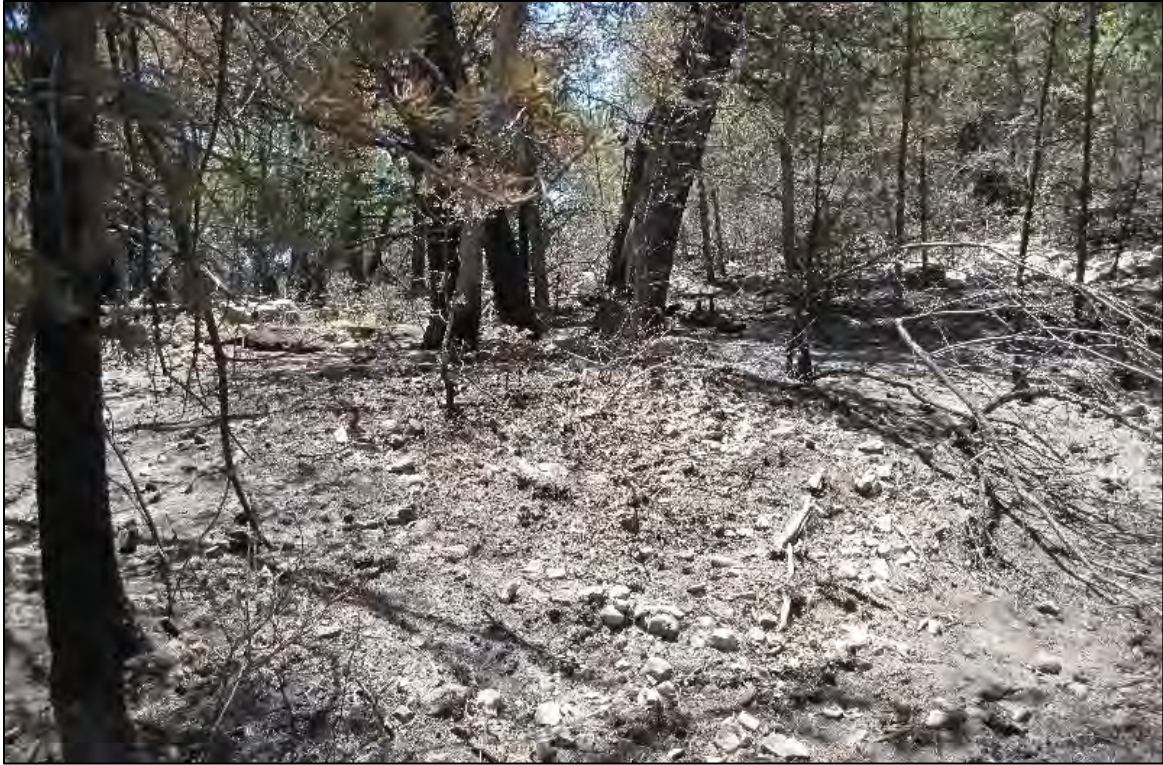
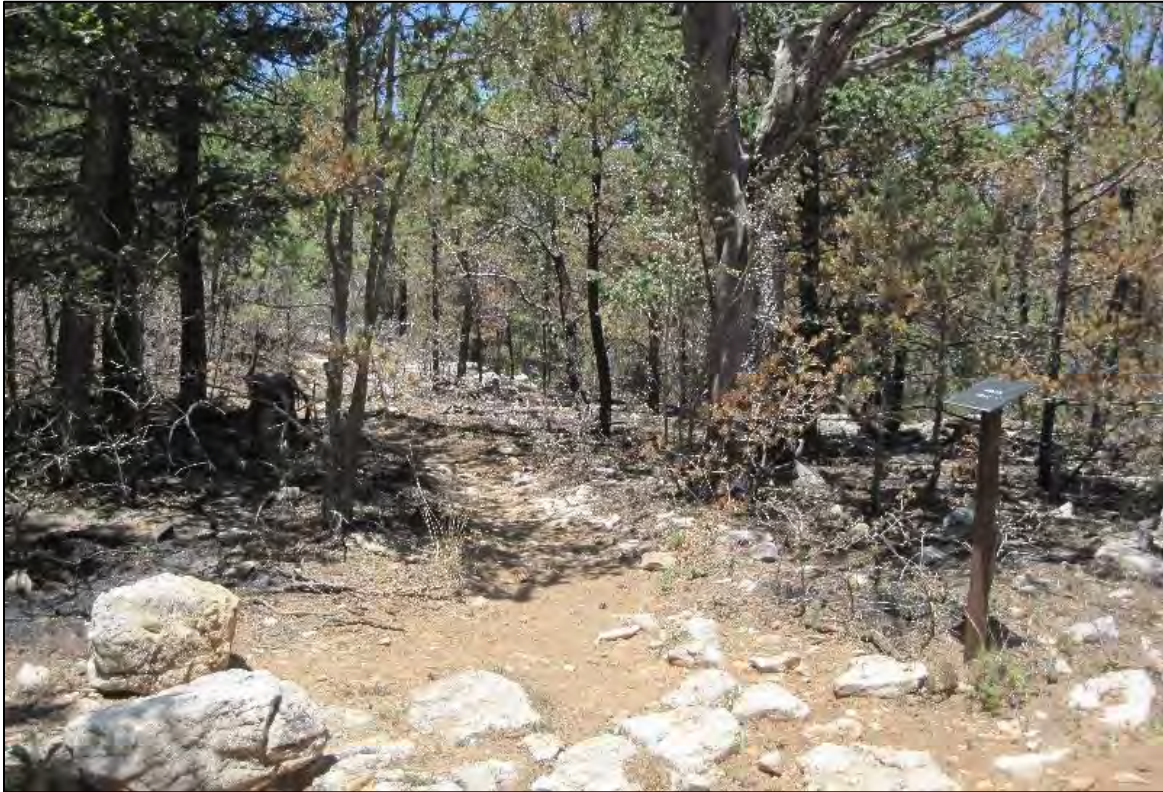
Site consists of a single ring midden and associated lithic scatter. When site was recorded in 2011, it was suggested that the four established trees within the ring midden be cut to prevent damage to the feature. I do not believe this is the appropriate action; the trees are well established and are not forming new roots. The damage has already occurred; cutting live trees would encourage new plant growth, further damaging the feature. During the Coyote Fire, a low level intense fire did burn the roots of the trees within the feature, increasing bioturbation, however, the trees may still be alive, and may still be protecting the feature from increased bioturbation. The site should be monitored annually for the next 3 years. If the trees within the feature die, they should be cut to prevent damage to the feature from uprooting when the dead trees fall.

Figure 62: Ring midden facing south-southeast.

Figure 63: 41CU219 overview facing north.
