Coyote Fire Burned Area Rehabilitation Plan

Guadalupe Mountains National Park

Coyote Fire

BURNED AREA REHABILITATION PLAN

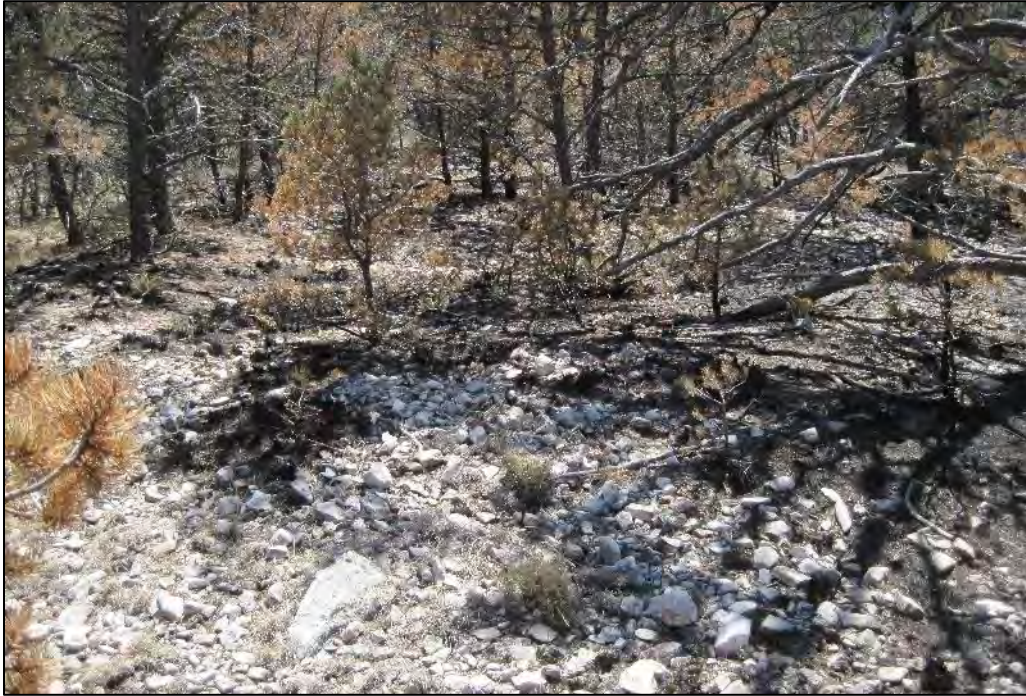
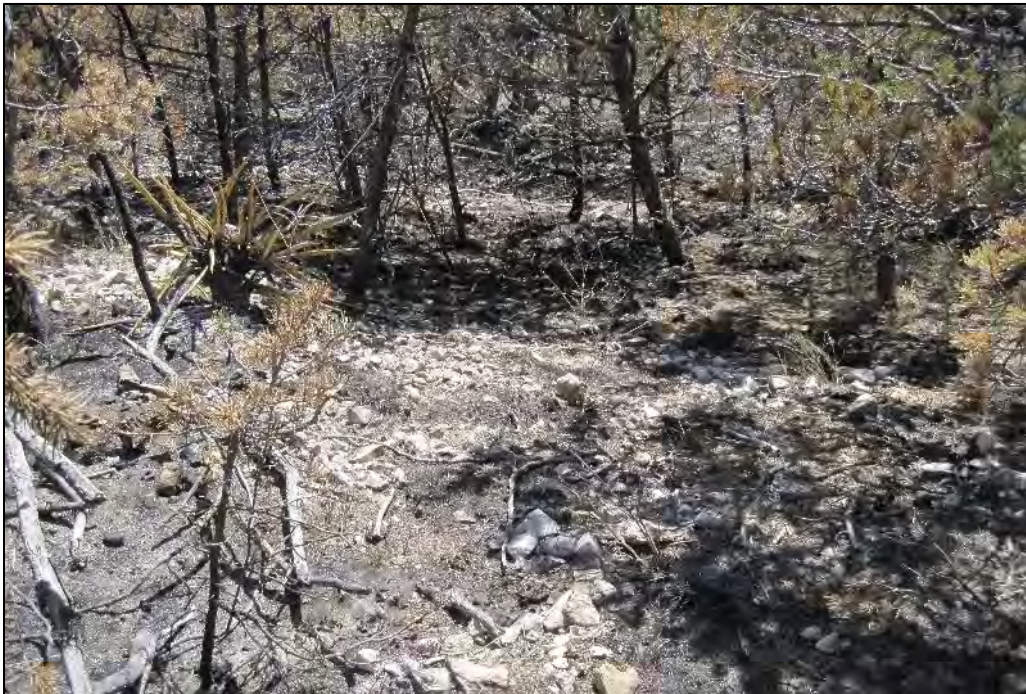
Site consists of five ring middens and an associated lithic scatter, in what used to be the Mescalero Campground. The campground has been relocated though elements, including the old trail, can still be seen. The site is in good and stable condition; no stabilization work needed.

Figure 64: 41CU218 Feature 2 facing south.

Figure 65: 41CU218 Feature 3 facing south.

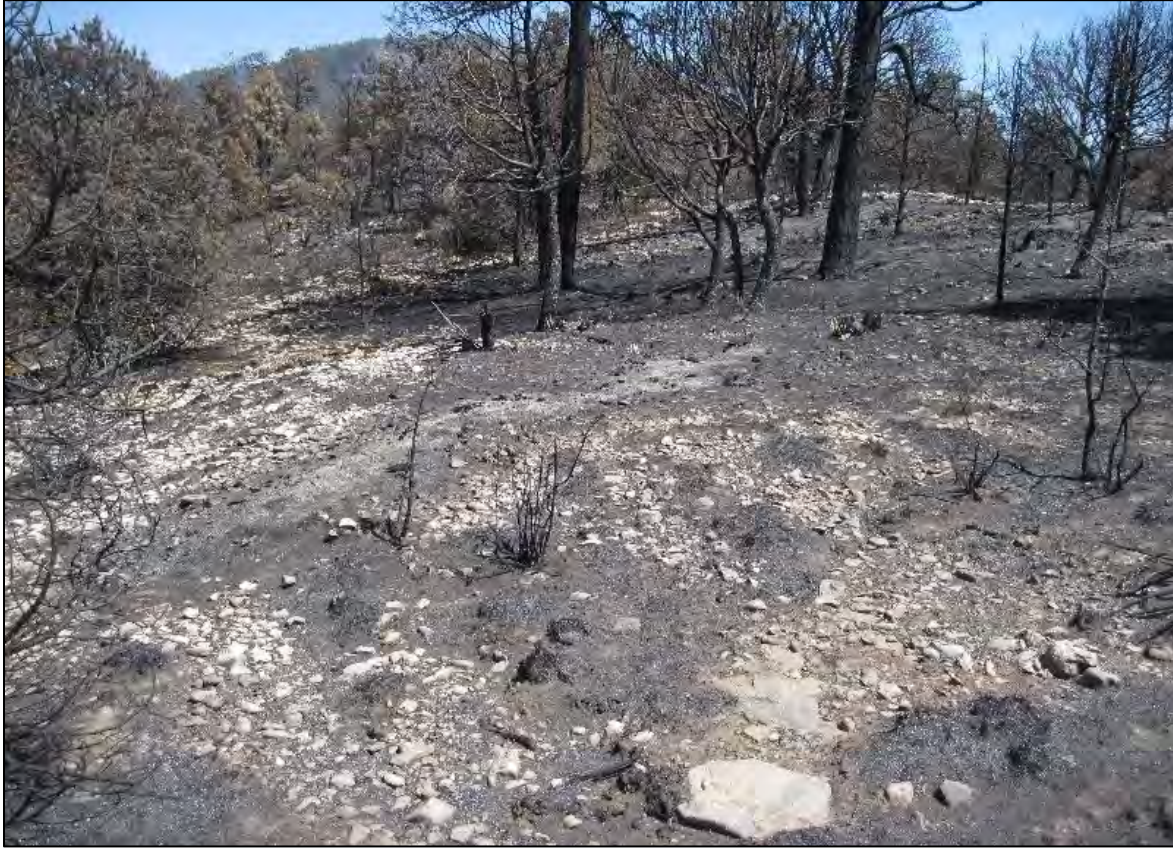
Figure 66: 41CU536 overview facing southeast.

Site is a ring midden and associated lithic scatter. The site was found to be as described. The site is in good and stable condition. No stabilization work is needed.

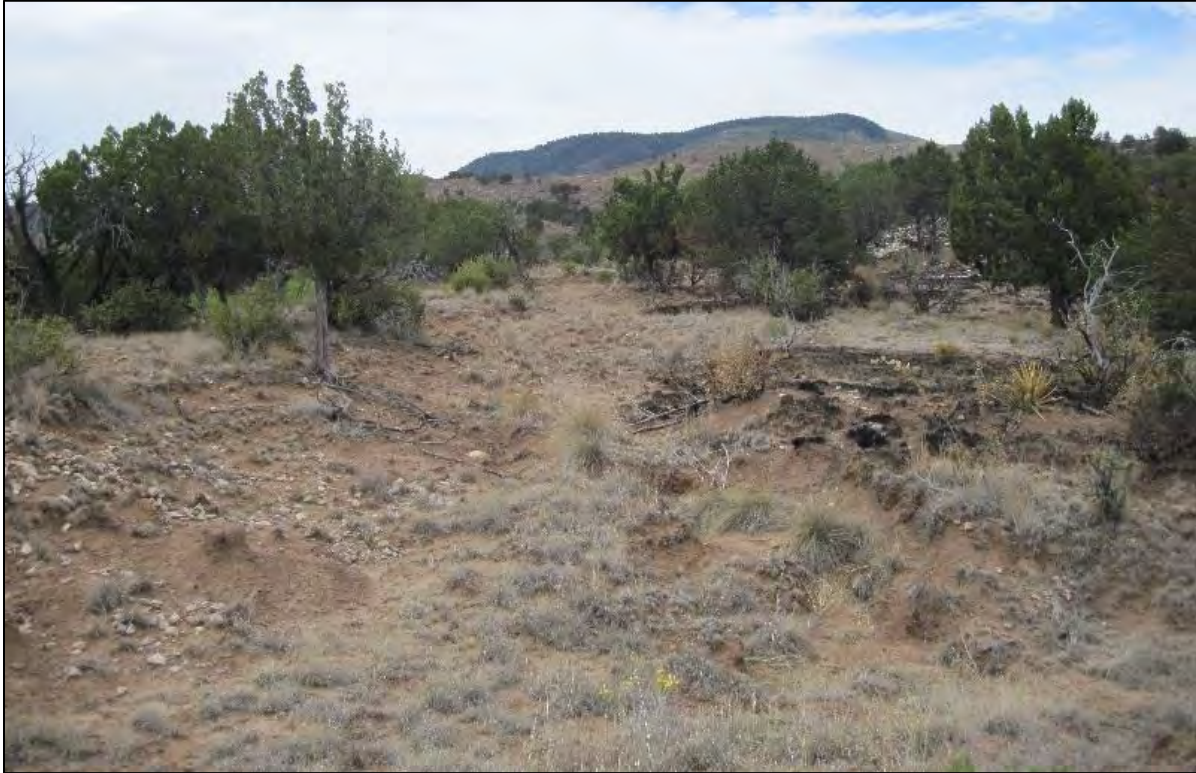
Figure 67: 41CU780 site overview facing south.

Site consists of several prehistoric ring middens and an associated artifact scatter. The site was found as described, though the GPS data do not match the site map; possibly the site has been updated since 2010. The site has experienced surface erosion; this will continue but will not be enhanced by the effects of the Coyote Fire as the immediate area is unburned. No stabilization work needed.

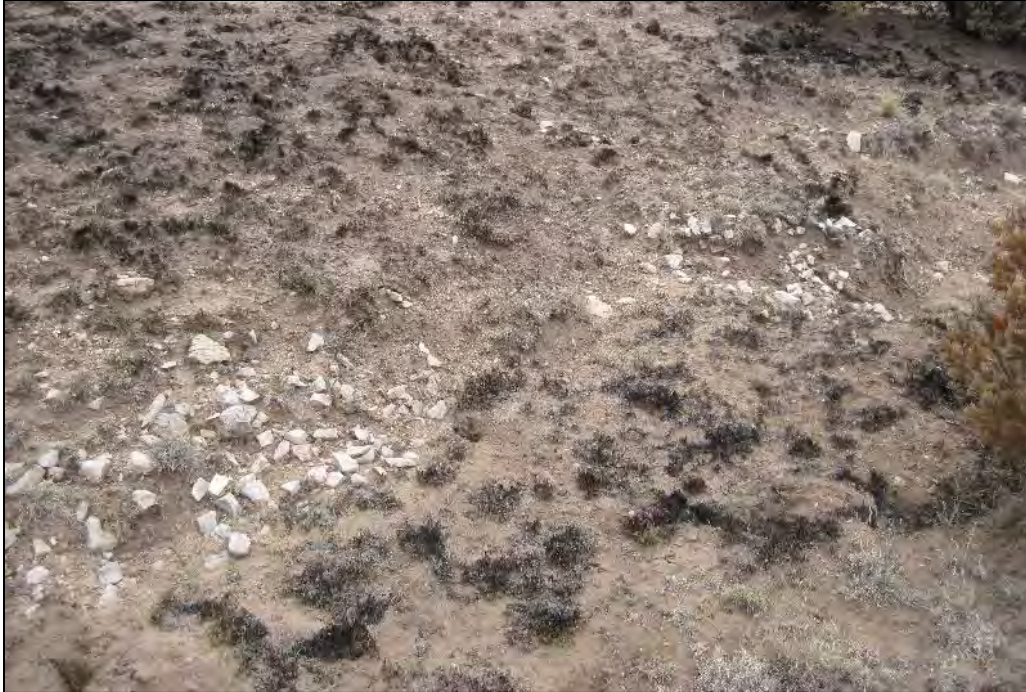
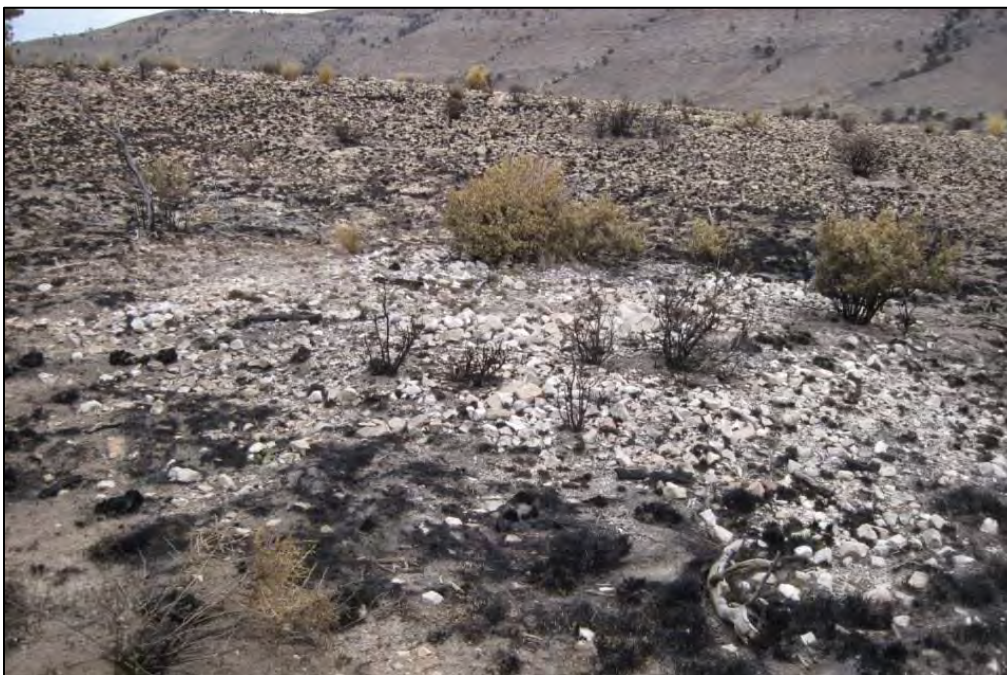
Site consists of three ring middens and an associate artifact scatter. The site is as described after the Cutoff Fire. BAER suggestions after the Cutoff Fire included stabilizing a gully through the site; however, it does not appear this was done. As such, it appears that the site self-stabilized after the Cutoff Fire, and will self-stabilize after the Coyote Fire; no further work needed.

Figure 68: 41CU787 Features 2 and 3 facing southeast.

Figure 69: 41CU787 Feature 1 facing southeast.

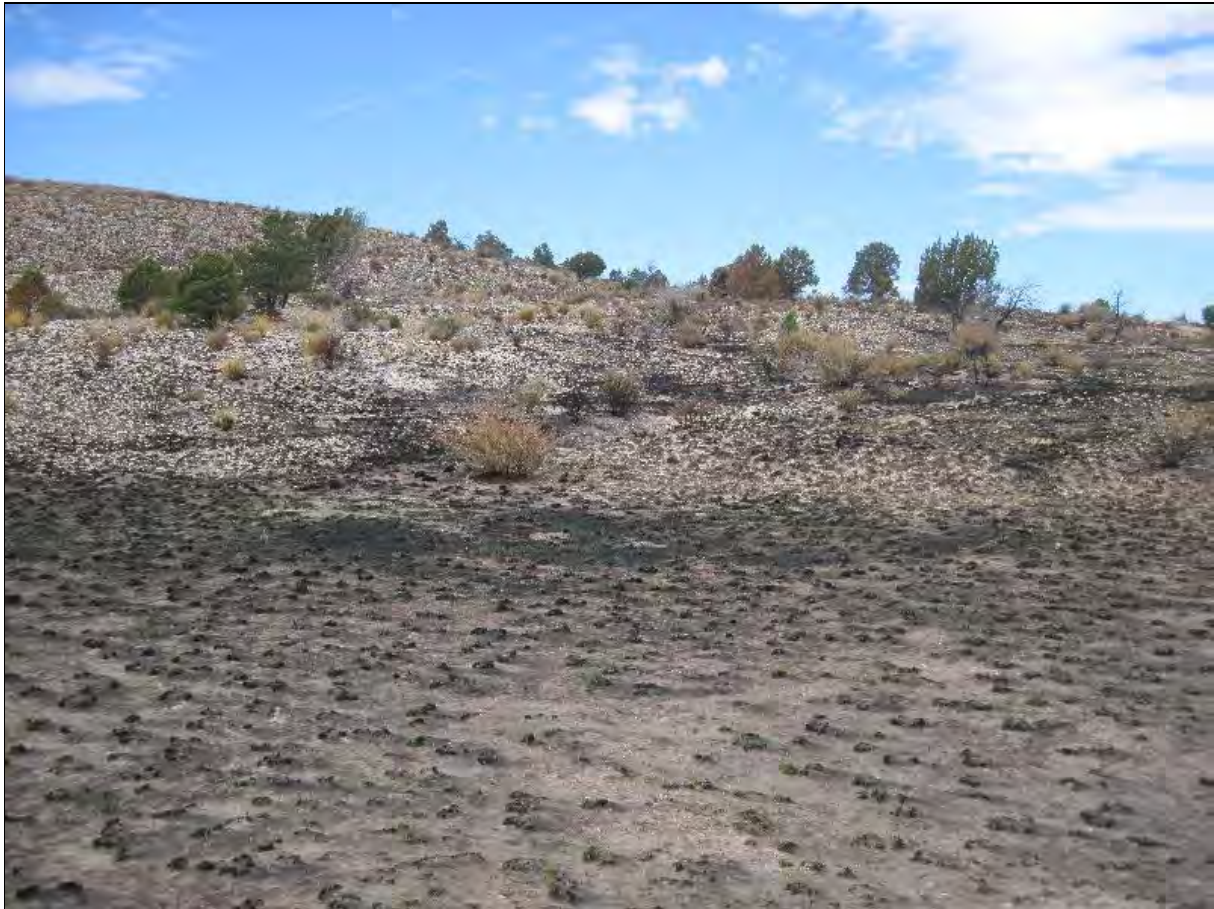
Figure 701: 41CU788 facing north.

Site is a prehistoric lithic scatter. The site is good and stable as described. The site is primarily on private land in New Mexico. Because permission was not granted to cross fence the north end of site was not inspected. No stabilization work needed.

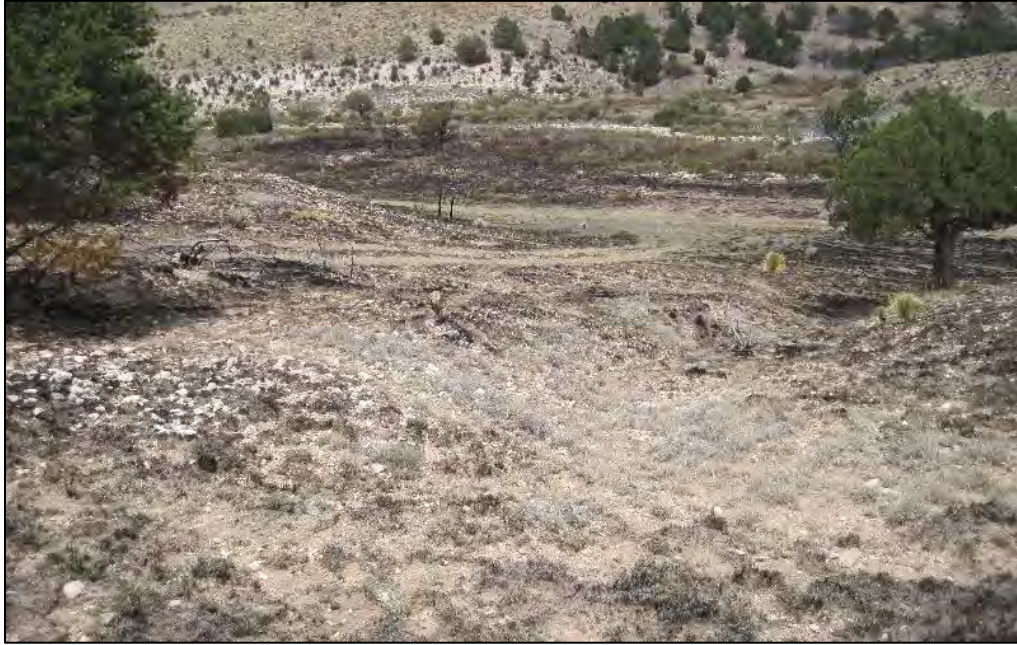
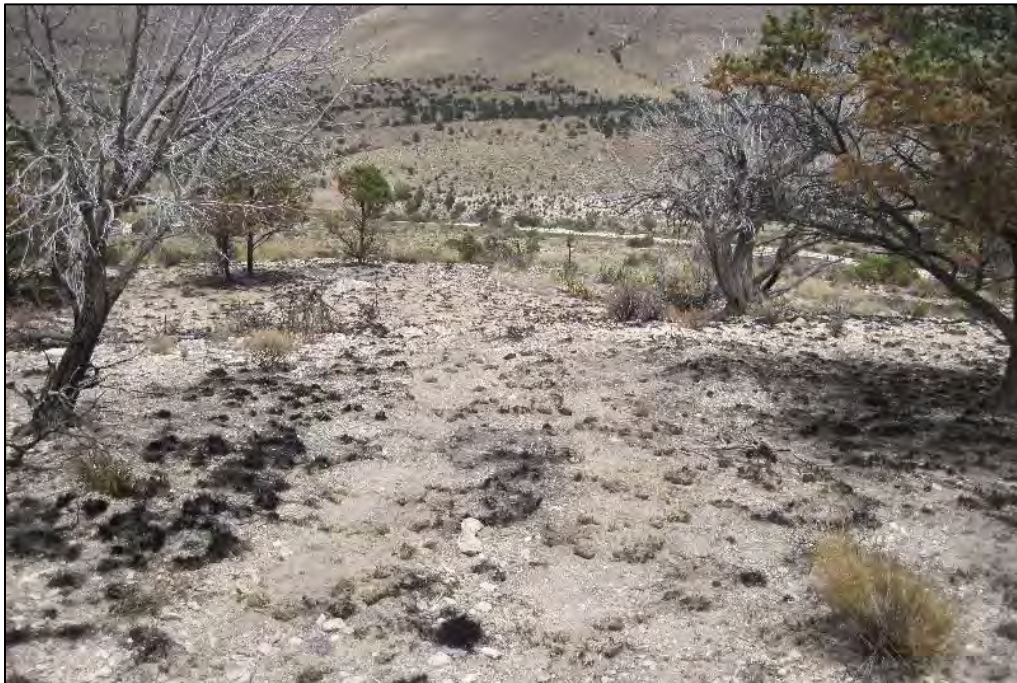
Site consists of several ring middens, thermal features, and associated artifact scatters. UTV tracks cross the site; this is likely a onetime event during efforts to suppress the fire, and is not an impact to the site. Features F4 and F2 have small erosional features that could be stabilized with slash and brush; however the site will likely self-stabilize with grasses regrowth. Monitor for 1 year, if erosion takes place, stabilize with slash and brush.

Figure 723: 41CU790 Feature 2 facing east.

Figure 734: 41CU790 Feature 4 facing east.

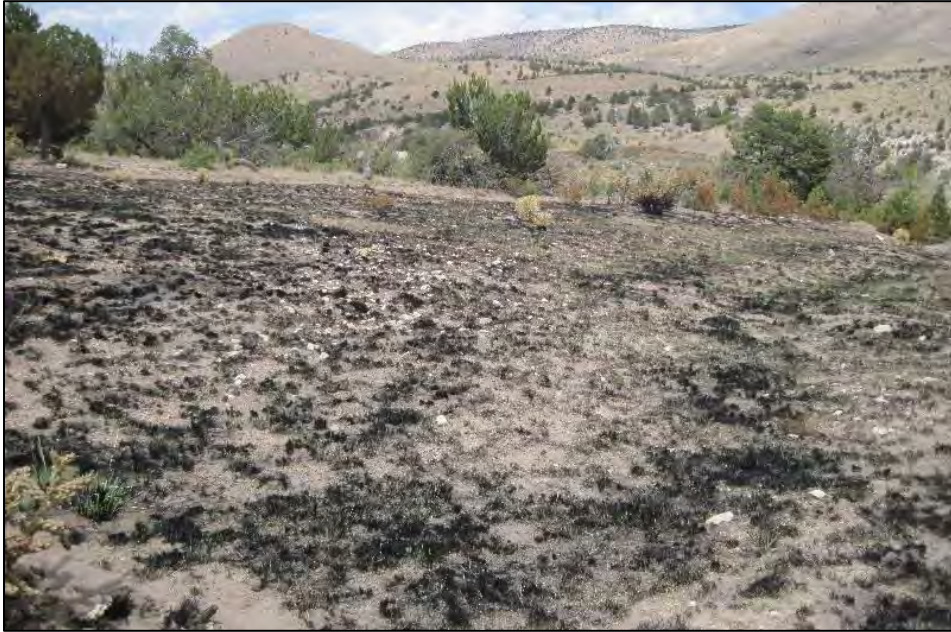
Figure 745: 41CU786 overview facing south.

Site is primarily subsurface; three features are eroding; however, the site slopes in the opposite direction and the site will likely self-stabilize with grass regrowth. Site is in good and stable condition; no stabilization work needed.

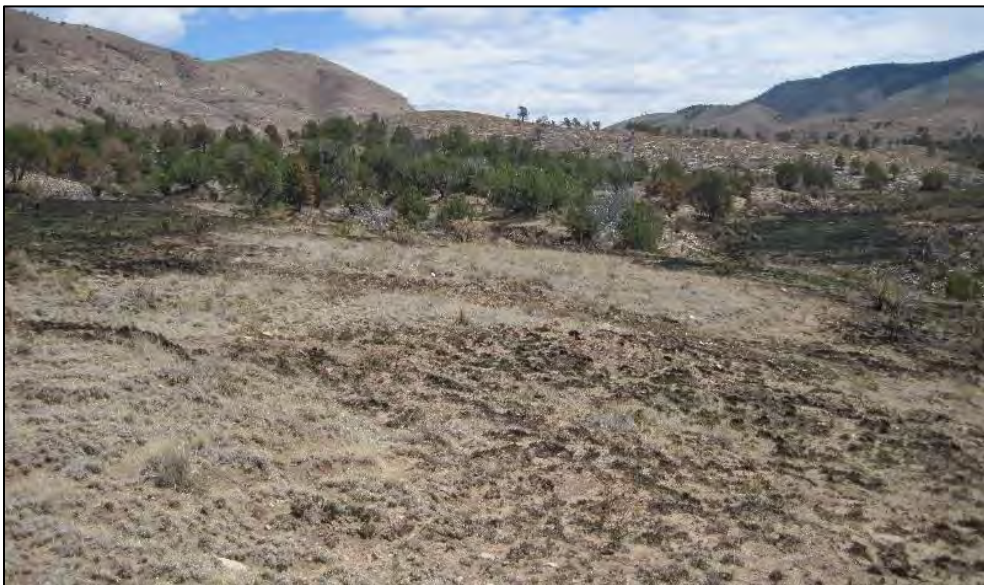
Figure 756: 41CU785 overview facing east.

Site consists of a prehistoric lithic scatter and thermal features. Site was found as described, and in good and stable condition. The area was very lightly burned; grasses and short slope protect the site stable. No stabilization work needed.

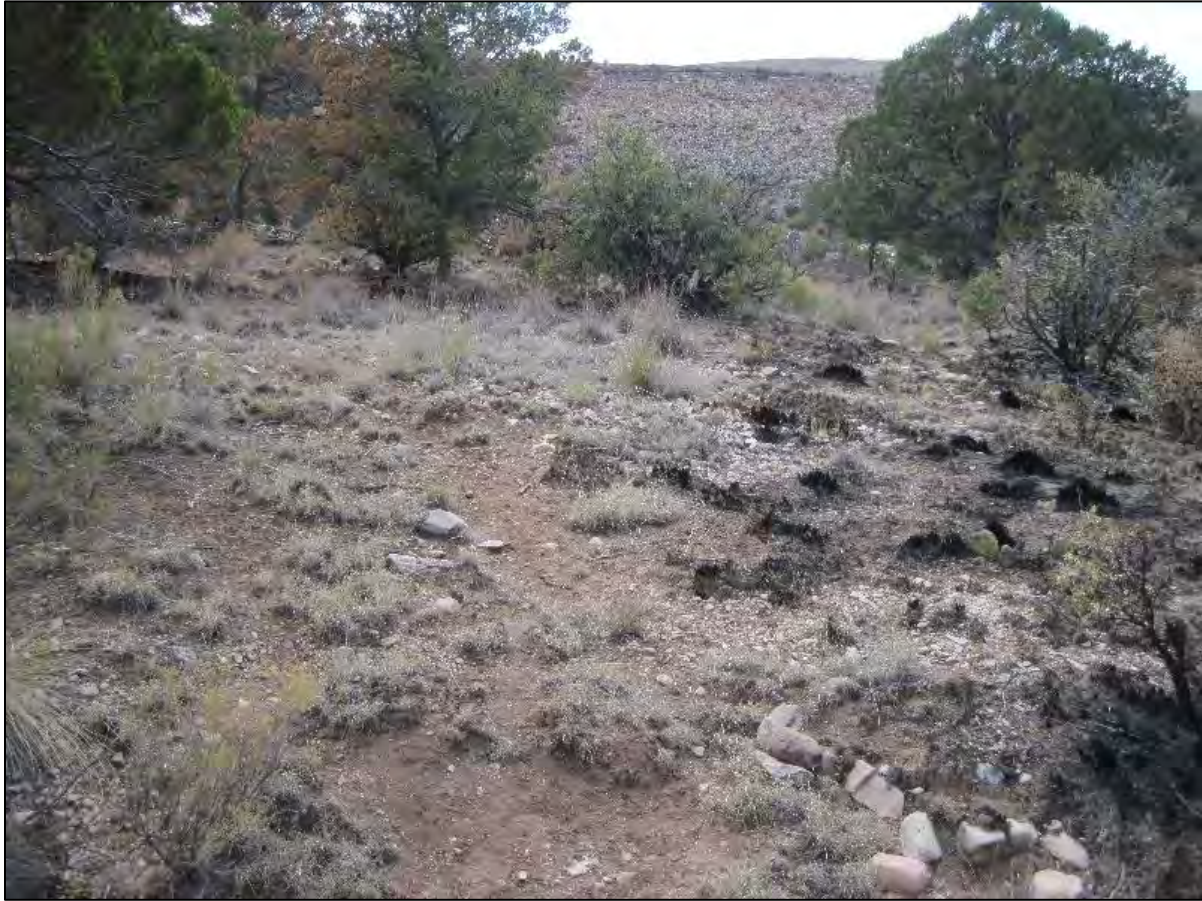
Figure 767: 41CU143 overview facing southeast.

Site is a prehistoric lithic scatter with several ring middens and thermal features. 2011 visit found that sites 41CU143-146 are one continuous site. Per TARL policy, the sites were combined into site 41CU143 and the remaining site numbers were nullified. This should be reflected in the site files and GIS data so future archeologists are not confused. Otherwise, the site is in good and stable condition. The site only experienced spot fires, and will not likely suffer from erosion.

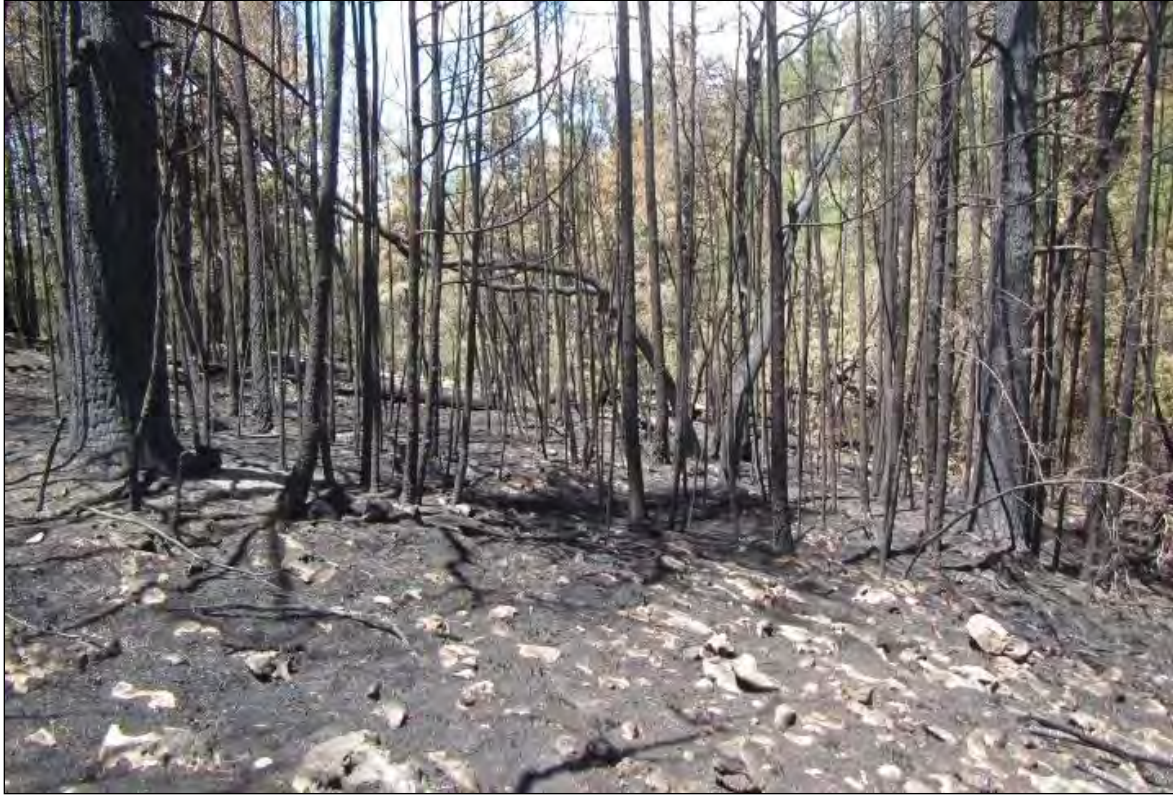
Figure 78: 41CU80 overview facing east.

Site consists of a prehistoric lithic scatter and with several associated ring middens and thermal features. The site was originally recorded in 1970. The site was observed to be stable and in good condition. Fire burned with overall low intensity across the site and will likely not cause erosion. No stabilization work suggested.

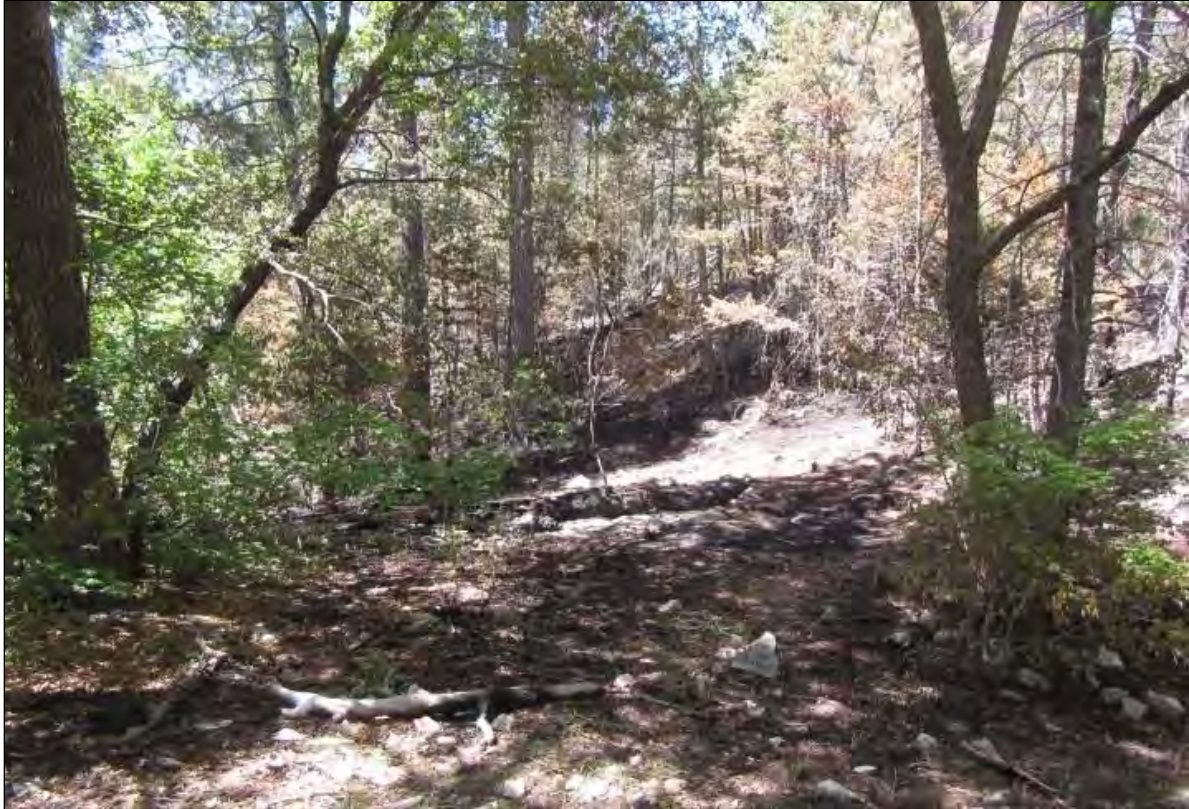
Figure 79: 41CU233 overview facing northeast.

Site is a multicomponent prehistoric feature with associated artifact scatter. Also on site are historic features with associated artifact scatter. The site was originally recorded in 1976. The site was observed to be stable and in good condition. Fire burned with low intensity across the site and will likely not cause erosion. No stabilization work suggested.

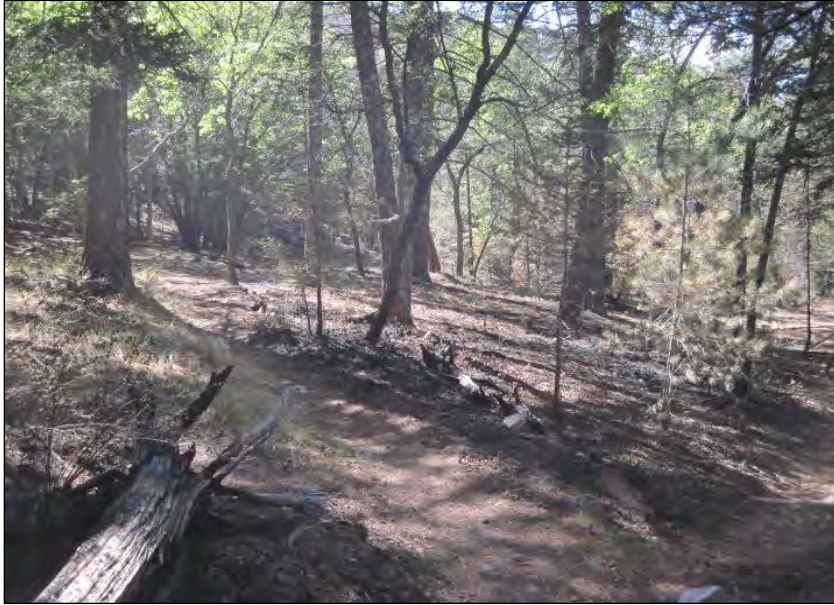
Figure 80: 41CU232 overview facing west.

Site consists of a prehistoric lithic scatter, a historic feature, and historic artifact scatter located within Tejas campground. The site was originally recorded in 1976. The site was observed to be stable and in good condition. Fire burned with low intensity across the site and will likely not cause erosion. No stabilization work suggested.

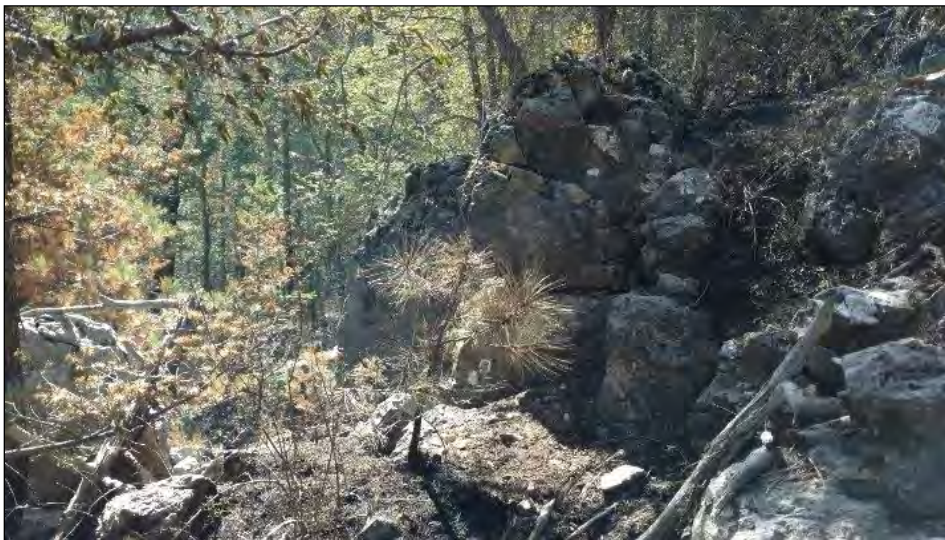
Figure 81: 41CU255 overview facing northwest.

Site consists of a prehistoric lithic scatter, originally recorded in 1976. The area was relocated with GIS but may be mis-plotted. The area indicated by GIS was stable and in good condition. Fire burned with low intensity across the site and will likely not cause erosion. No stabilization work suggested.

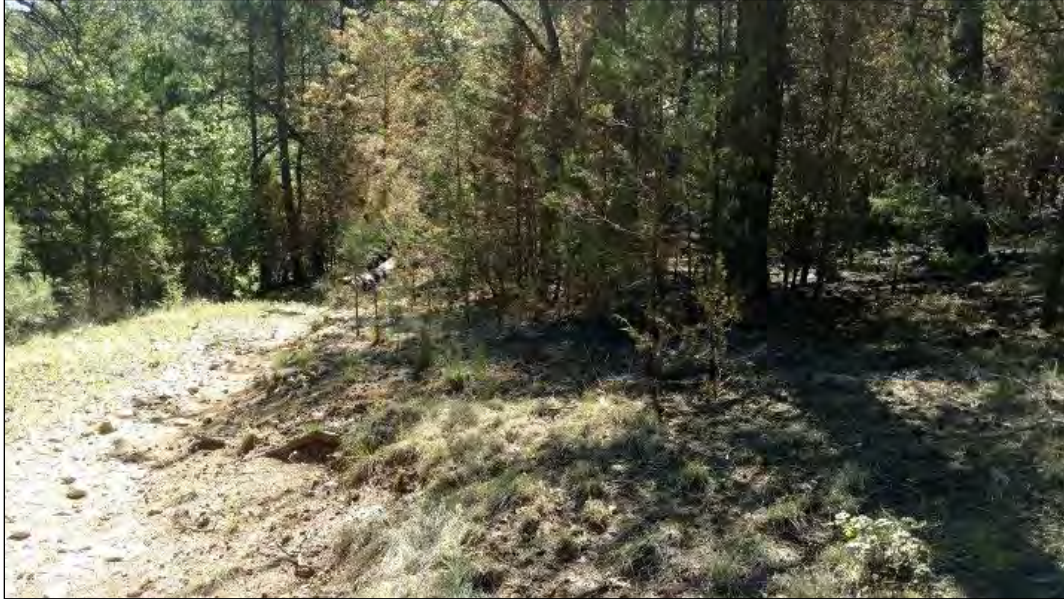
Figure 82: 41CU254 overview facing northwest.

Site consists of a prehistoric lithic scatter and associated features, originally recorded in 1976. The site was stable and in good condition. Fire burned with low intensity across the site and will likely not cause erosion. No stabilization work suggested.

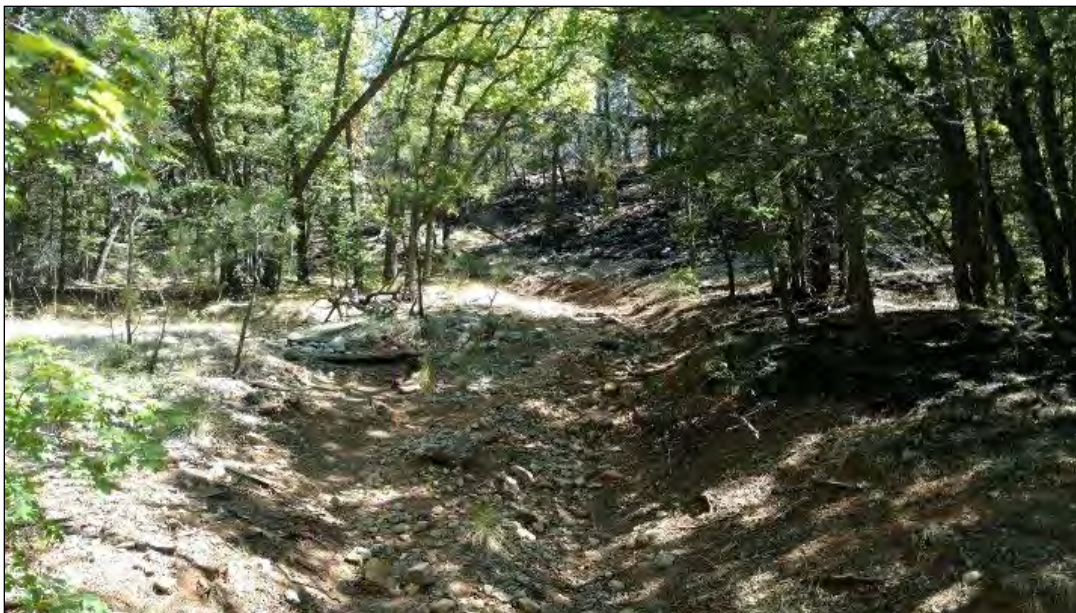
Figure 83: 41CU231 overview facing northwest.

Site consists of a prehistoric lithic scatter and with associated ring middens and thermal features, originally recorded in 1976. The site was stable and in good condition. Fire burned with low intensity across the site and will likely not cause erosion. No stabilization work suggested.

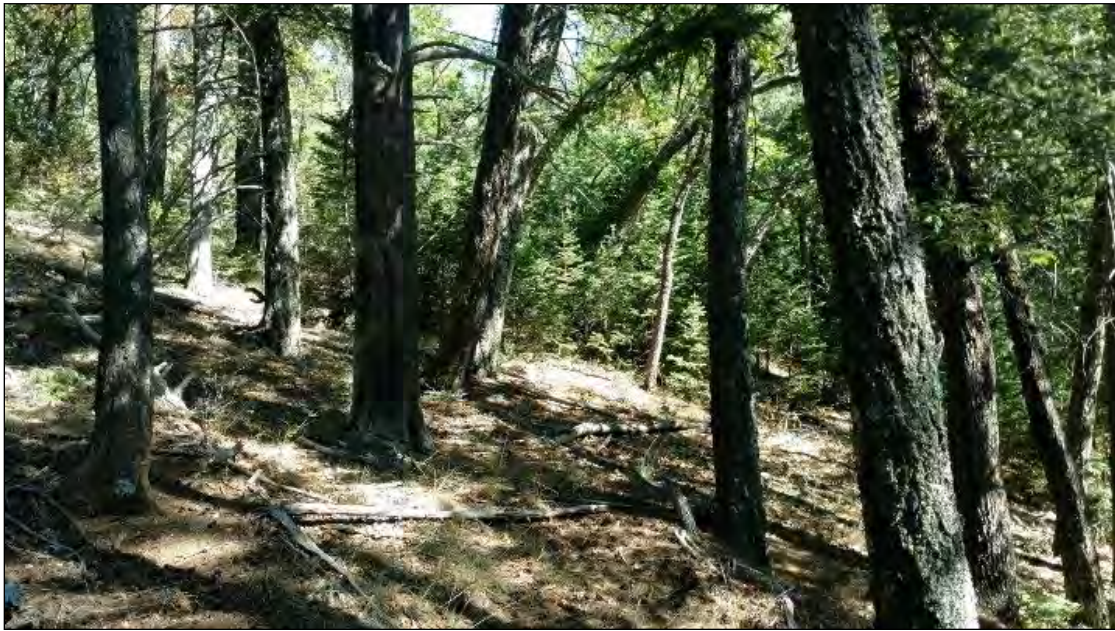
Figure 84: 41CU230 overview facing north.

Site consists of a prehistoric lithic scatter, originally recorded in 1976. The site was stable and in good condition. Fire did not burn across the site. No stabilization work suggested.

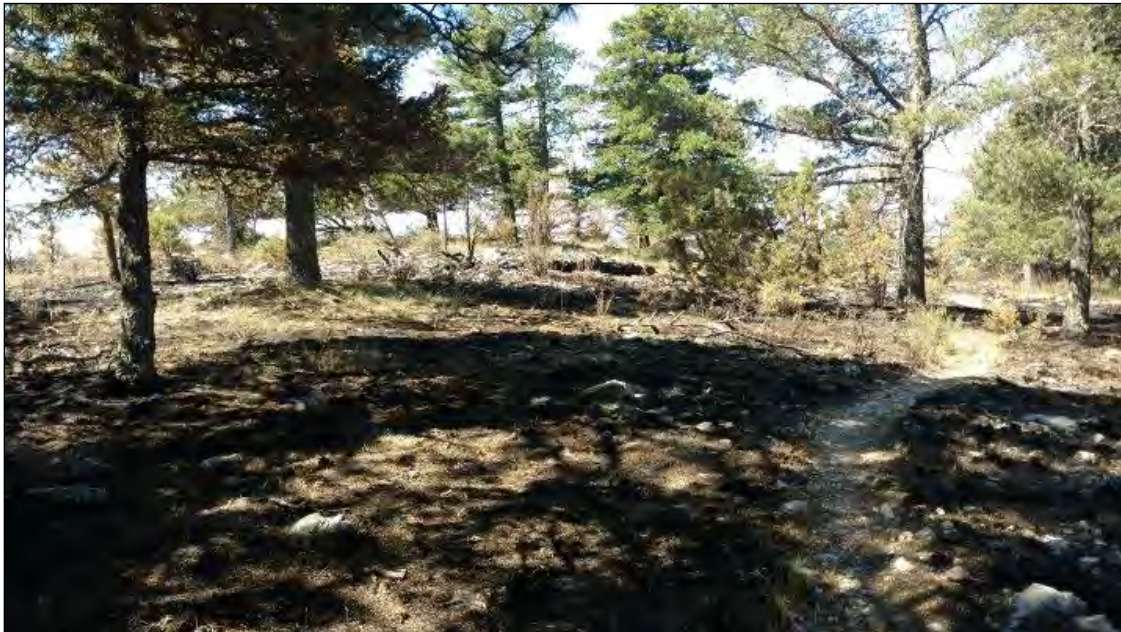
Figure 85: GUMO-2009-47 overview facing south.

Site consists of a prehistoric lithic scatter, originally recorded in 2009. The site was stable and in good condition. Fire burned with low intensity across the site and will likely not cause erosion. No stabilization work suggested.

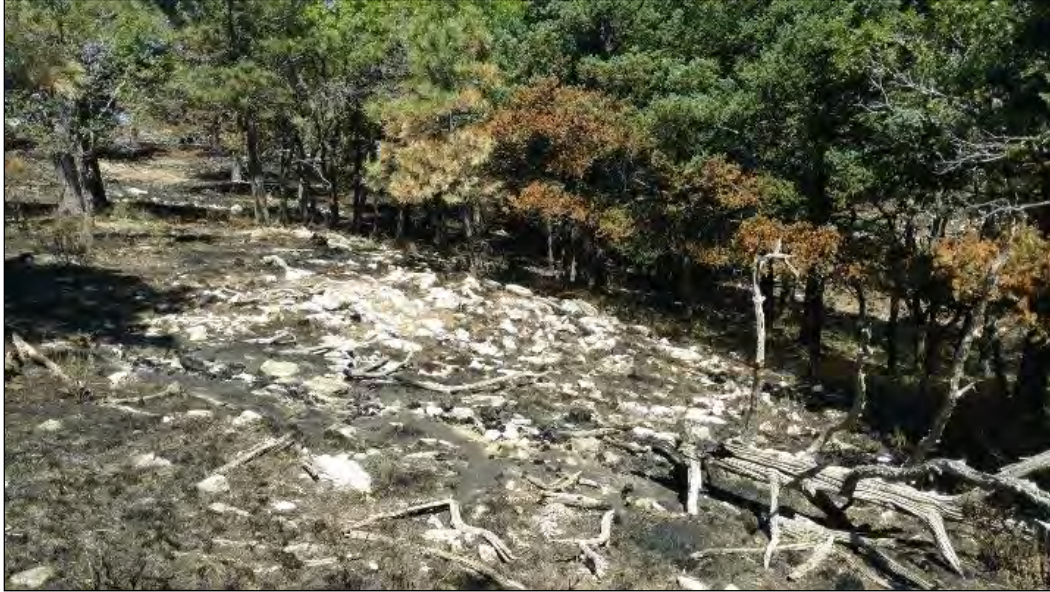
Figure 86: 41CU228 overview facing northwest.

Site consists of a prehistoric lithic scatter, originally recorded in 1976. It was stable and in good condition. Fire burned with low intensity fire across the site and will likely not cause erosion. No stabilization work suggested.

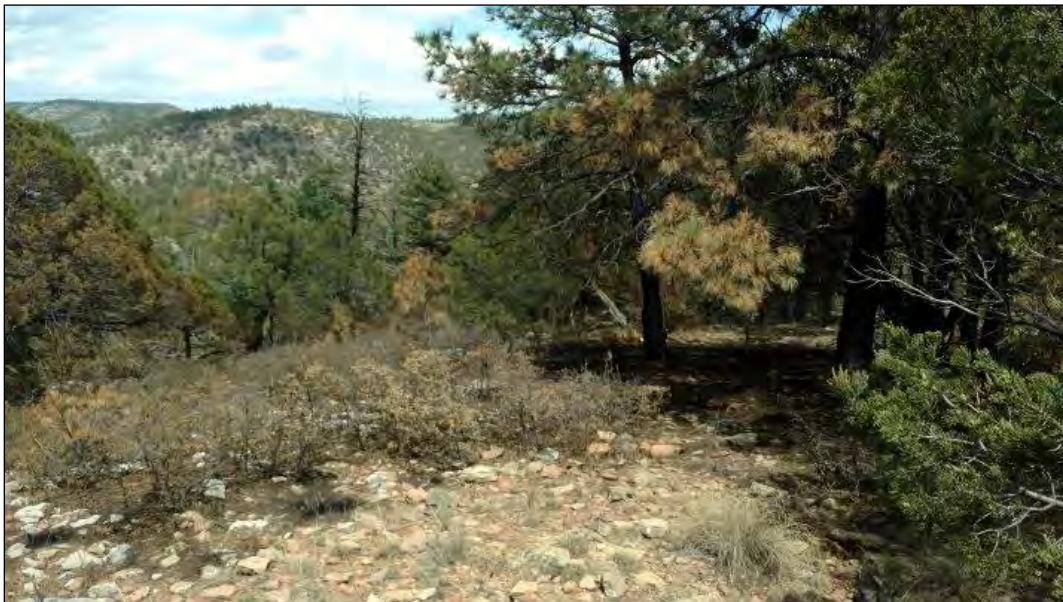
Figure 87: GUMO-2009-41 overview facing northwest.

It is unknown the type of feature occur at the site, originally recorded in 2009. We were unable to locate any information besides GIS data for this site. The area was relocated using GIS and was stable and in good condition. Fire burned with low intensity across the site area and will likely not cause erosion. No stabilization work suggested.

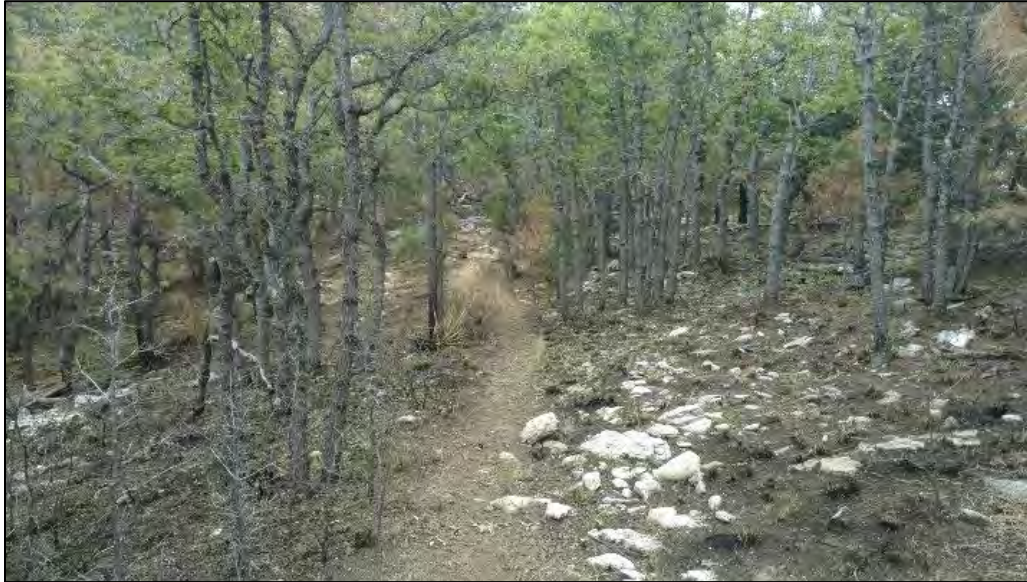
Figure 88: 41CU239 overview facing west.

Site consists consist of a prehistoric lithic scatter, originally recorded in 1976. The site was stable and in good condition. Fire burned with low intensity across the site and will likely not cause erosion. No stabilization work suggested.

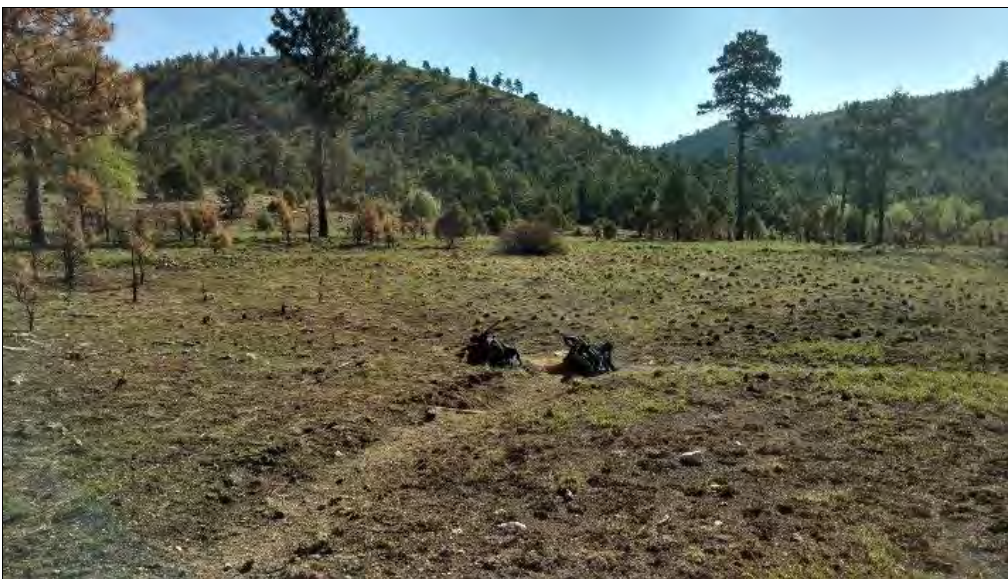
Figure 89: 41CU186 overview facing northeast.

Site consists of a prehistoric lithic scatter and with several ring middens and thermal features. The site was originally recorded in 1974. The site area was used for multiple operational tasks during fire suppression, but no lasting evidence was noted. The site was stable and in good condition. Fire burned with low intensity across the site and will likely not cause erosion. No stabilization work suggested.

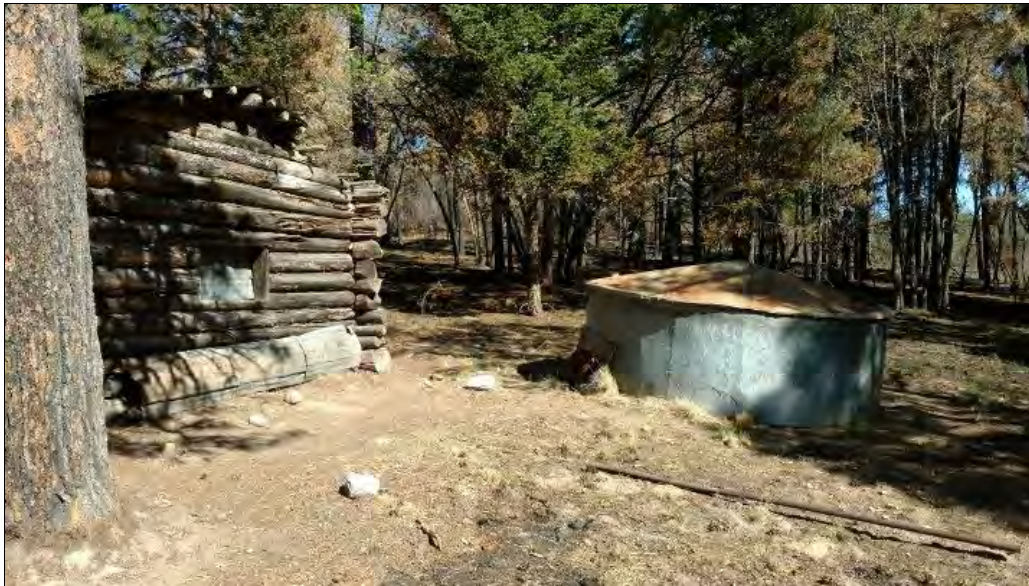
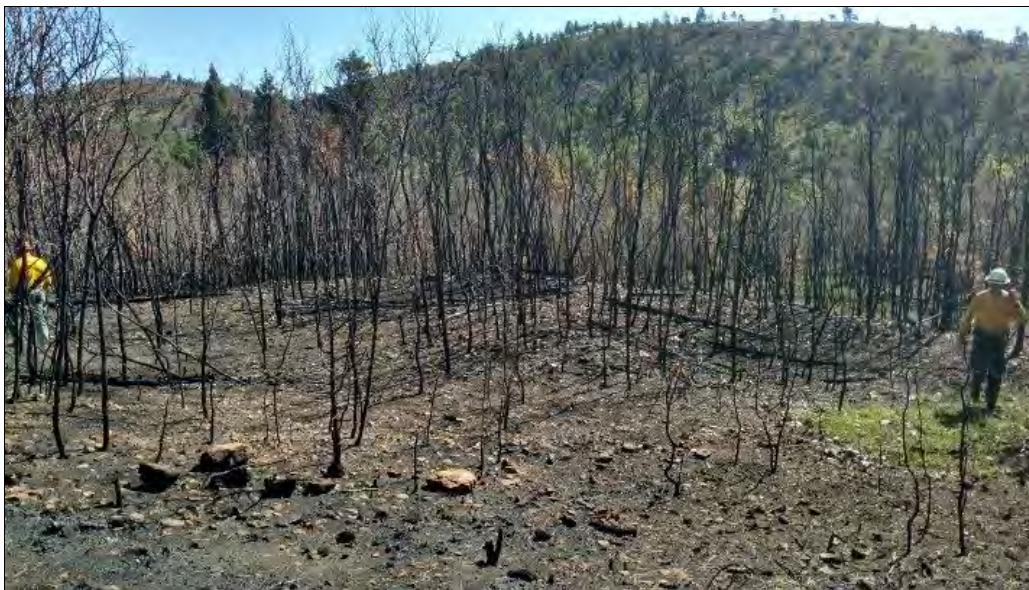
Site is a multicomponent historic cabin with associated features and artifacts. Also on site are prehistoric features with associated artifact scatter. The site is known as the Bowl Cabin, originally recorded in 1973. The cabin was prepped and wrapped with fireproof material prior to burnout. The site was stable and in good condition. Fire burned with low intensity across the site and will likely not result in erosion.

A 36"+ DBH live Douglas-fir tree took fire in a lightning scar up the entire length of the tree. The tree is alive and healthy. The tree does *not* appear to have a distinctive lean towards the cabin. The tree is 35 feet bearing 164 degrees from the front door of the cabin. During the next monitoring session the tree should be assessed for potential failure.

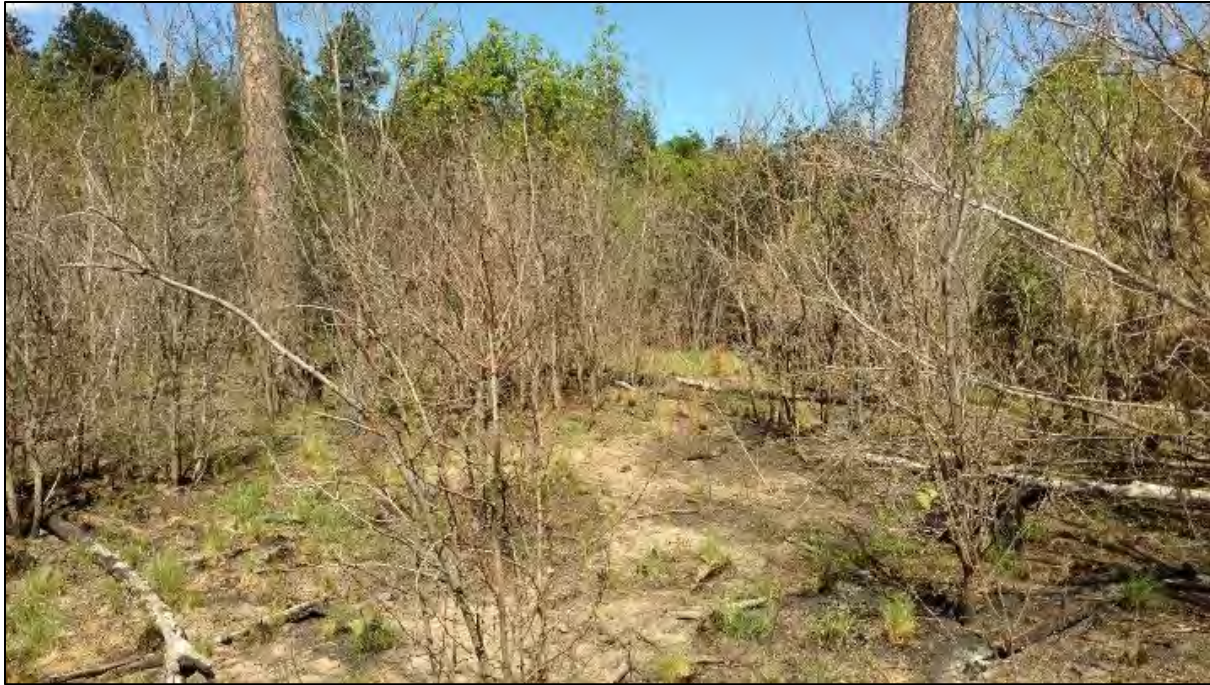
Figure 92: 41CU111 overview facing west.

Site consists of a prehistoric lithic scatter and with several associated ring middens and thermal features. The site was originally recorded in 1970. The site was observed to be stable and in good condition. Fire burned with low intensity across the site and will likely not cause erosion. No stabilization work suggested.

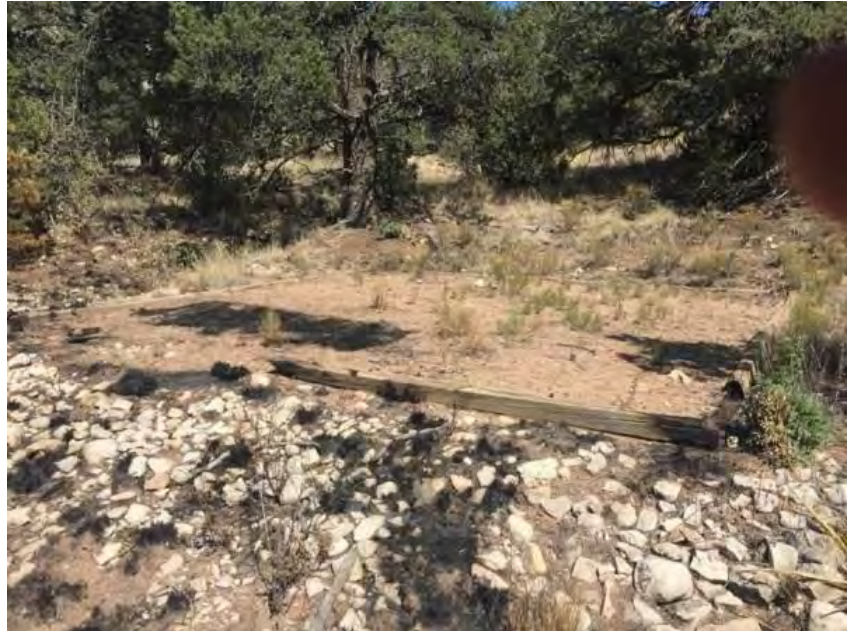
Campsite Tent Pads

Eight feet of tent pad cribbing burned. Recommend replacement with native rock.

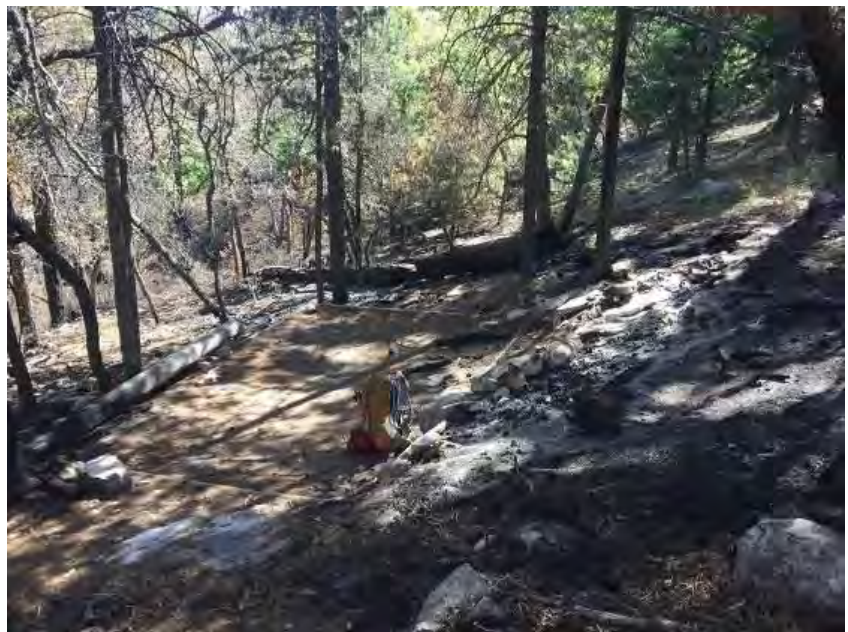
Campsite Tent Pads

Eight feet of tent pad cribbing burned. Recommend replacement with native rock.
