Coyote Fire Burned Area Rehabilitation Plan

Guadalupe Mountains National Park

Coyote Fire

BURNED AREA REHABILITATION PLAN

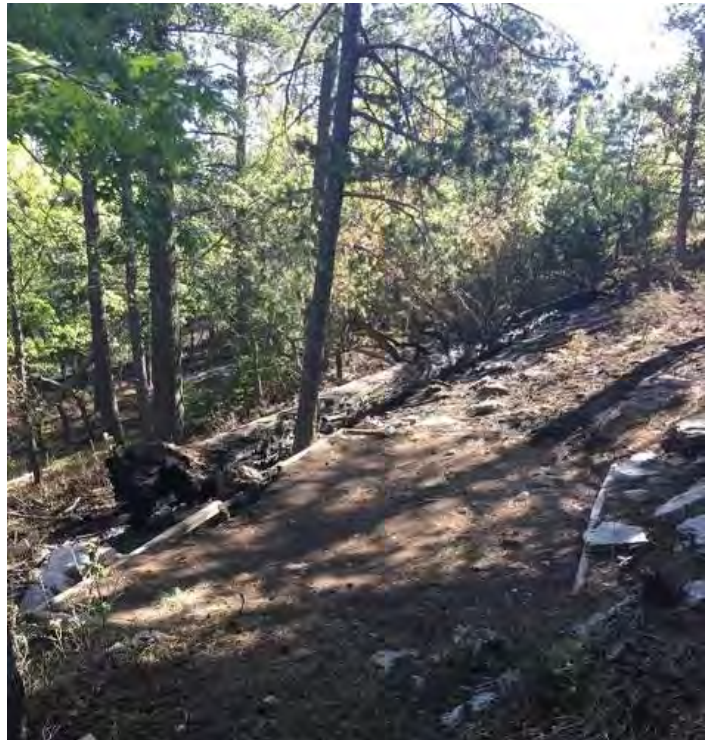
Trail Signs

Four feet of tent pad cribbing burned.
Recommend replacement with native rock.

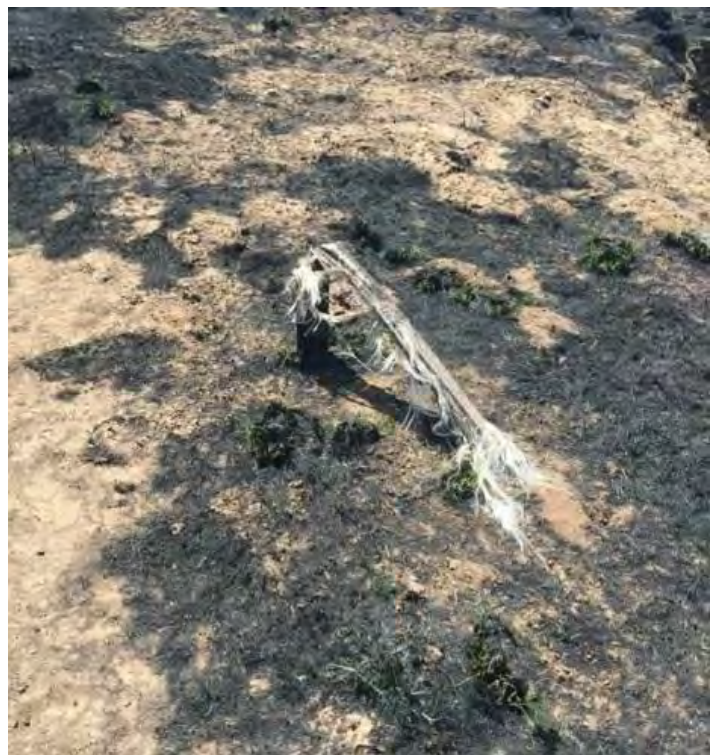
Carsonite trail arrow burned. Recommend replacement with a more fire-proof sign.

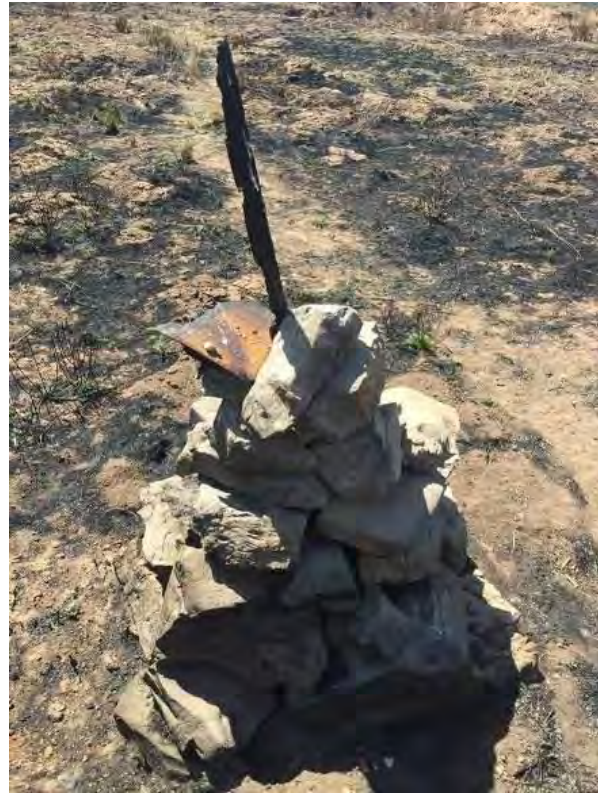
Wood trail sign “No Horses” burned.
Recommend replacement in kind.

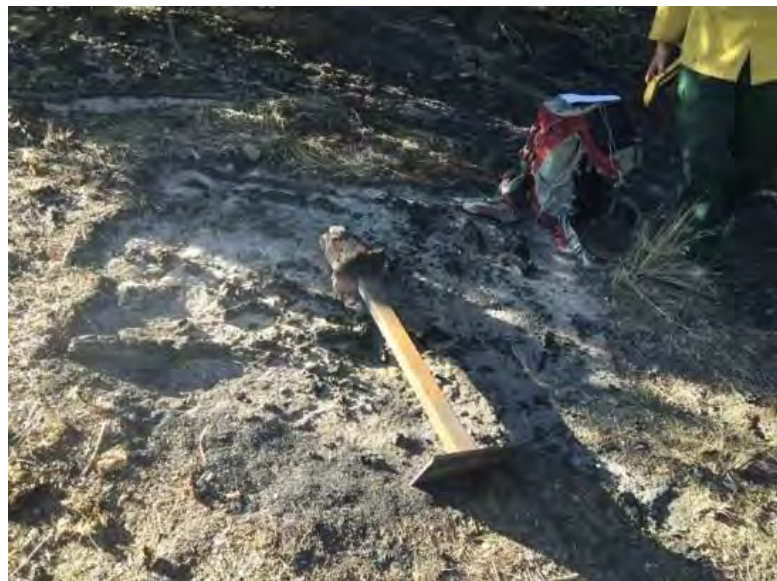
Sign has been replaced. This sign and
post was on a pile of replaced water
bars that burned. Recommend back
haul out of wilderness.

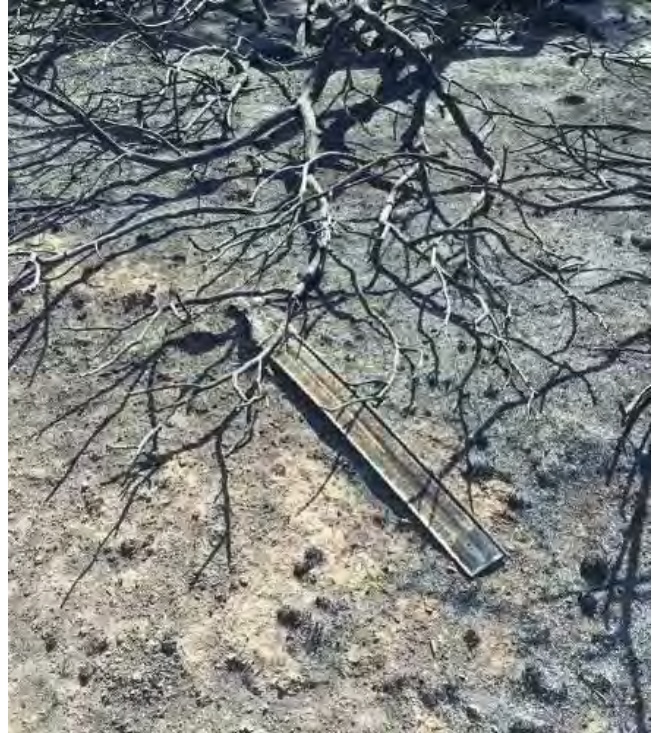
Carsonite trail arrow. Recommend replacement with a more fireproof sign.

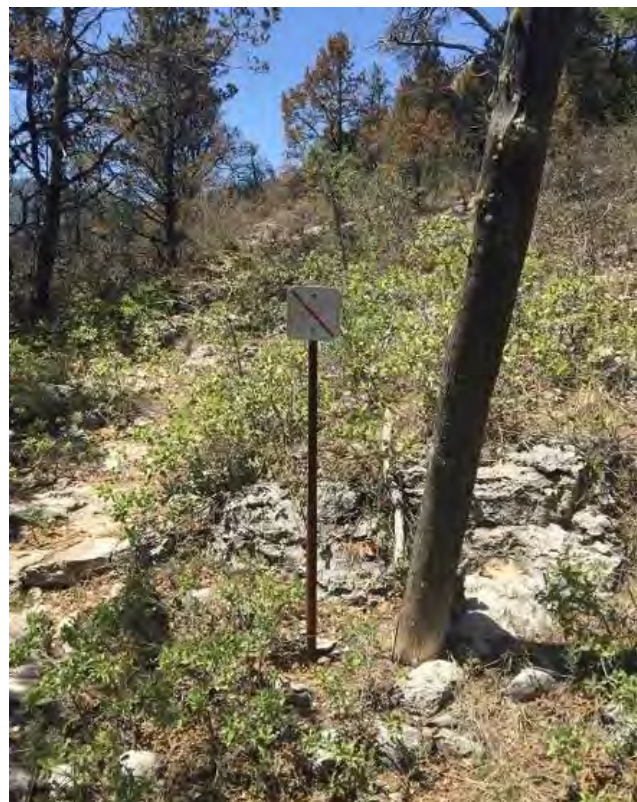
This sign was not damaged by fire but is unreadable and needs to be replaced with a fresh “No Horses” sign.

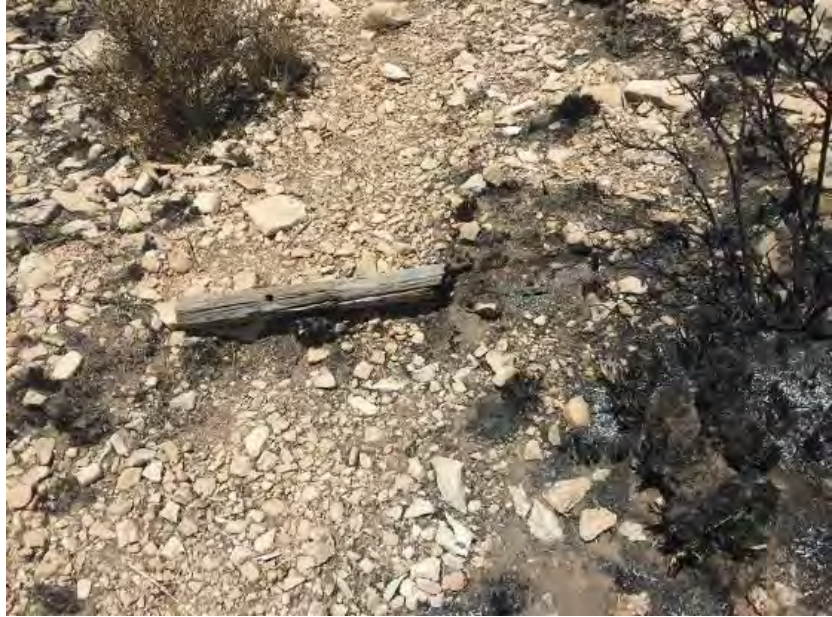
This photo represents about six water bars that burned along this reach of trail. Recommend replacement with native stone.

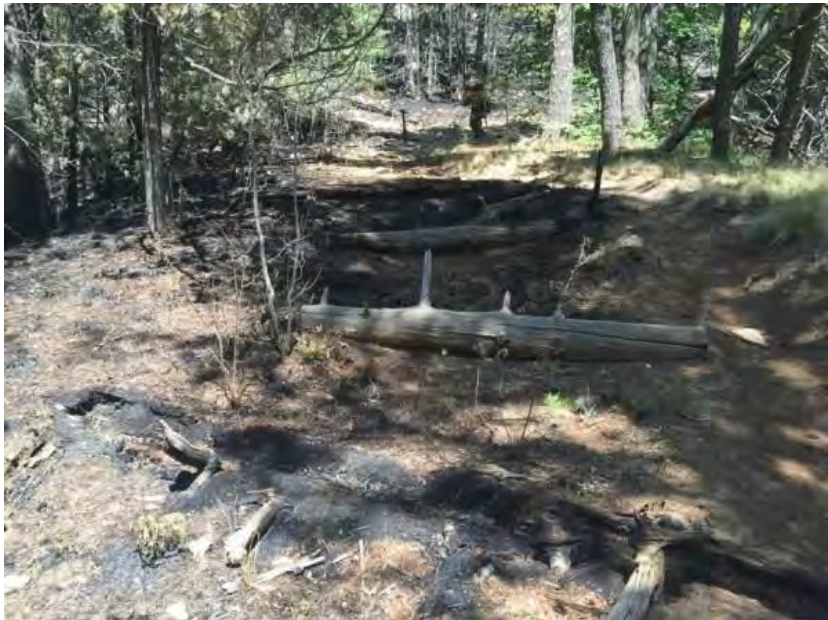
Three natural log water bars impacted by fire. Recommend replacing in kind with native logs.

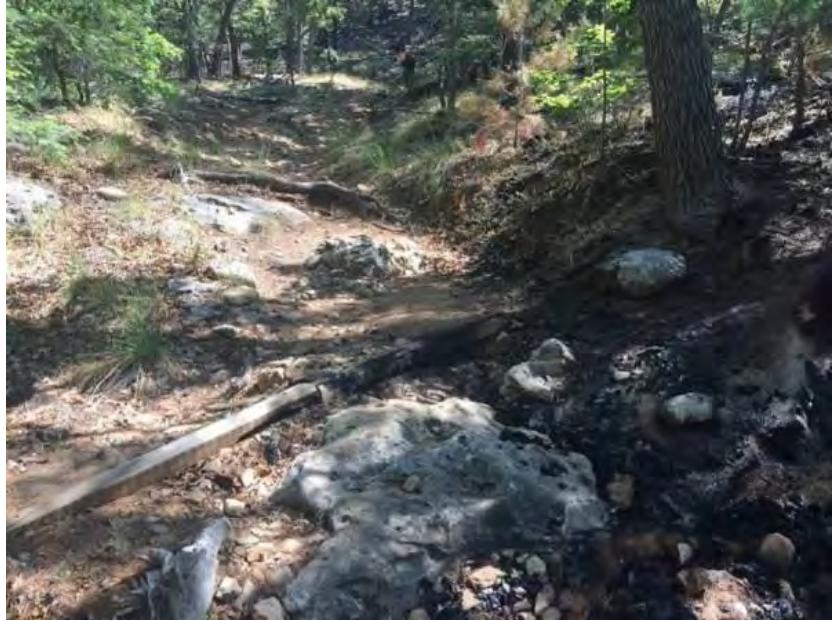
Landscape timber water bar impacted by fire. Recommend replacing with native rock.

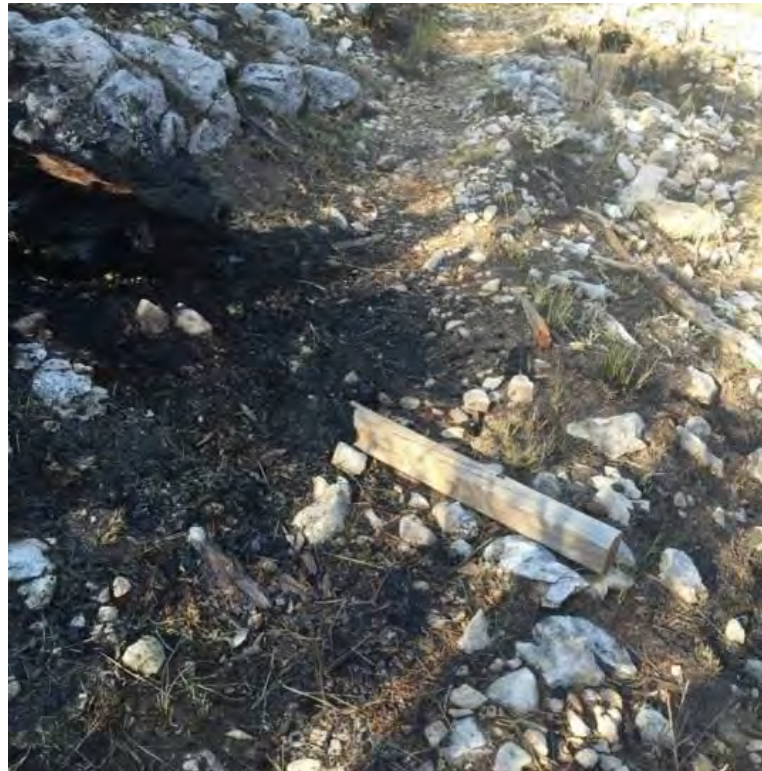
Landscape timber water bar impacted by fire. Recommend replacing with native rock.

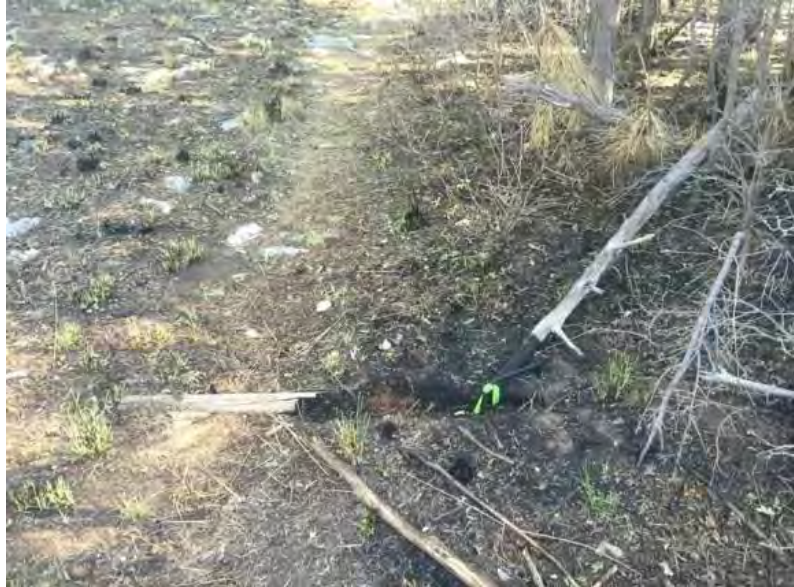
Landscape timber water bar impacted by fire. Recommend replacing with native rock.

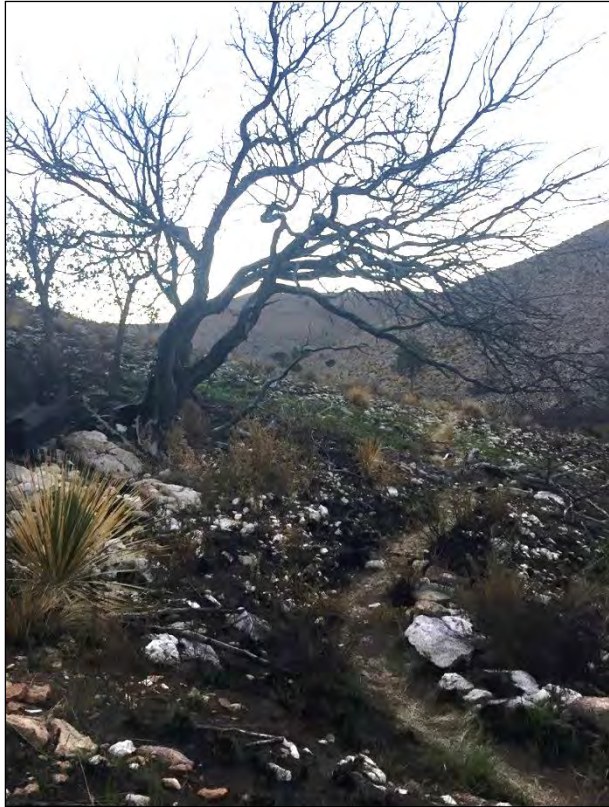
Hazard Rating: 5

Fire-impacted 26 inch dead juniper dropping limbs onto trail. Recommend felling due to the number a visitors that walk under this tree so close to Dog Canyon developed area. This is the first section where people will start uphill looking down at the trail and may not notice the hazard overhead.

*HZ1 was cut by the engine crew with a chainsaw on June 2, 2016. No hazard remains to be mitigated.

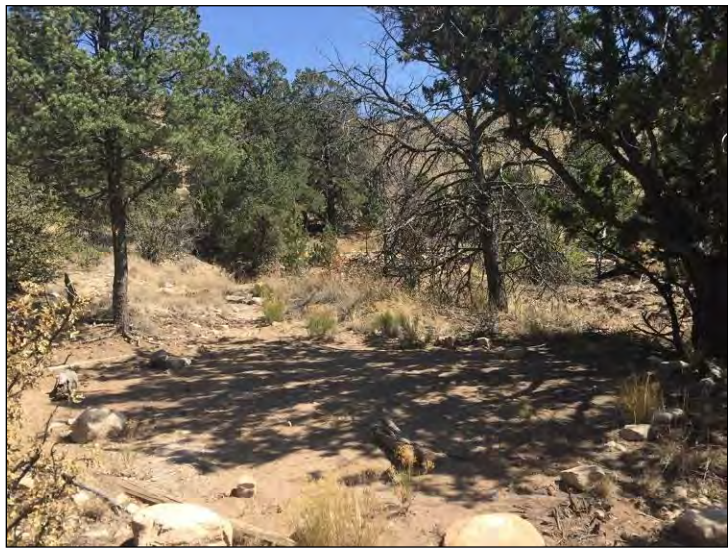
HZ2 - Marcus Campsite #5

Hazard Rating: 3

There is an 8 inch, dead pinyon near campsite #5 that could fall and block the site access trail. This tree is not recommended for treatment. The lower limbs will prevent this tree from falling, and will break down naturally with time. This tree was included to illustrate the rating system.

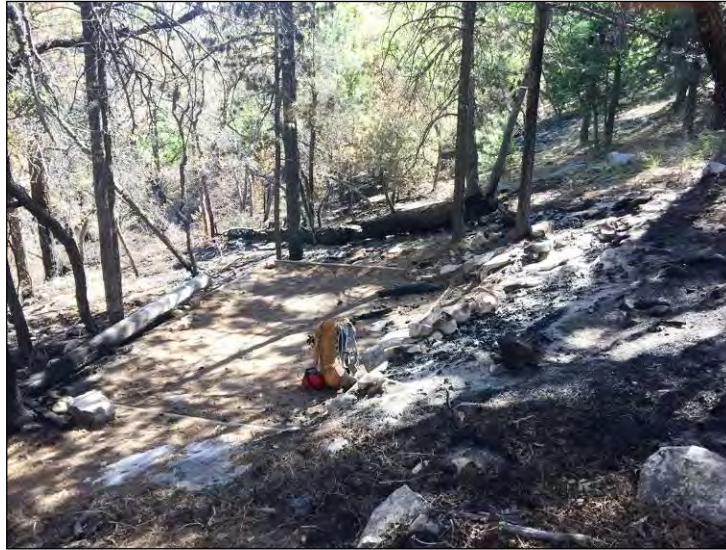
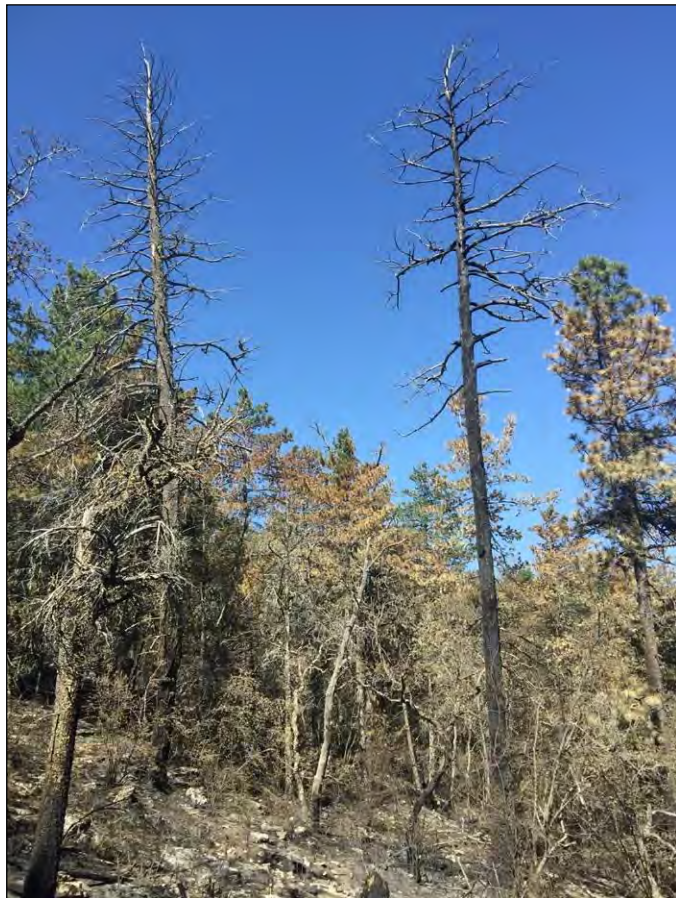
H3, H4 & H5 - Marcus Campsite #2*

Hazard Rating: 4, 12 & 12

H3 is a 15 inch dead alligator juniper that will not fall as much as roll on its lower branches. No treatment recommended.

H4 is a 24 inch dead Douglas fir reduced by fire to 15 inches at the base. It leans 10 degrees toward campsite #2. The tree is 66 feet tall and the campsite is 42 feet upslope. Recommend felling H4.

H5 is a 20 inch dead Douglas-fir 66 feet tall and 66 feet from campsite #2, with a 10-degree lean toward the campsite. Recommend felling H5.

*Both H4&H5 where cut by chainsaw on 6/3/2016

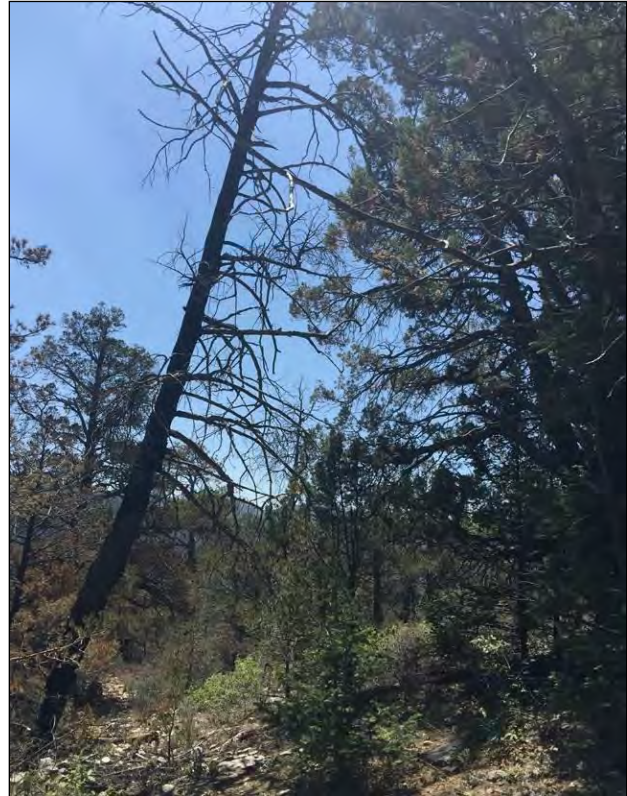
H_z6 – Marcus Trail at Blue Ridge trail junction*

Hazard Rating: 5

H_z6 is an 18 inch dead Douglas fir impacted by the fire and leaning 20 degrees over the Marcus trail. This tree will fall over the trail and block stock access. There are several more snags in the vicinity that rated lower than 5 on the hazard analysis. Recommend felling and clearing H_z6.

*H_z6 cut by chainsaw 6/3/2016.

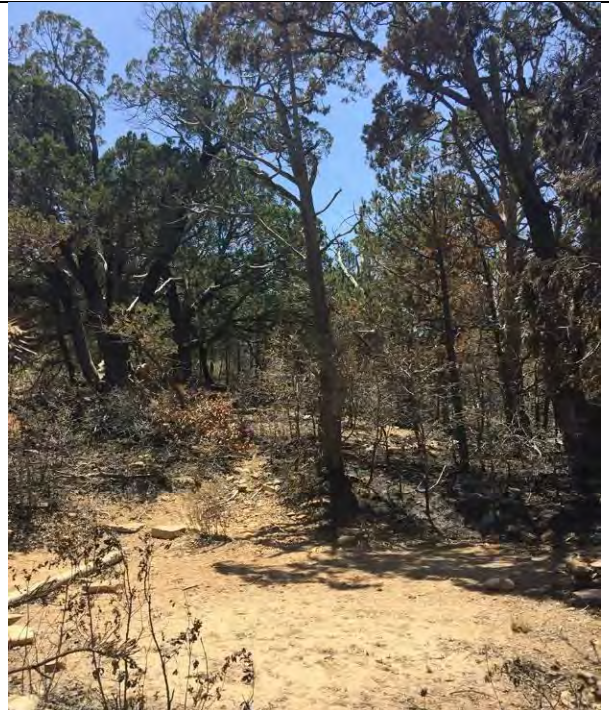
H_z7 –NW Campsite*

Hazard Rating: 12

H_z7 is an 11 inch base dead juniper that has loose roots, adjacent to, and leaning toward tent pad. Recommend pulling down H_z7.

*H_z7 mitigated 6/3/2016, pulled with rope and rigging to look like a natural blow down.

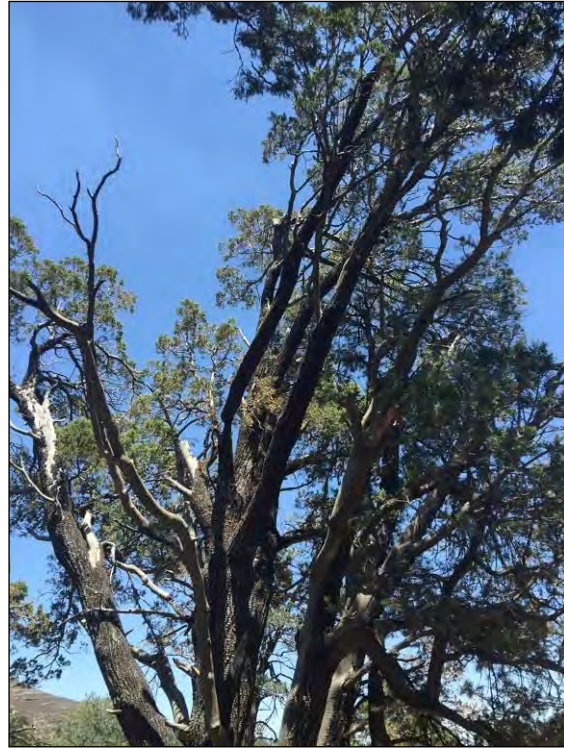
Hz8 – West Campsite*

Hazard Rating: 12

Hz8 is an 18 inch alligator juniper with a fire impacted widow maker limb and other dead branches directly over the tent pad of the westernmost campsite. Recommend trimming Hz8.

*Hz8 climbed and trimmed on 6/3/16 using rope and hand saw.

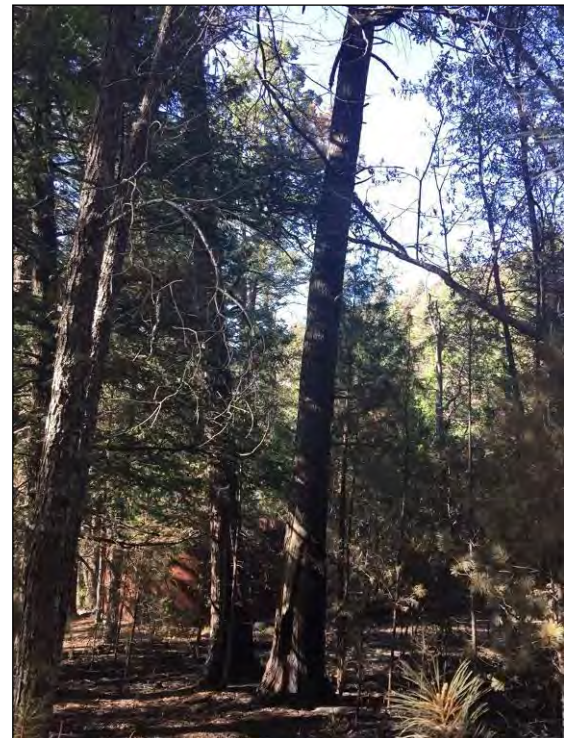
Hz14 & Hz15 – Campsite #1

Campsites 1-6 had no fire damage. Off campsite #1 east, near the metal water tank, there are two large trees with burned cat faces at their bases: Hz14 is a 26 inch southwestern white pine and Hz15 is a 28 inch southwestern white pine. These trees are alive and stable at this time. Recommend checking them annually for mortality.

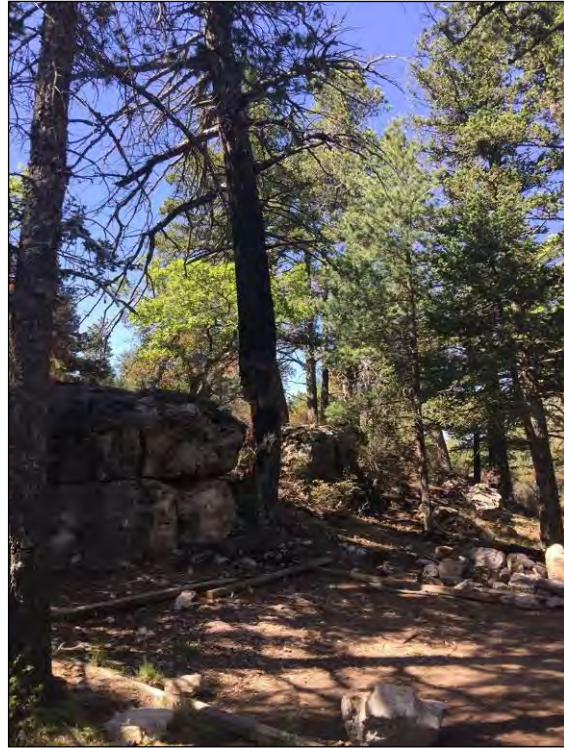
Hz17 – Campsite #4*

Hazard Rating: 12

Hz17 is a dead and burned-out 30 inch Douglas fir located adjacent to campsite #4. Recommend felling Hz17.

*Mitigated on 6/4/16 by pulling it over by means of a rope looped around the top of the tree.

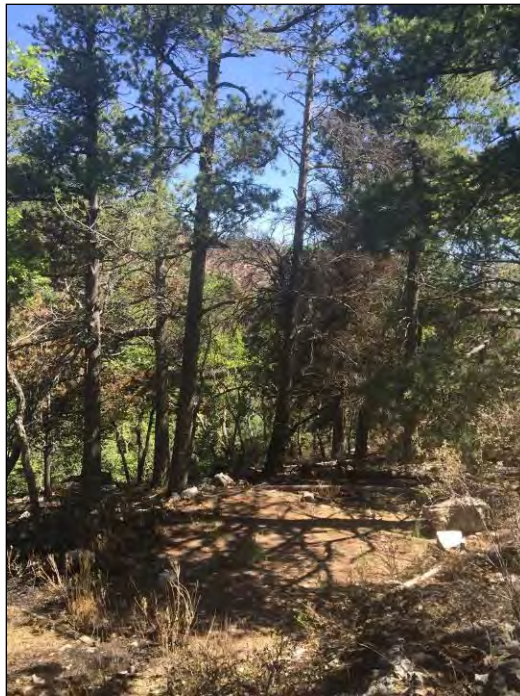
Hz18 & Hz19 – Campsite #5*

Hazard Rating: 12

Hz18 is a 14 inch dead Douglas-fir adjacent to and leaning toward the tent pads. Hz19 is a 12 inch dead Douglas-fir adjacent to and leaning toward the tent pads. Recommend felling both trees.

*Both trees felled 6/4/16 using axe and handsaw.

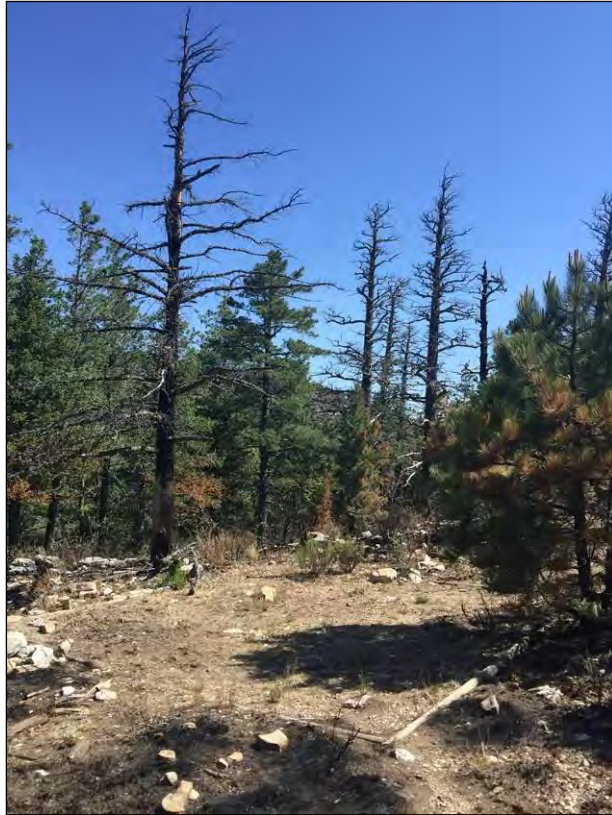
Hz 20 – Campsite #2*

Hazard Rating: 12

Hz20 is a 14 inch dead Douglas fir adjacent to and leaning toward tent pad. Recommend felling this tree.

*Felled 6/4/16 with axe and hand saw.

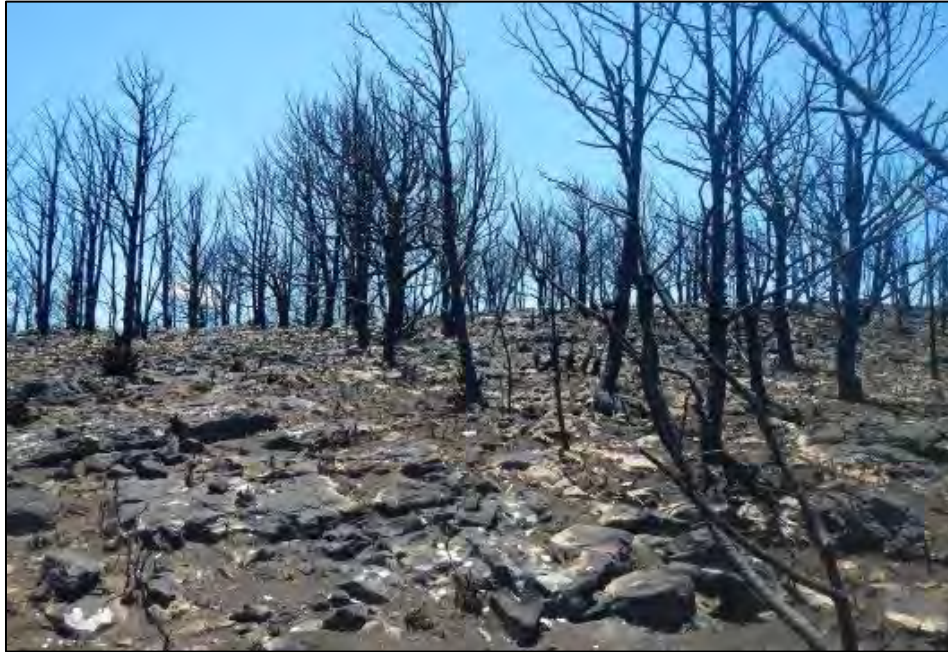
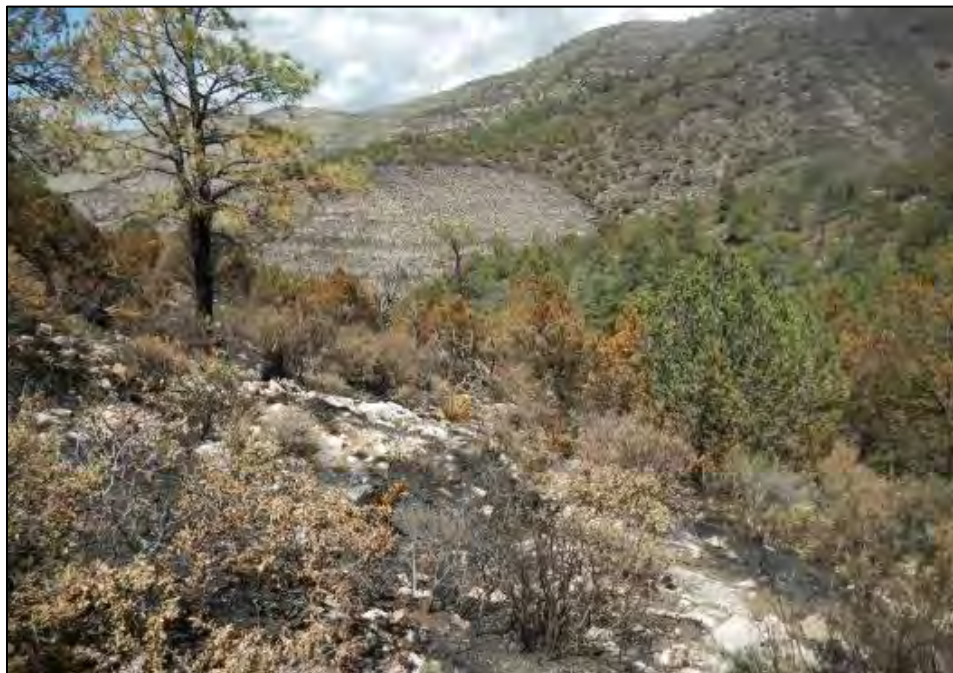
Figure 79. Contrast of burn severity classification in the Madrean Pinyon Juniper Woodland: moderate severity fire with stand replacement (upper photo) and with surface fire (lower photo). 43 acres of this vegetation type (30%) was mapped moderate severity, which represents 7% of the Madrean Pinyon Juniper Woodland in the PAC. The upper image is photopoint 26 looking ESE; the lower is photopoint 90 looking NE.

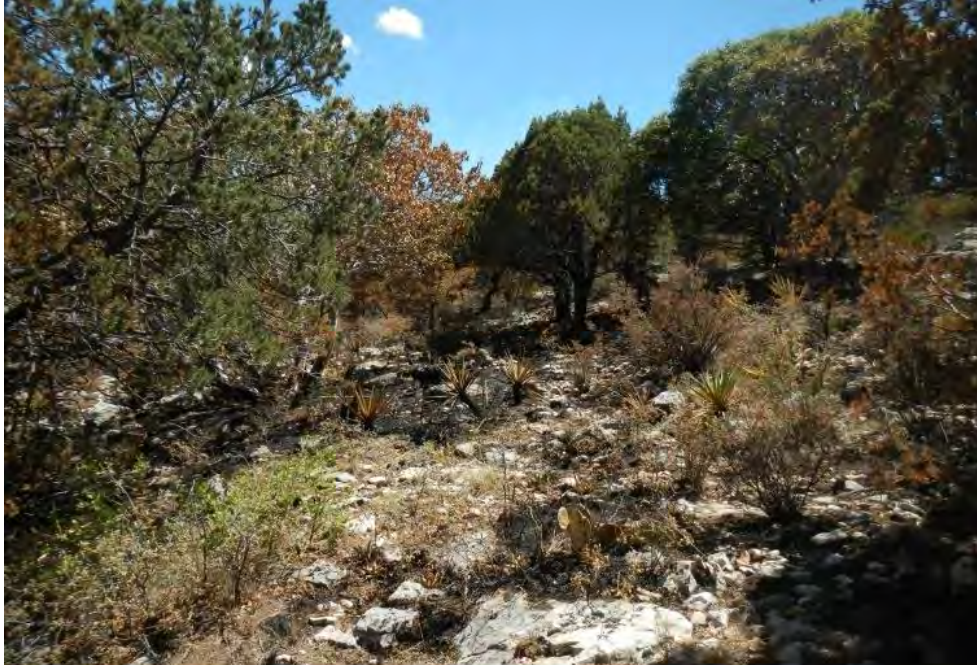
Figure 80. Madrean Pinyon Juniper Woodland with low severity fire. 45 acres of this vegetation type (32%) were mapped as low severity, which represents 7% of the entire PAC. Photopoint 85 looking SSE.

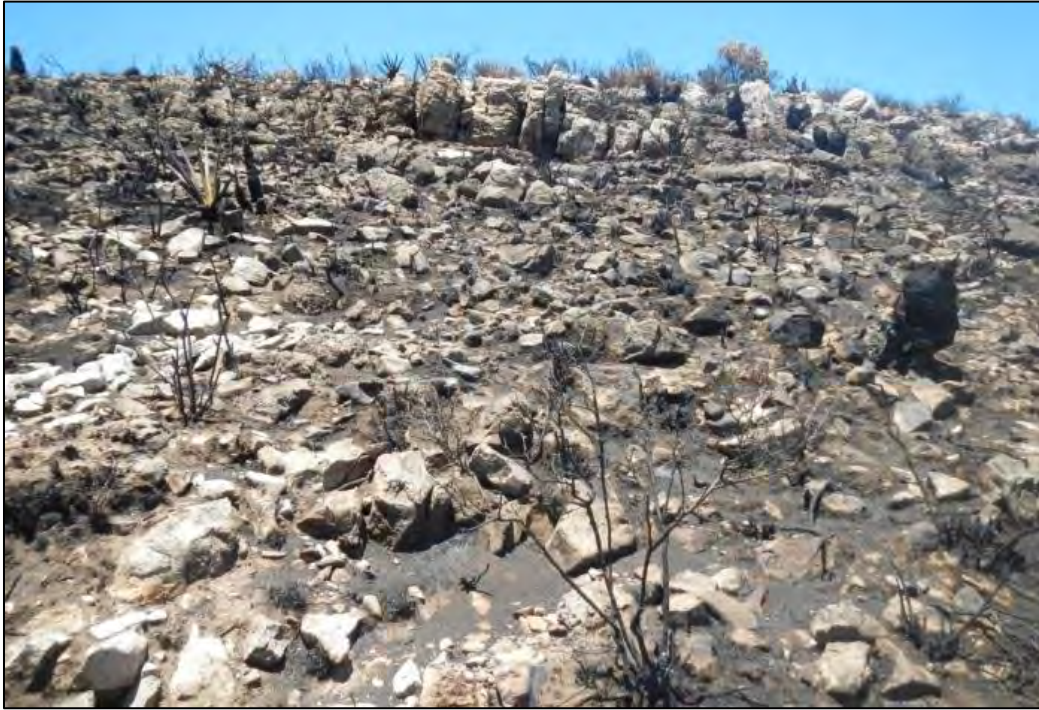
Figure 81. Wavyleaf oak community on the NW side of Dog Canyon Spring PAC, classified as moderate severity burn. Moderate fire affected 80 acres (40%) of the vegetation type within the PAC and 12% of the. Photopoint 8 looking NW.

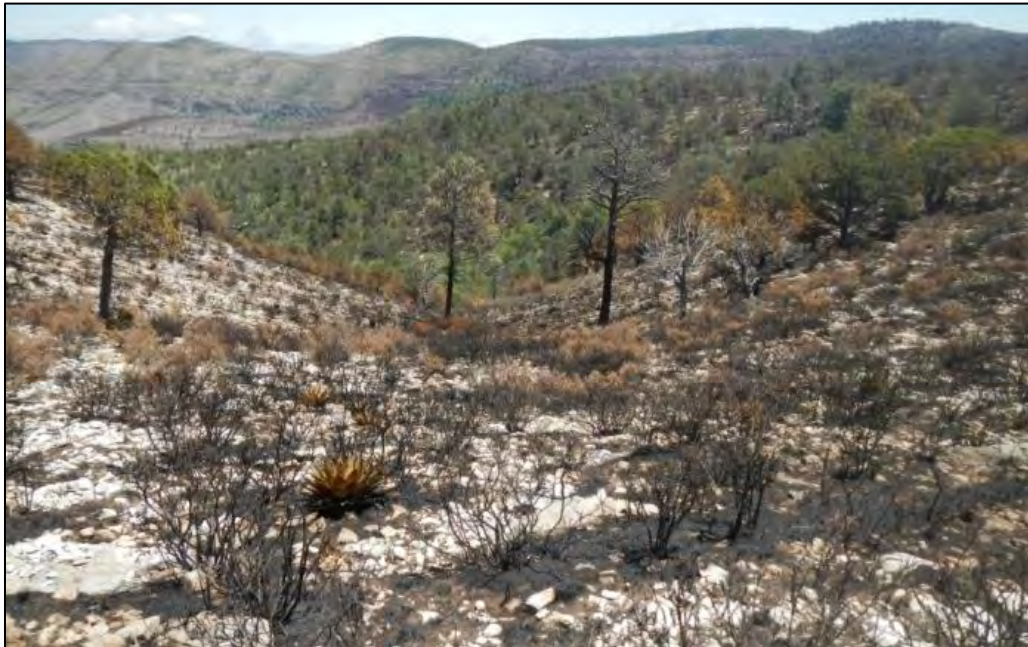
Figure 82. Wavyleaf oak community mapped as low severity burn. In this PAC, 38.4 acres (19.2% of the vegetation type and 5.9% of the PAC) mapped as low severity fire. Photopoint 10 looking ENE.

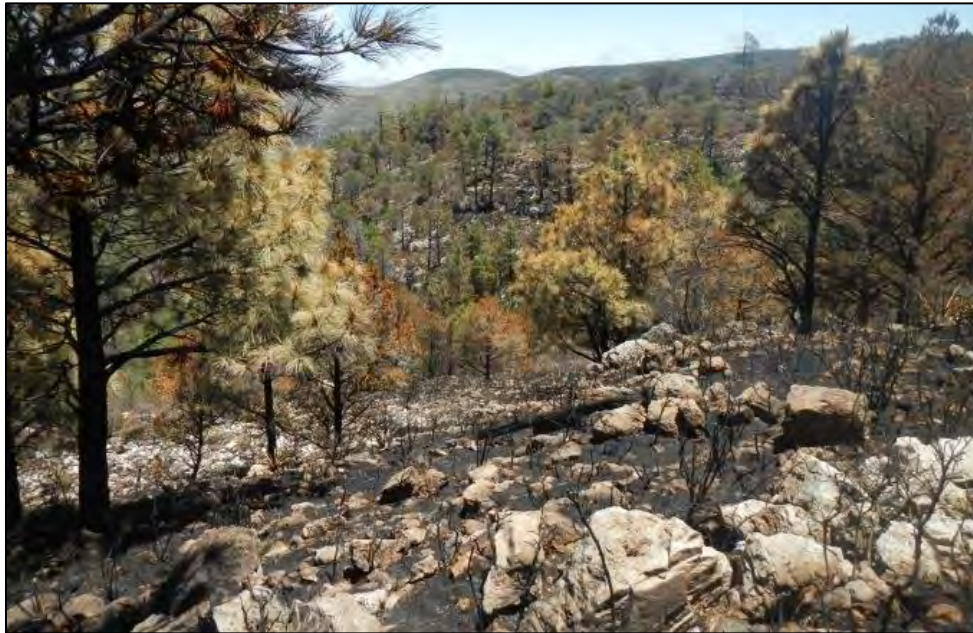
Figure 83. Moderate severity burn within this vegetation type. Within this PAC, 18 acres were classified as moderate severity (19% of this vegetation type within the PAC, 3% of the PAC as a whole). Photopoint 15 looking NE.

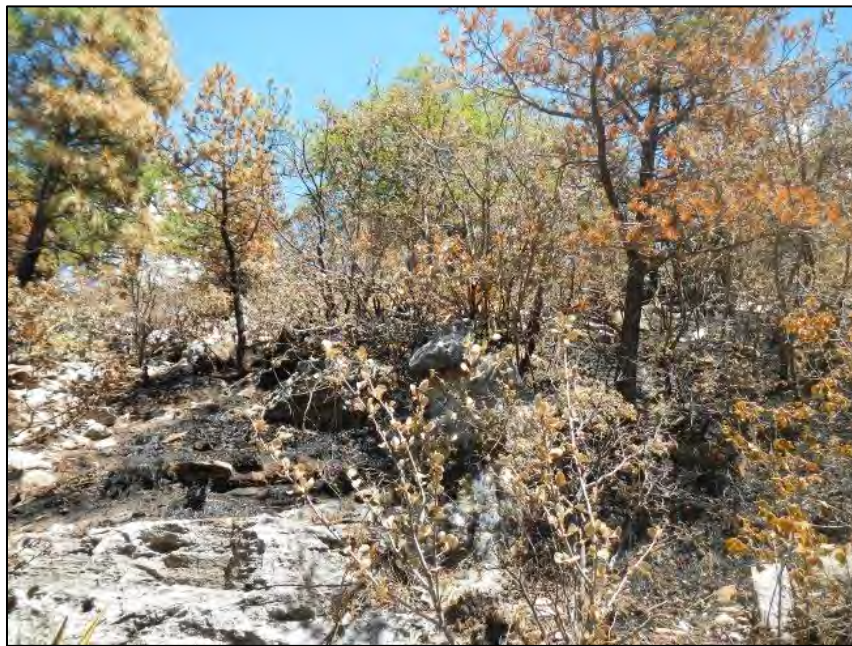
Figure 84. Low severity burn within this vegetation type. 38 acres were classified in this PAC as low severity (42% of this vegetation type within the PAC, 3% of the PAC as a whole). Photopoint 44 looking E.

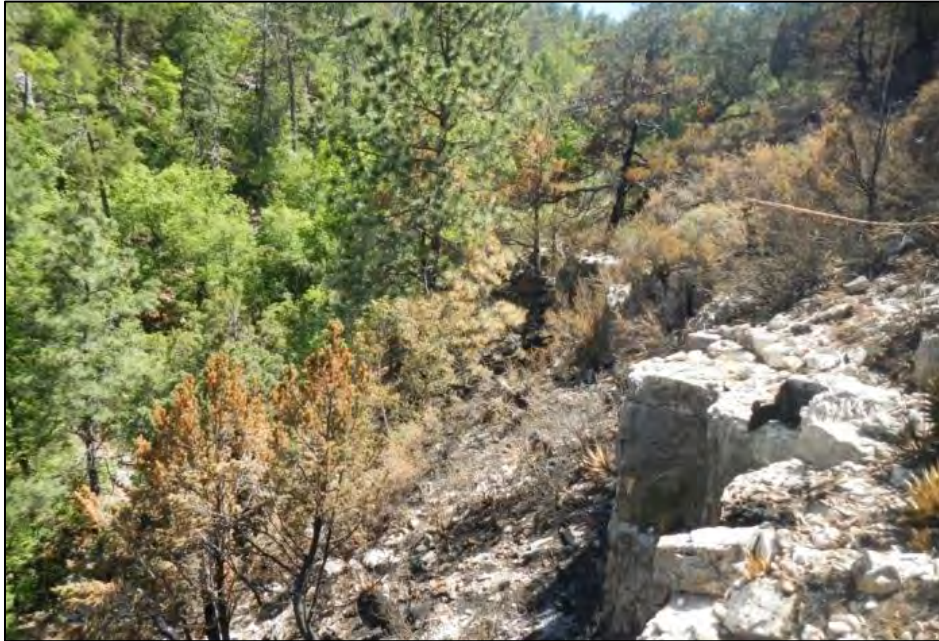
Figure 85. Moderate severity burn within this vegetation type. 19 acres were classified in this PAC as low severity (31% of this vegetation community within the PAC and 7% of the PAC area). Photopoint 121 looking south.

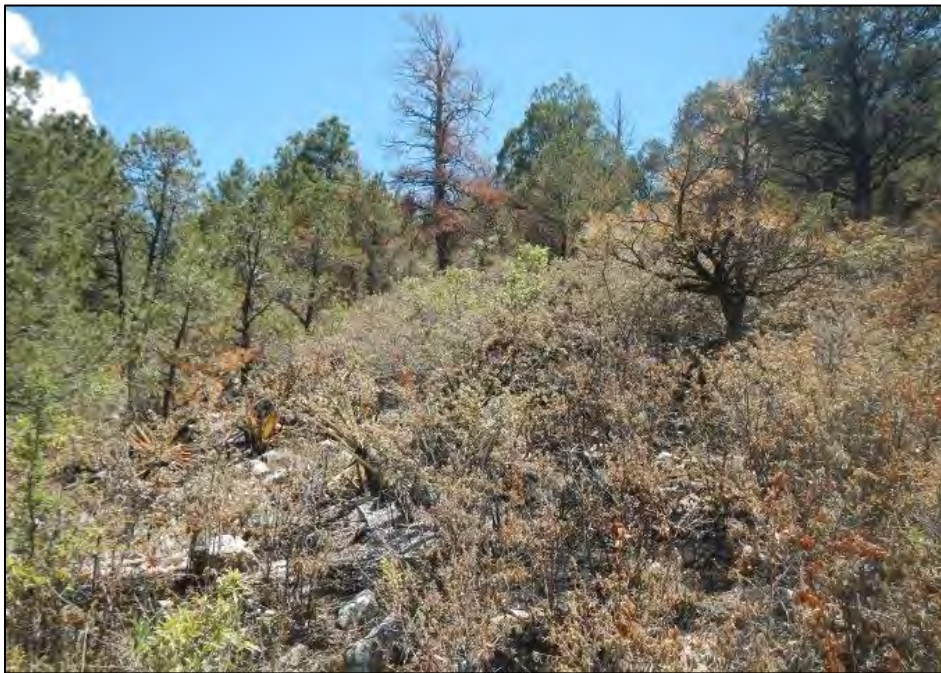
Figure 86. Madrean Ponderosa Pine / Wavyleaf Oak mapped as low severity. 21 acres of this vegetation type in the PAC classified as low severity (33.7 % of this vegetation community within the PAC, 7% of the PAC area). Photopoint 59 looking SSE.

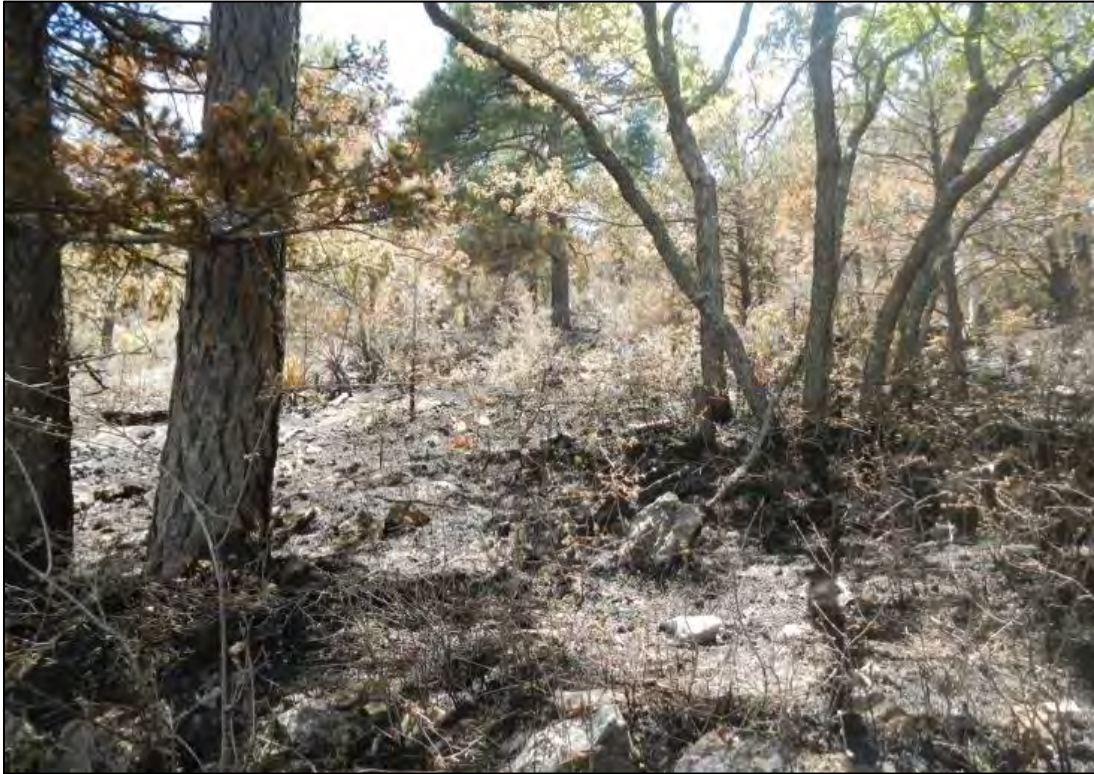
Figure 87. Photopoint 66 looking SSW, low severity burn. 19 acres of this vegetation type was classified as low severity (22% of vegetation type within the PAC and 2.8% of the PAC area). No photos available for moderate severity for this vegetation type.

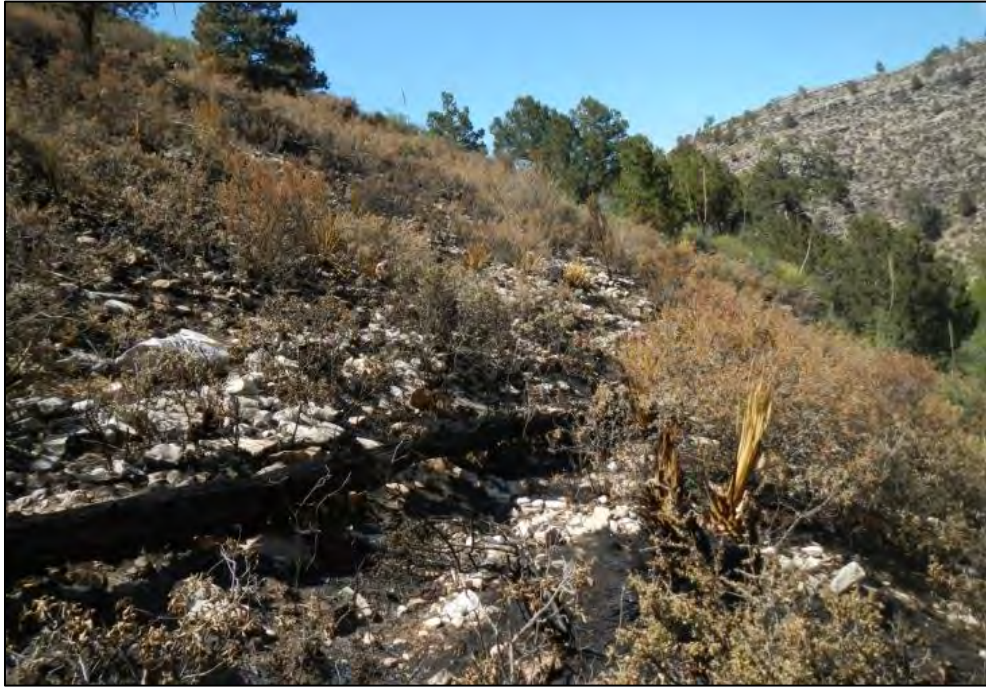
Figure 88. Photopoint 134 looking N, moderate severity burn. 16 acres of Mountain Mahogany shrubland was classified as moderate severity, which is 60% of this vegetation type within the PAC and 2.5% of the PAC area.

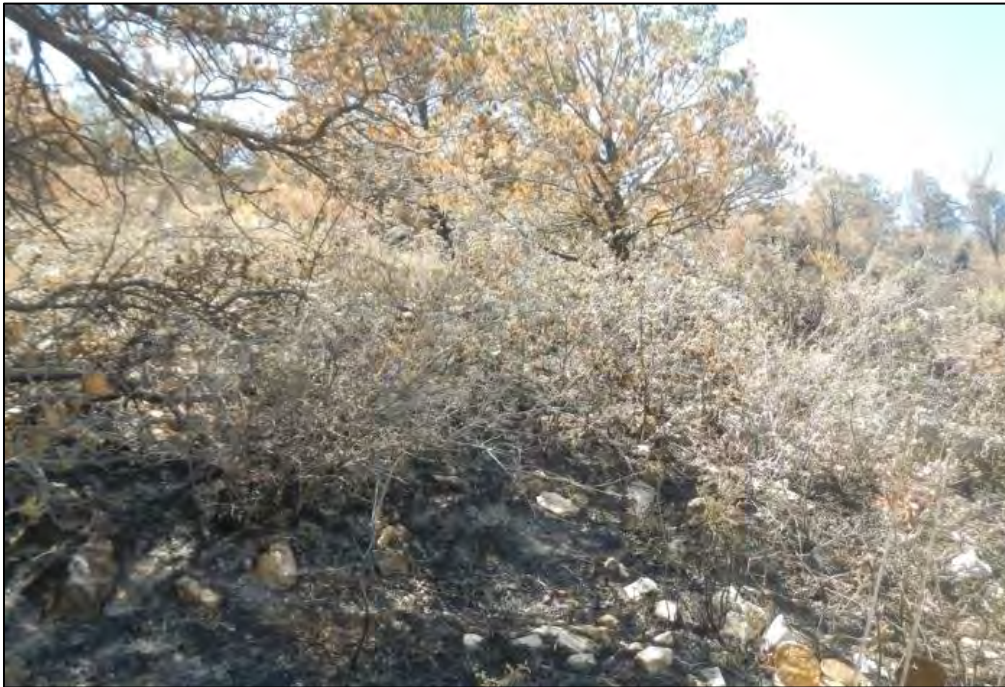
Figure 89. Three acres of this vegetation type were classified as low severity which is 9% of this vegetation type within the PAC and 0.4% of the entire PAC area. Photopoint 97 looking NNW.

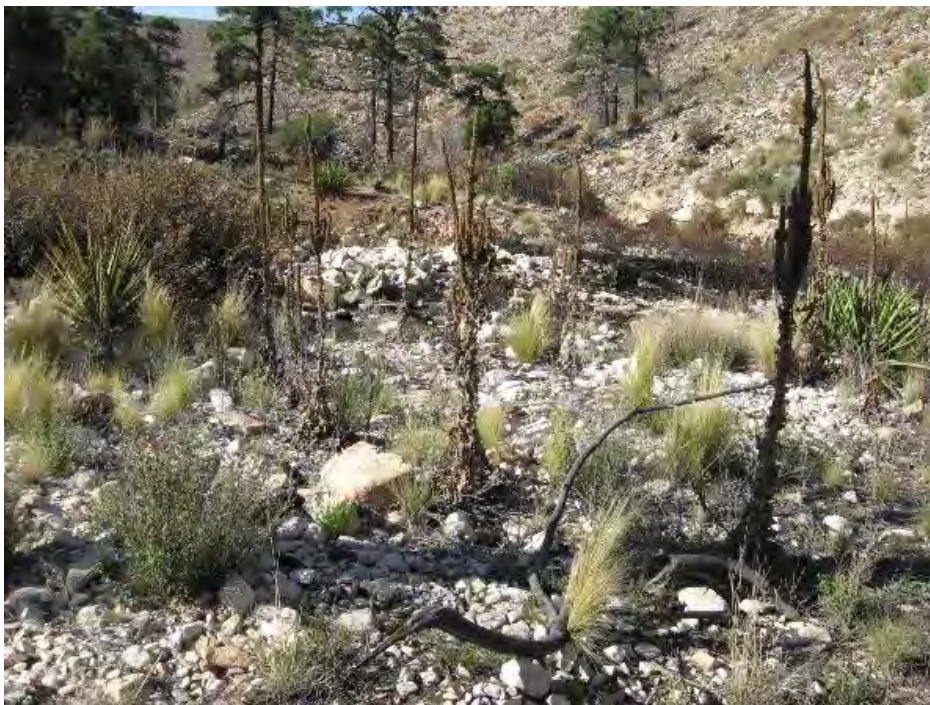
Figure 2. Woolly mullein in a low-severity burned tributary of Dog Canyon.

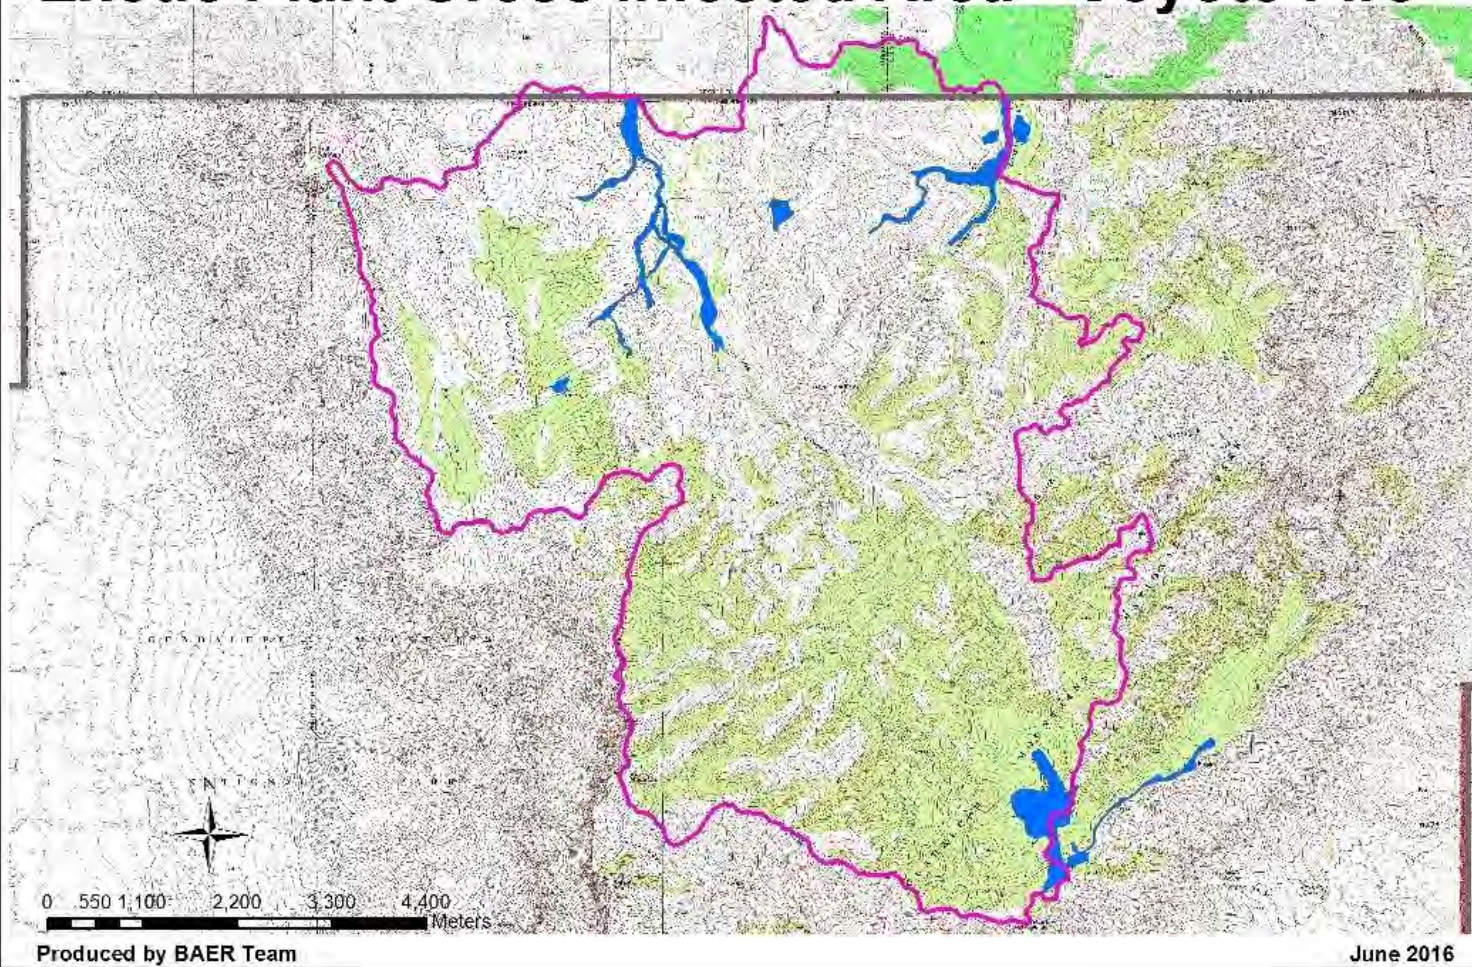
Exotic Plant Gross Infested Area - Coyote Fire

extensive seed bank. The other known weed locations burned with low to moderate severity and weed remnants were readily recognizable (Figures 1 and 2). We modified the gross infested area boundaries with the new field data to produce the attached map (Figure 3).

Gross infested area represents a line drawn around “near neighbor” individual weed populations (Table 6, Figure 3). Weed cover within the gross infested area is generally 1% or less.

Figure 3. Map of the Coyote Fire (magenta outline) showing (in blue) the 2016 extent of known weed infestations at Cox Tank, West Dog Canyon, Manzanita Ridge, Dog Canyon, and the Bowl.
