Coyote Fire Burned Area Rehabilitation Plan

Guadalupe Mountains National Park

Coyote Fire

BURNED AREA REHABILITATION PLAN

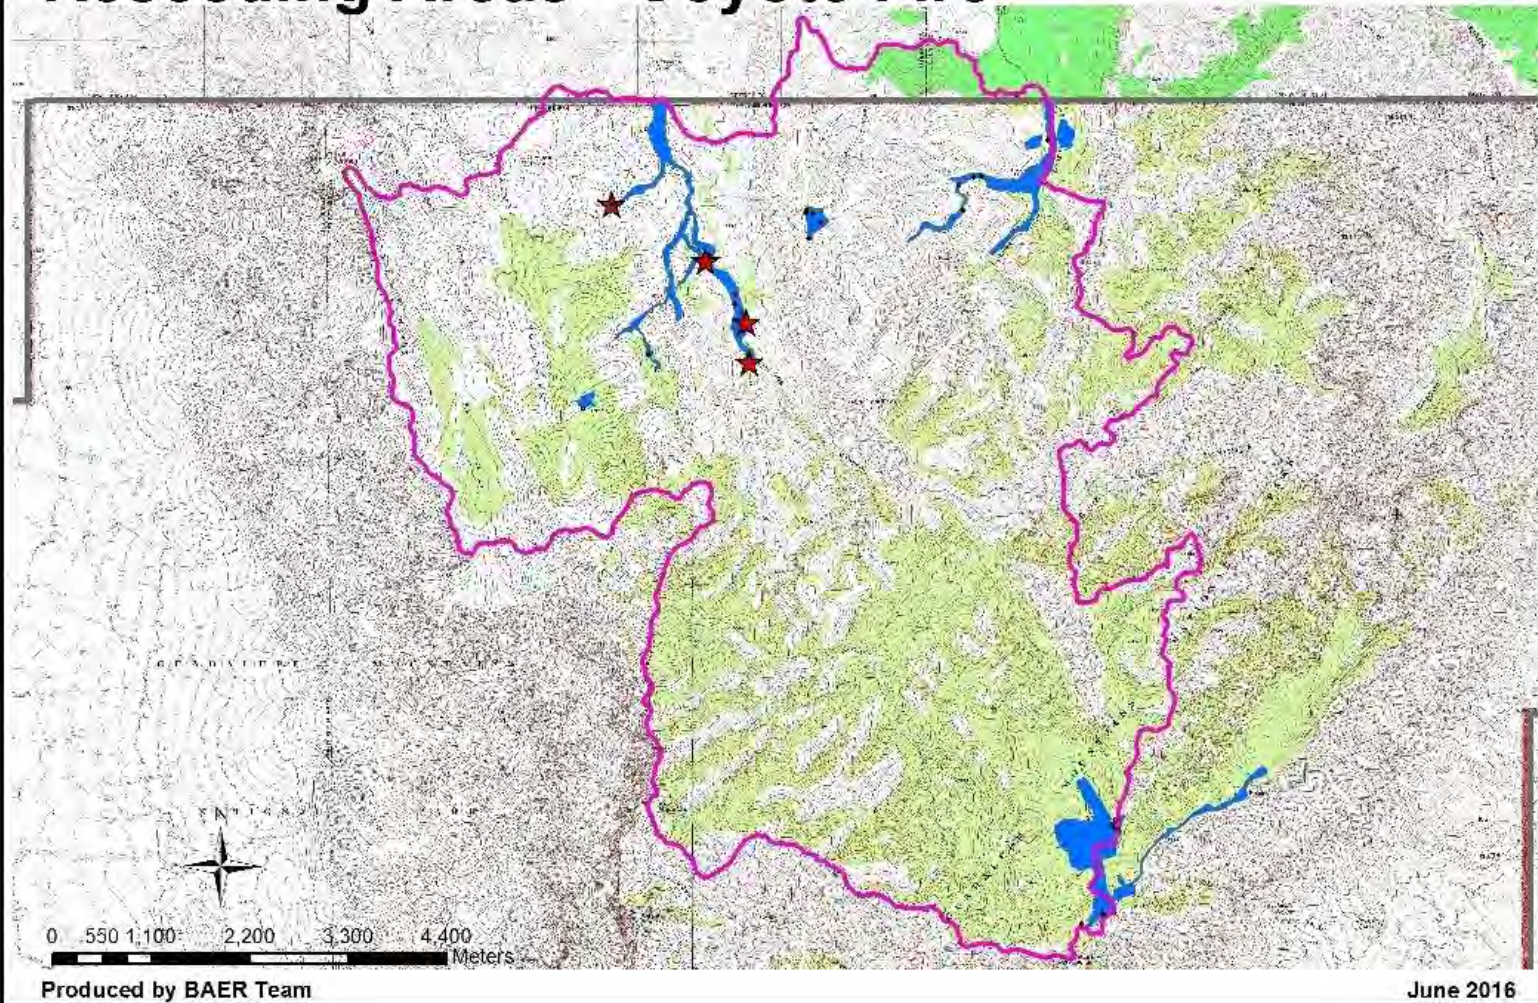
Reseeding Areas - Coyote Fire

Figure 4. Map of the Coyote Fire showing the four areas (red stars) proposed for reseeded and stabilization in West Dog Canyon.

- B. Reseeding highly degraded areas (Specification V2). Four locations in West Dog Canyon (Figure 4) are stuck in a cycle of Russian thistle – bare ground – Russian thistle infestation. Erosion is affecting these areas severely, and a lack of a native seed bank means that without intervention this pattern will continue until all soil erodes away. Three areas are former stock ponds and one is a former corral; all are also cultural sites that will benefit greatly from stabilization. Total area proposed for reseeded is approximately five acres. Gather native grass seed (Mexican feathergrass, black grama, blue grama, and alkali sacaton) in Dog Canyon and West Dog Canyon during the summer; scatter in 10m x 10m patches covered with anchored jute netting to hold the seed in place. Time the planting after the monsoon so to take advantage of gentle winter rains (October-November).

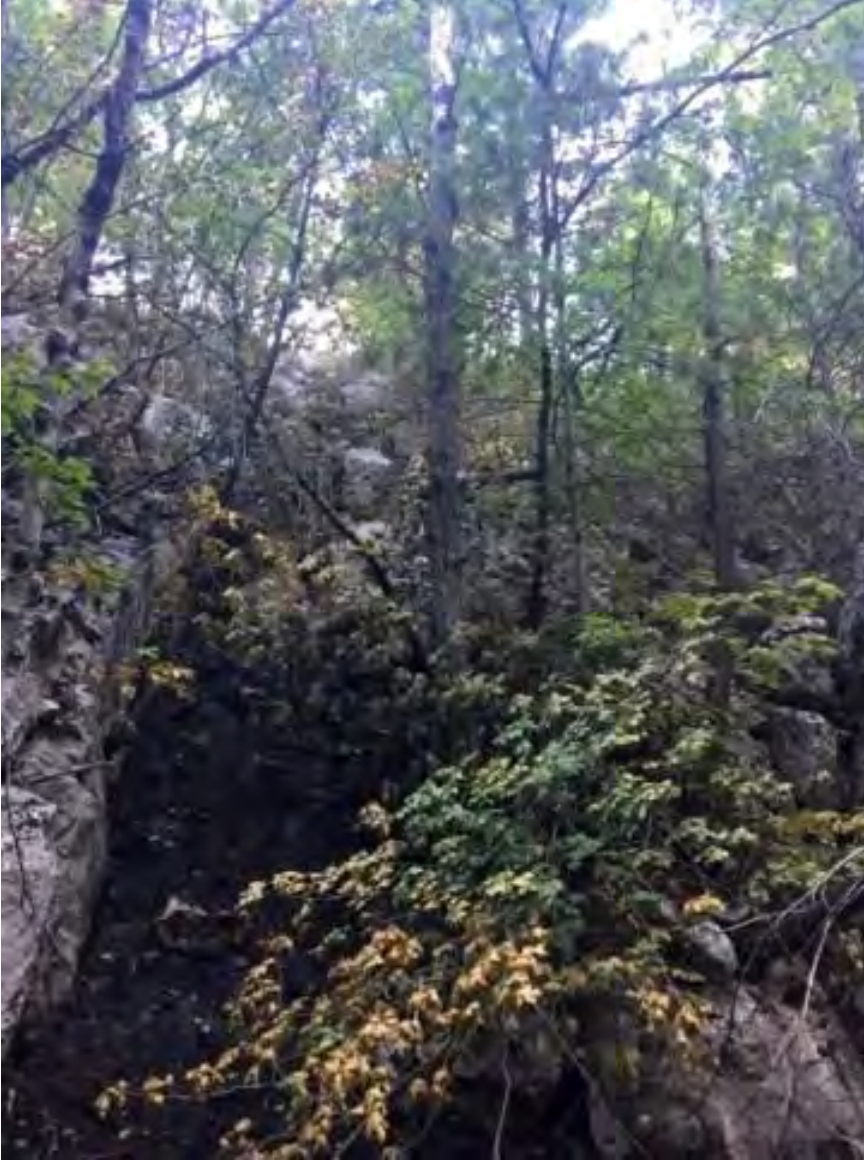
Figure 5. Relict aspen grove in Guadalupe Mountains National Park.

1. Thin conifers from the interior of the aspen stand (Figure 5). Low- to moderate-intensity fire is likely to stimulate this declining, relict stand to re-sprout. High-intensity fire, as would be likely with a dense infill of conifers, would probably kill the remaining aspen root stock. Removing the recent conifer growth will help protect this stand until fire can naturally regenerate it.
2. Resurvey the high country for rare plants, especially Guadalupe violet. The Texas Parks and Wildlife Department has proposed a rare plant survey of the high country for 2017.
